BDK Septic Service
P.O. Box 7641
Santa Rosa, CA 95407
707-527-8788

Client Information: Record Number inv#30986

Micallef, Barbara
6341 W. Dry Creek
Healdsburg, CA 95448

Inspected 5/1/15 2:00 PM

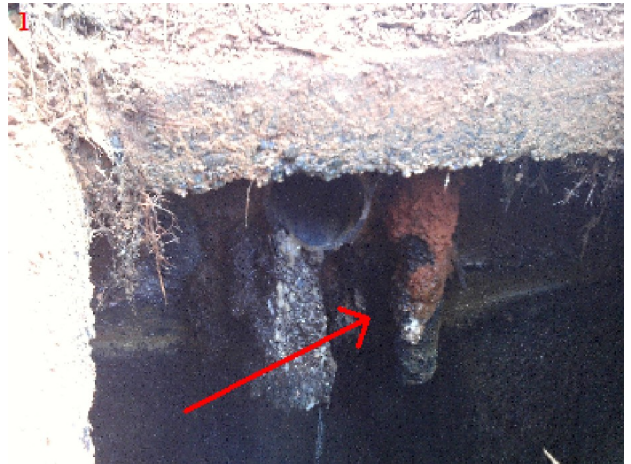
Condition of Inlet Baffle:

Needs to be replaced - Cost would be \$450.00

Unsatisfactory **Condition of Inlet Baffle: - Severely Damaged**

Needs to be replaced - Cost would be \$450.00

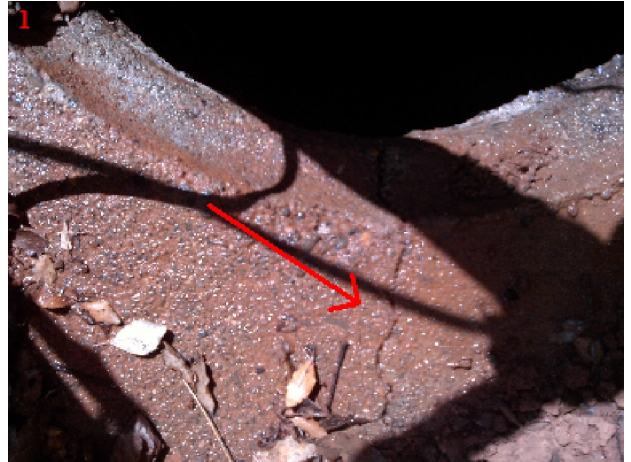
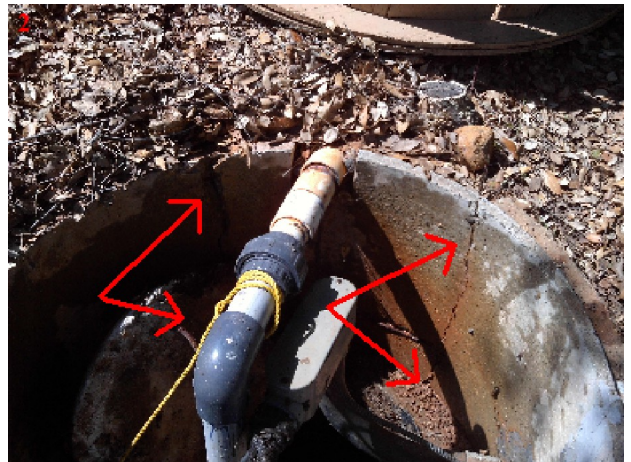
Condition of Tank and Lid:

Found crack on the top of the pump station and the riser - Need to patch the cracks
Cost would be \$250.00

Unsatisfactory **Condition of Tank and Lid: - Damaged**

Found crack on the top of the pump station and the riser - Need to patch the cracks
Cost would be \$250.00

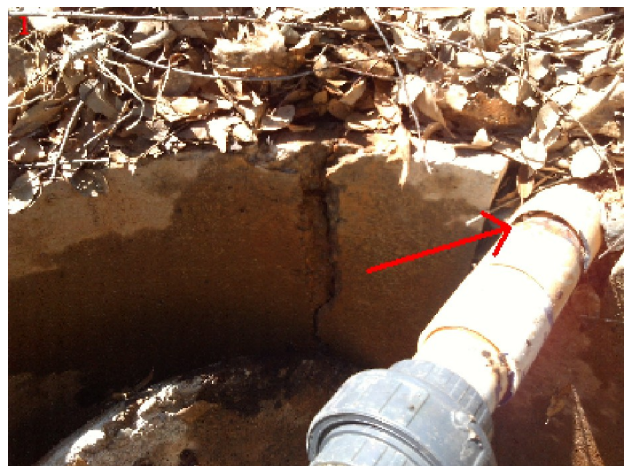
Pump Elevated Off Floor:

Does not sit on the pedestal properly, Pump needs to be reset
pipe from the pump to the leach line leaks at fitting - need to be replumbed
Cost for this would be \$350.00

Unsatisfactory **Pump Elevated Off Floor: - Yes**

Does not sit on the pedestal properly, Pump needs to be reset
pipe from the pump to the leach line leaks at fitting - need to be replumbed
Cost for this would be \$350.00
