## Spring Yield Test & Water System Inspection

7625 Tarwater Rd, Santa Rosa Ca 95404

Date: 4/8/15  
Report #: 7167-2  
Client Name: Torgeson Trust  
Agent Name: Doug Swanson - Pacific Union  
Phone: 707 291 4400

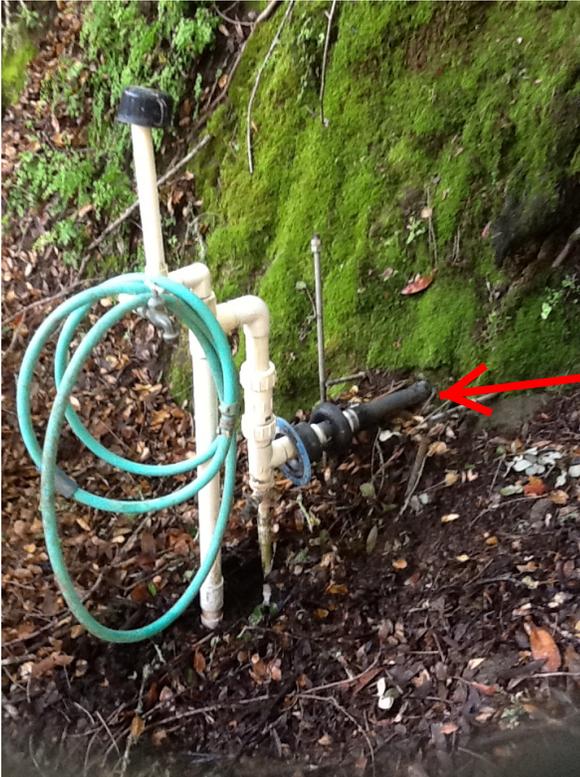
Spring source

There is a 1.5" PVC pipe emerging from the hillside near the storage tanks. There is a clay seal around the pipe. It appears to be a horizontally drilled spring source.

1.5" PVC pipe

5. Spring sources are vulnerable to bacteria since they are surface water sources. We recommend installation of an Ultraviolet treatment system for the house supply. Water test results pending.

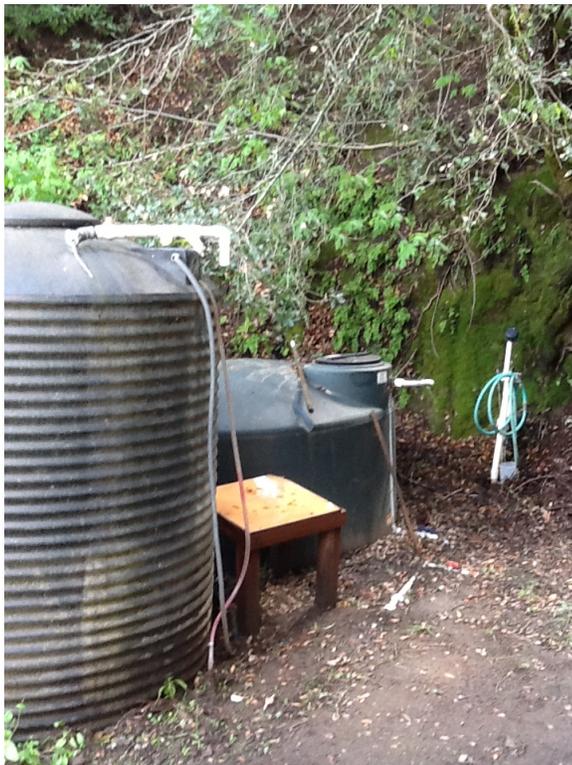
The spring gravity flows to fill the 1100 gallon storage tank. It fills the tank from the bottom flange. There is an overflow pipe that routes the overflow water out of the top of the tank to a nearby drainage ditch.

There is also a 2000 gallon storage tank (pictured left), which is empty and the valve at the base is closed since the tank has a leak.

1. The booster pump is not protected from dry running. Recommend installing a low level float in storage tank.
2. The pressure tank is only sized for one occupant. Recommend installing larger pressure tank to prevent the pump from short cycling or installing a gravity feed system (possibly using the existing storage tank at the top of the hill).

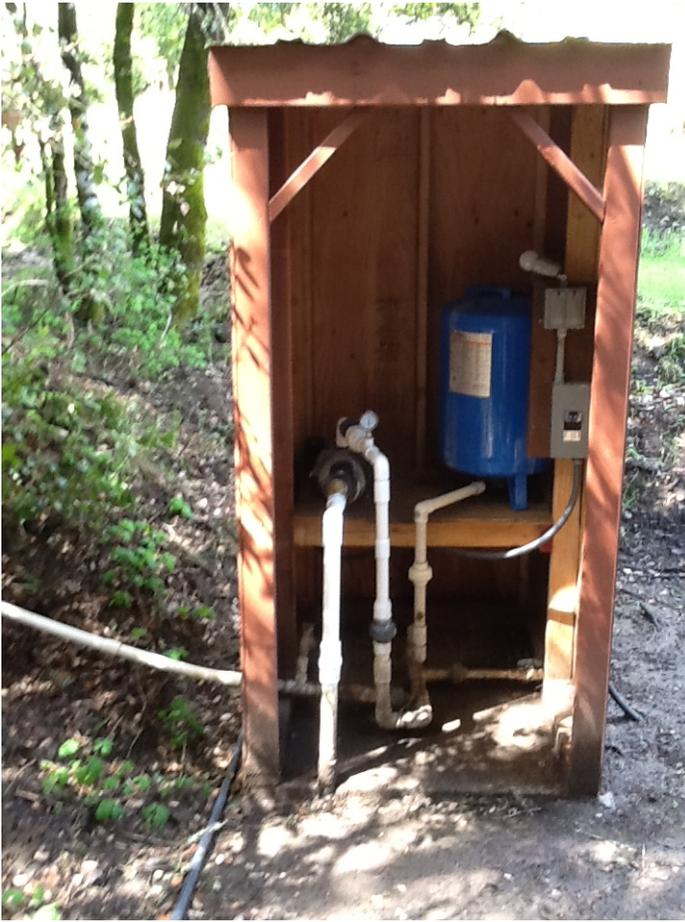
The pump system located next to the spring pressurizes water up the hill to the house.

Pump:  
1HP 230V FloTec FP4032  
Jet pump

Breaker:  
15 amp 2 pole

Pressure Tank:  
FP7110T  
Air charge:  
30 psi

System operating  
pressure:  
32 psi to 52 psi (at pump  
elevation)

3. The pressure switch setting on the booster pump is too low relative to the elevation change from the pump to the house therefore the pressure at the house tested 22 psi. Recommend readjusting the system pressure or installing a gravity feed system.

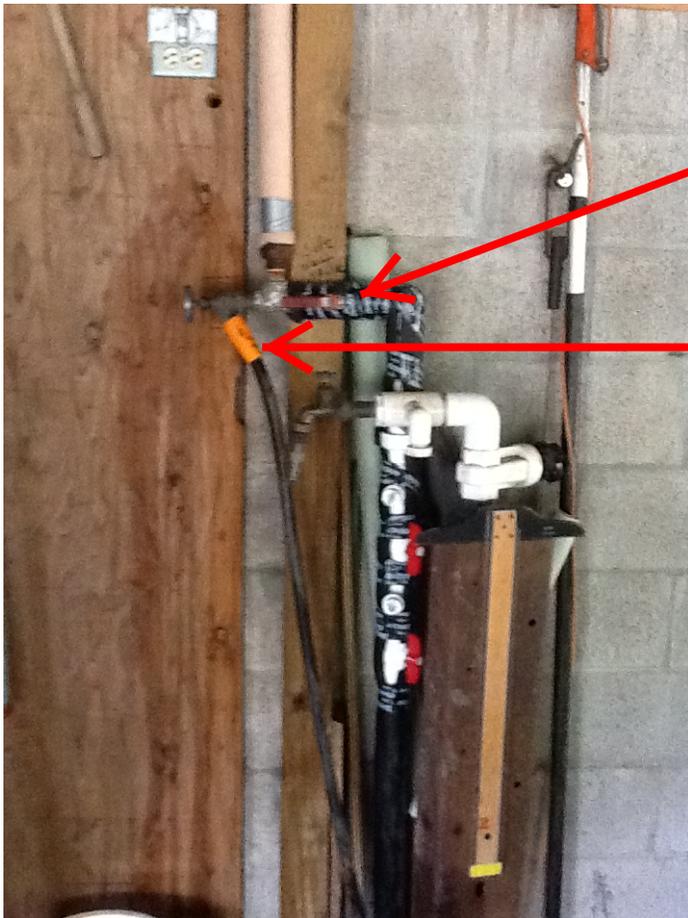
The house water main located in the garage.

There is a cross connection with a garden hose that allows the well located near the rental house to supply the house in an emergency. Similarly, the spring pump can supply the rental using the same garden hose.

4. We noted a garden hose connects from the well to the main water pipe at the house. The well is only used as a backup source to the house. A more reliable method of allowing the well to cross connect to the house would be to install a buried water pipe.

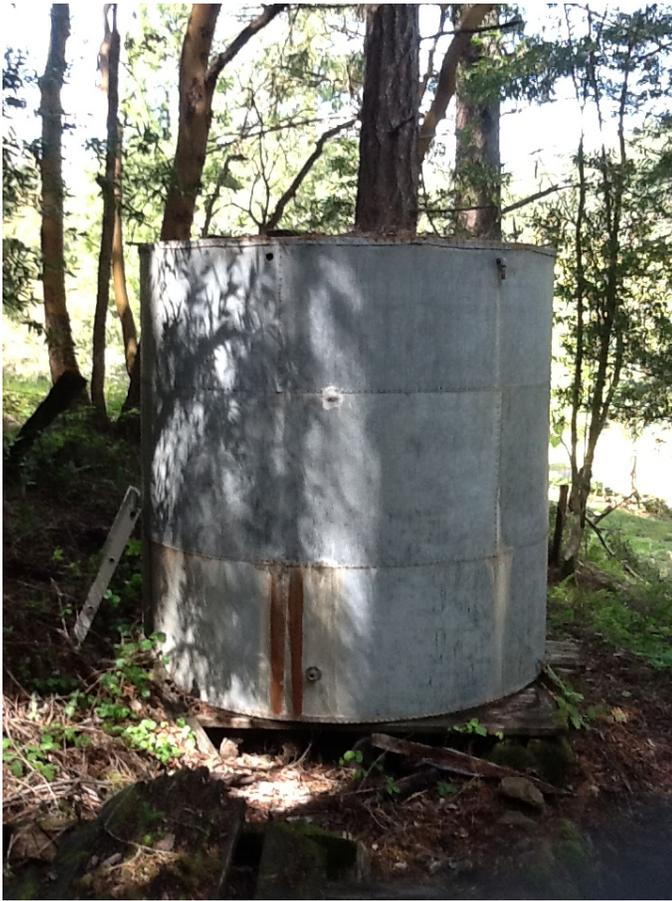
There is an old galvanized tank up the hill from the house. The tank is empty and is not connected.

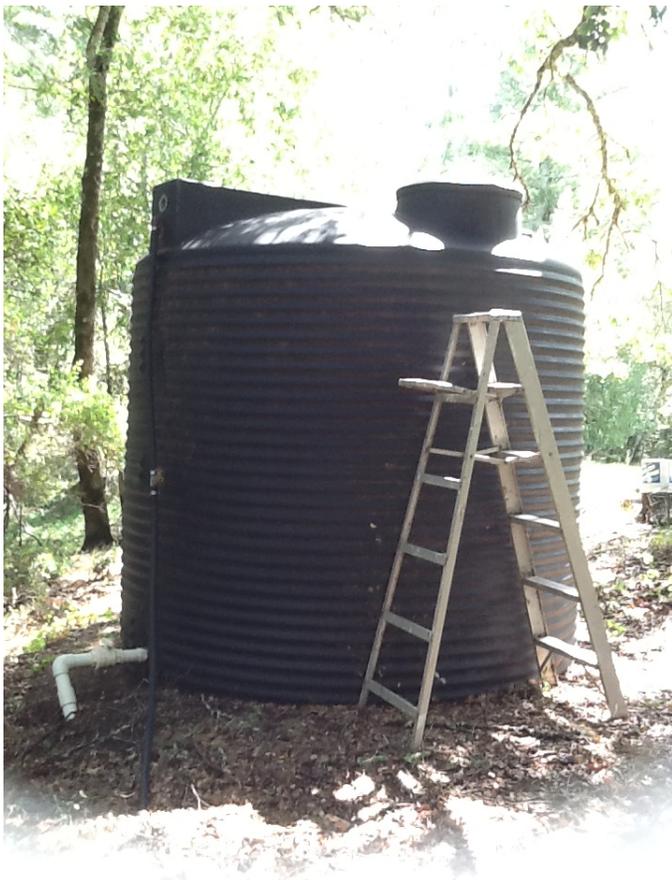
There is a 2500 gallon poly tank at the top of the hill above the house.

There is a hose spigot on the 1" black poly tube fill pipe. The spigot did not run.

There is a 2" PVC line leaving the bottom of the tank that appears to run down the hill. The valve at the base of the tank was closed. It appears this serves a fire hydrant along the driveway. Since the valve was found closed, this line was not tested.
