Gage Inspection Services

Property Inspection Report

2403 Helena View Ln, Sebastopol, CA 95472
Inspection prepared for: James Kershner
Real Estate Agent: Mary Haufler - Sothebys

Date of Inspection: 12/6/2017 Time: 9:00 AM
Order ID: 7

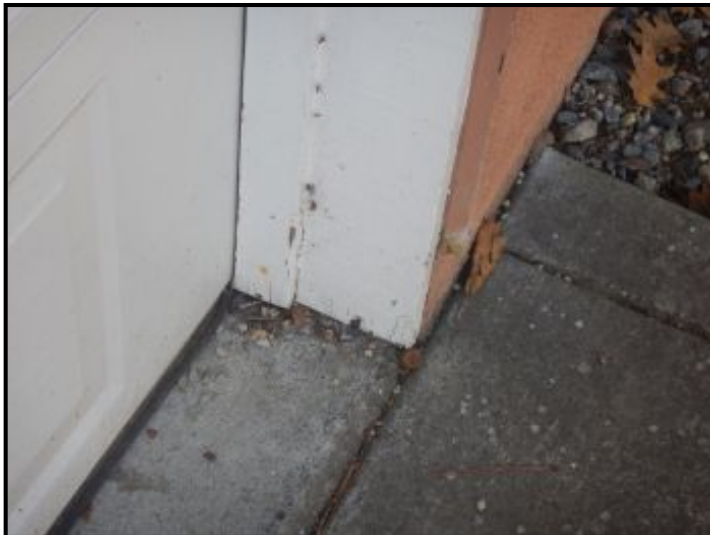
Page 9 Item: 7	Fascia Boards/Trim	<p>Maintenance Trim/fascia damage has been noted at the front right side of the home. We recommend referring to the pictures and contacting a qualified contractor to review the current pest report and make needed repairs.</p>
----------------	--------------------	---

Trim damage at garage

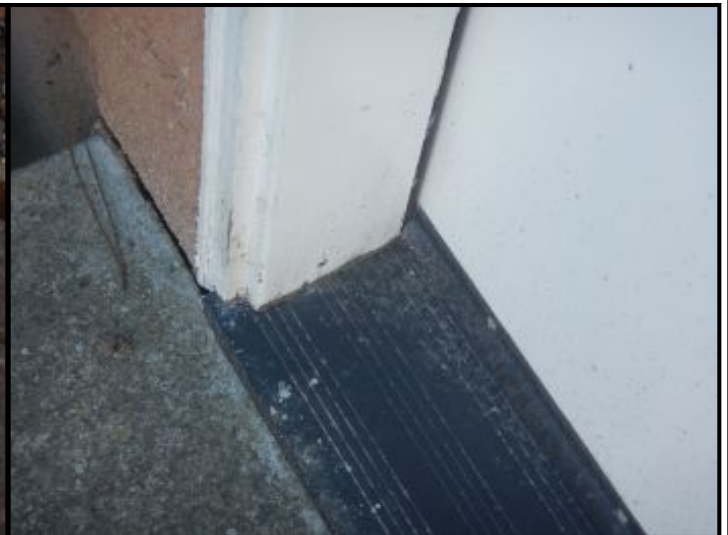
Door jamb damage to rear exterior door

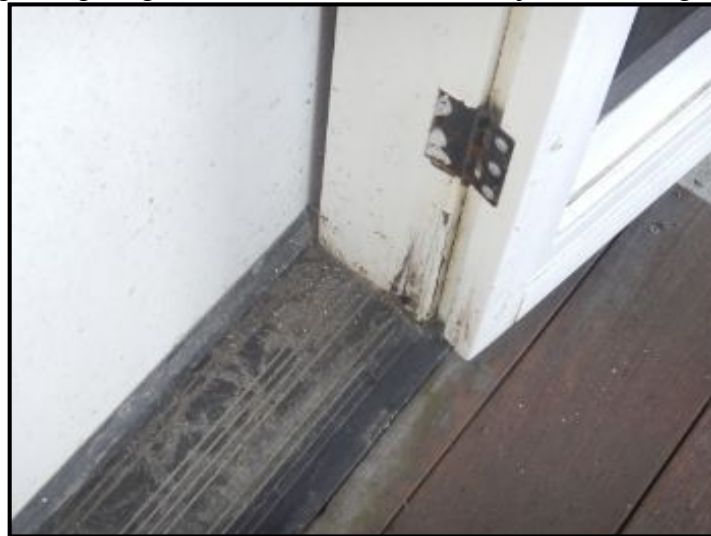
Door jamb damage at rear exterior door

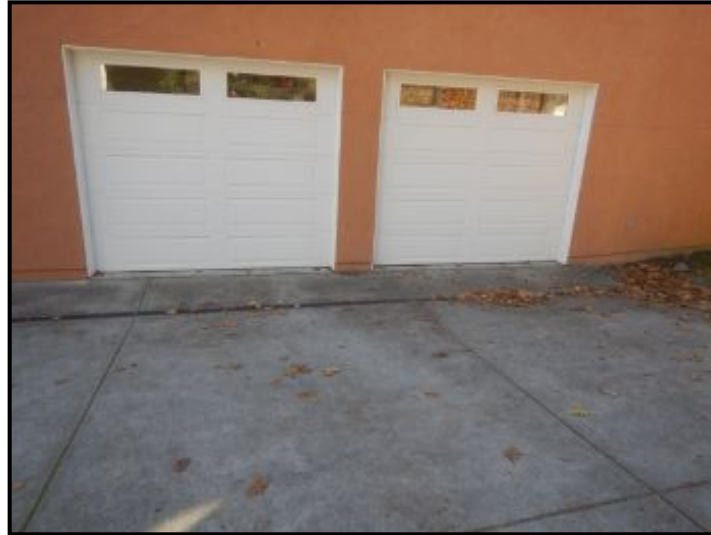
Page 12 Item: 1	Driveway(s)/Parking	<p>Attention The driveway slopes to the home. There is a drain installed to divert runoff away from the home. Recommend monitoring this area during the rains to determine proper function. Inquire with owner disclosures for any past moisture intrusion or ponding water.</p>
-----------------	---------------------	--

Driveway slopes to home.

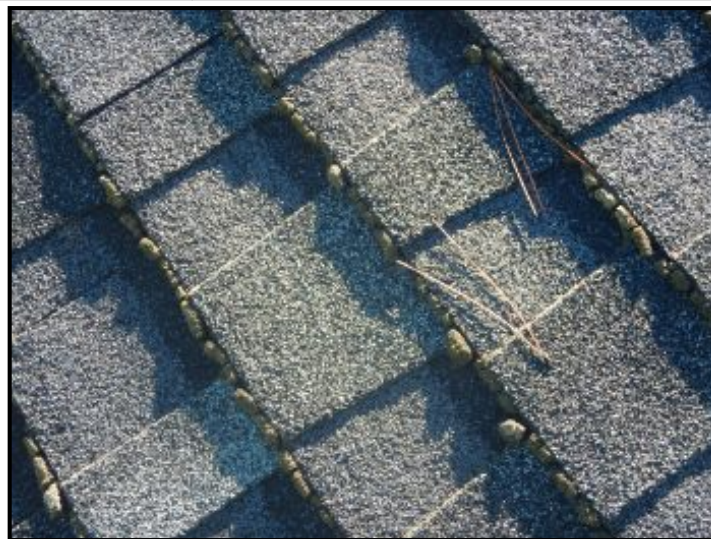
Page 15 Item: 3	Moss/Mildew	<p>Yes There is moss growth on the roof. The moss growth should be treated and removed.</p>
-----------------	-------------	---

Moss growth at roof top.

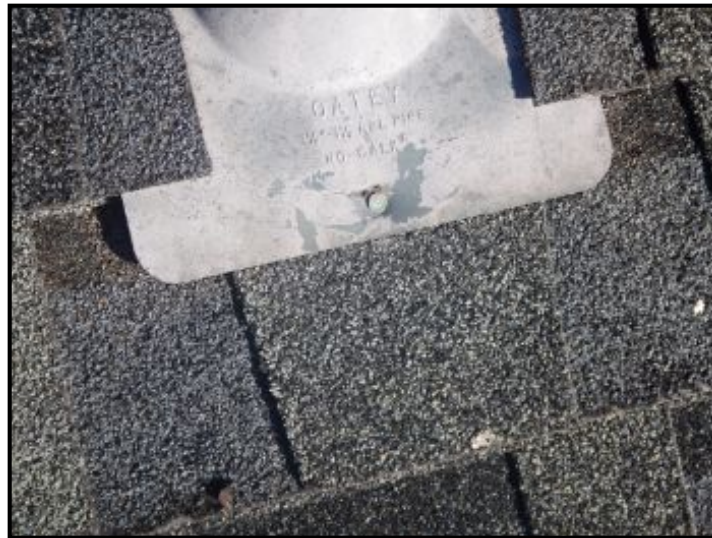
Page 16 Item: 9	Flashing/Caulking	<p>Attention There are some exposed fasteners at the roof top flashings. These are potential leaking points. It is advised to seal of these areas with a mastic type material as a preventative measure.</p>
-----------------	-------------------	--

Seal exposed fasteners as needed.

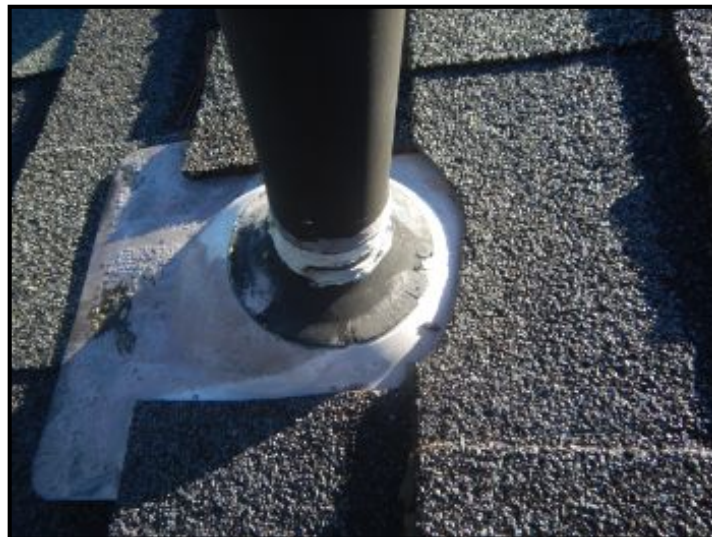
Some of the roof top plumbing vents are cracking and showing wear. Though functional future replacement of the storm collars is recommended Typically the storm collars are expected to have a 10 year life expectancy.

Worn storm collars at plumbing vents.

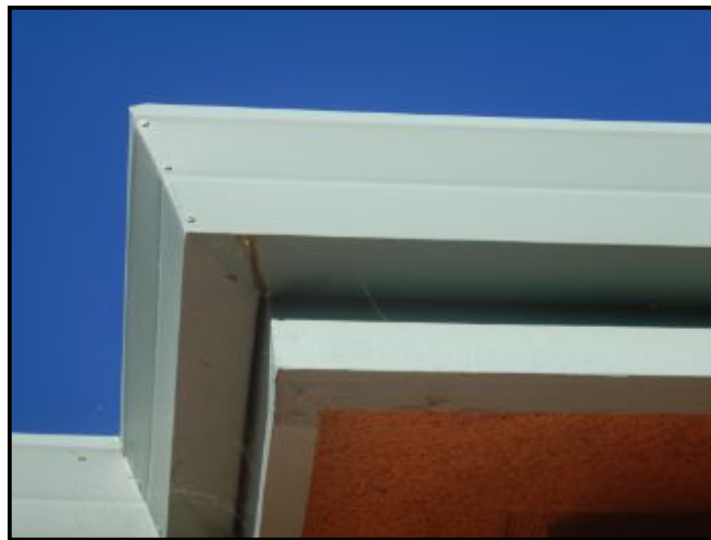
There is a gutter seam at the rear of the home that is leaking. It is recommended to caulk and seal the seams of the gutter to properly protect the structure and maintain intended drainage.

Leaking point at rear gutter seam.

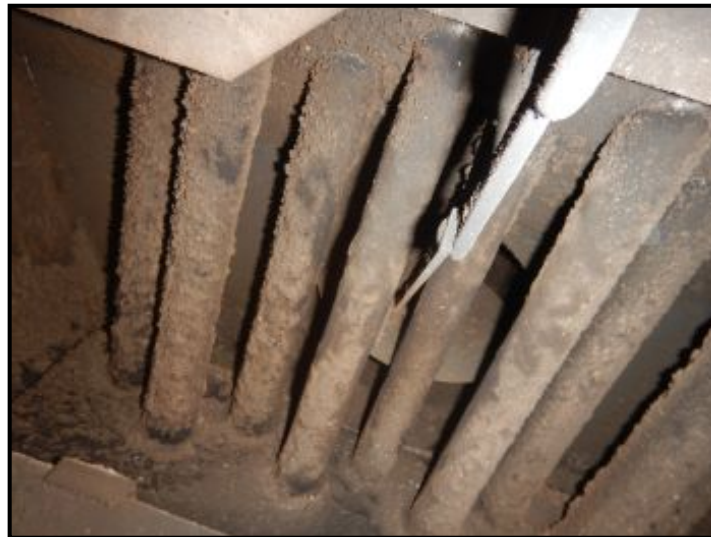
Page 24 Item: 1	Solid Fuel/Gas Logs/Gas Appliances	There is soot build up at the interior of the fireplace indicating cleaning is needed. Recommend contacting a qualified chimney sweep company for service.
-----------------	------------------------------------	--

Soot build up at fireplace.

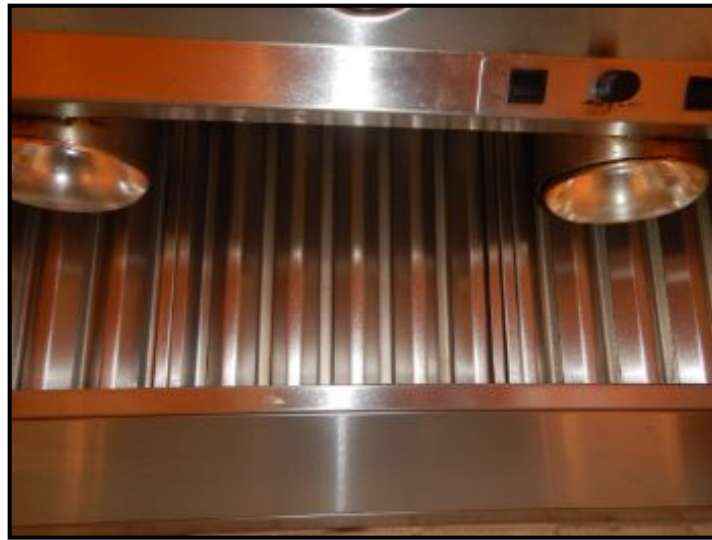
Page 25 Item: 9	Stove Exhaust Fan	Attention The stove top exhaust area is greasy. Recommend cleaning this area as a preventative measure.
-----------------	-------------------	---

Greasy stove top exhaust.

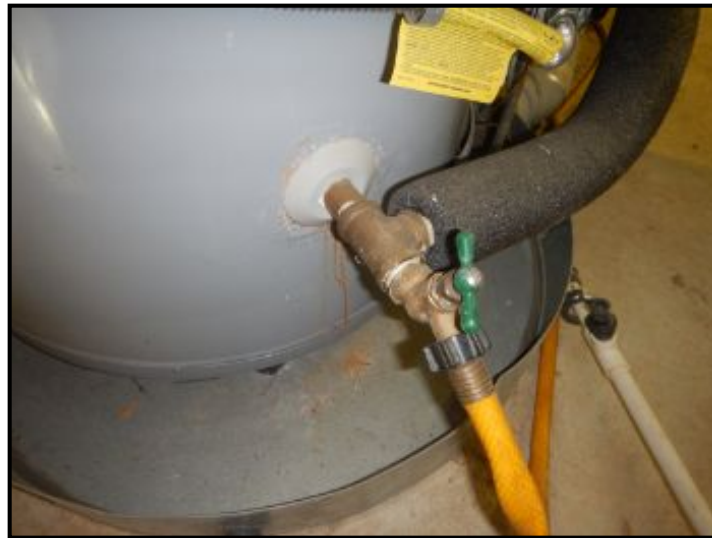
Encrustations at water heater

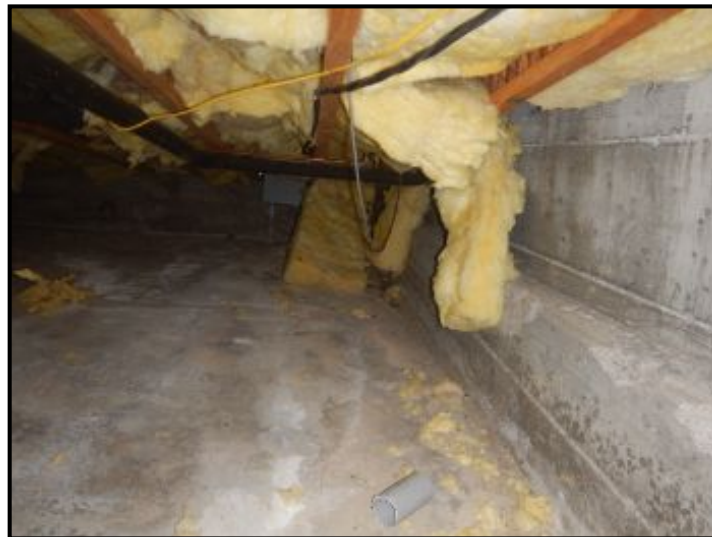
Some insulation has fallen in the sub area. It is recommended to reinstall insulation as needed and replace if wet or damaged.

Fallen insulation in the sub area.

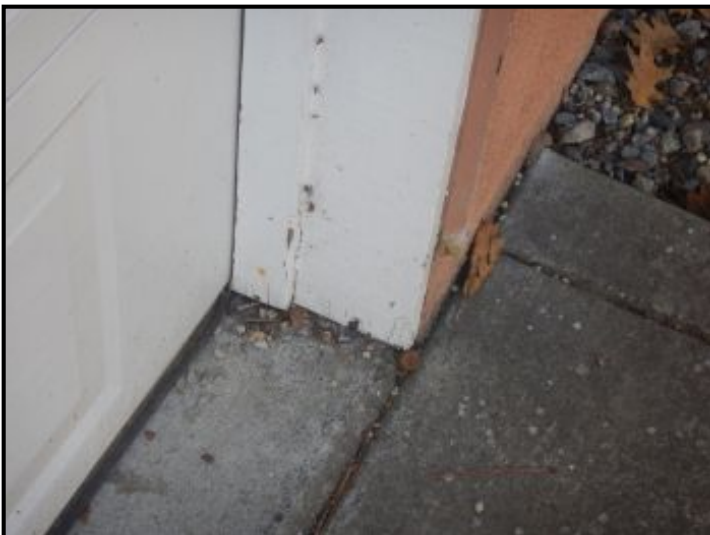
Trim/fascia damage has been noted at the front right side of the home. We recommend referring to the pictures and contacting a qualified contractor to review the current pest report and make needed repairs.

Trim damage at garage

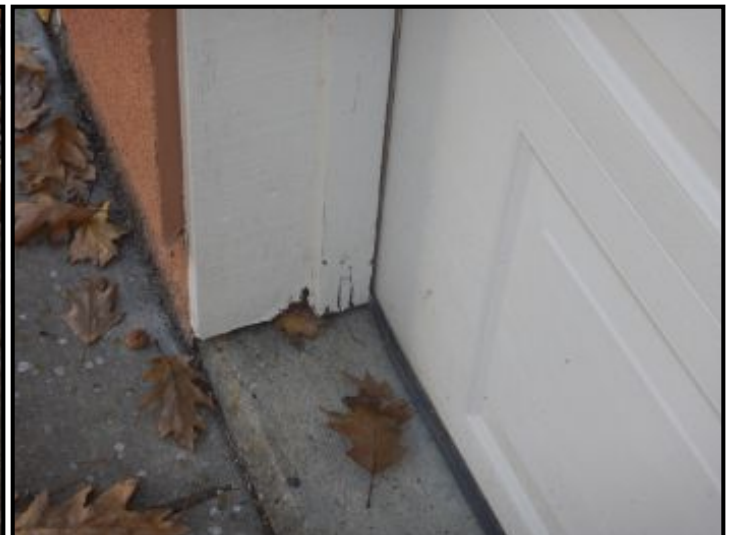
Trim damage at garage

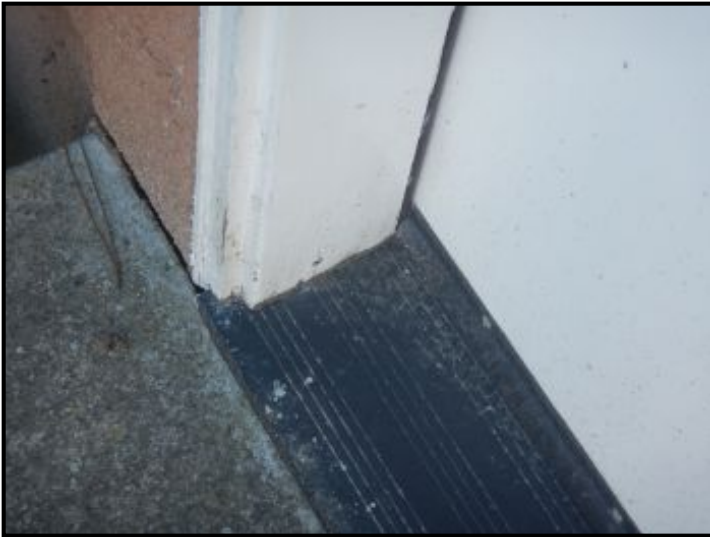
Door jamb damage to rear exterior door

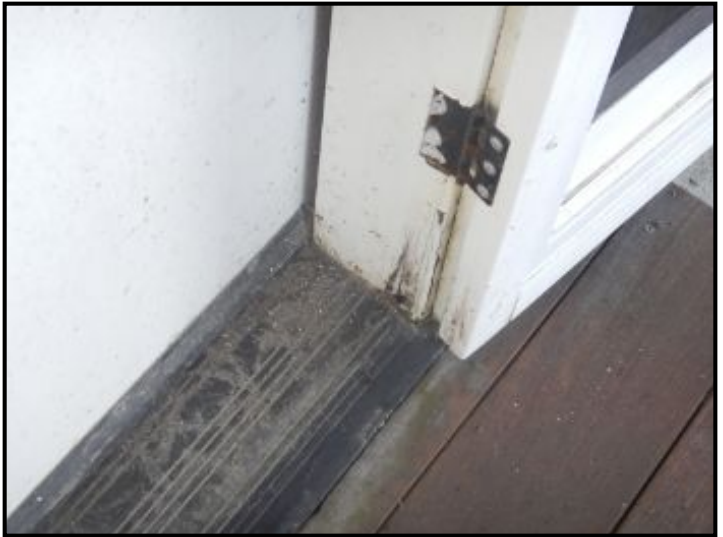
Door jamb damage at rear exterior door

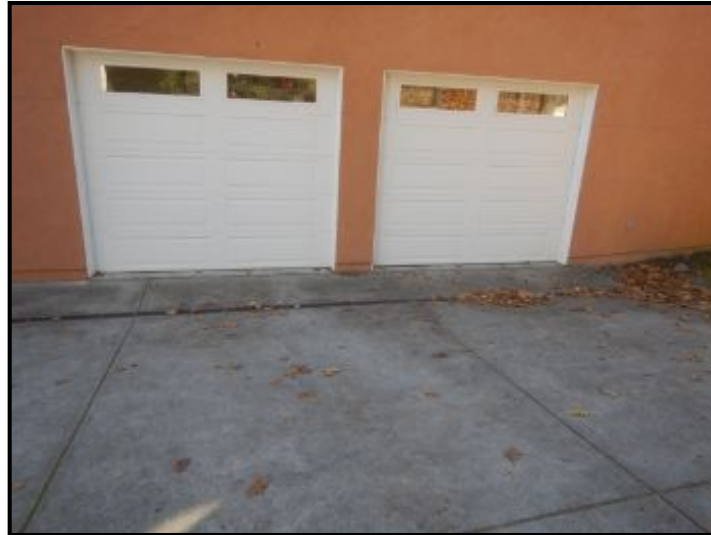
The driveway slopes to the home. There is a drain installed to divert runoff away from the home. Recommend monitoring this area during the rains to determine proper function. Inquire with owner disclosures for any past moisture intrusion or ponding water.

Driveway slopes to home.

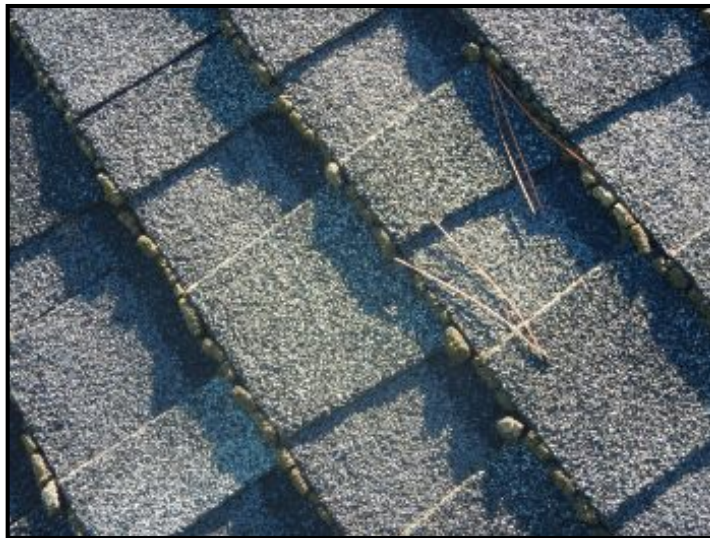
There is moss growth on the roof. The moss growth should be treated and removed.

Moss growth at roof top.

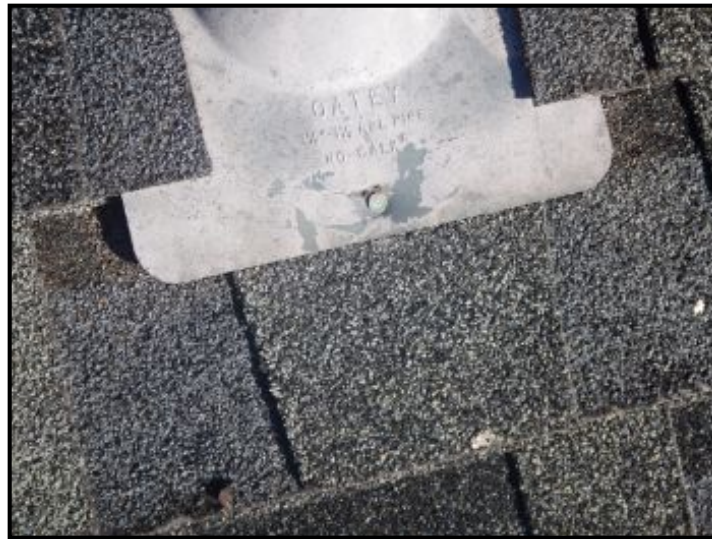
There are some exposed fasteners at the roof top flashings. These are potential leaking points. It is advised to seal of these areas with a mastic type material as a preventative measure.

Seal exposed fasteners as needed.

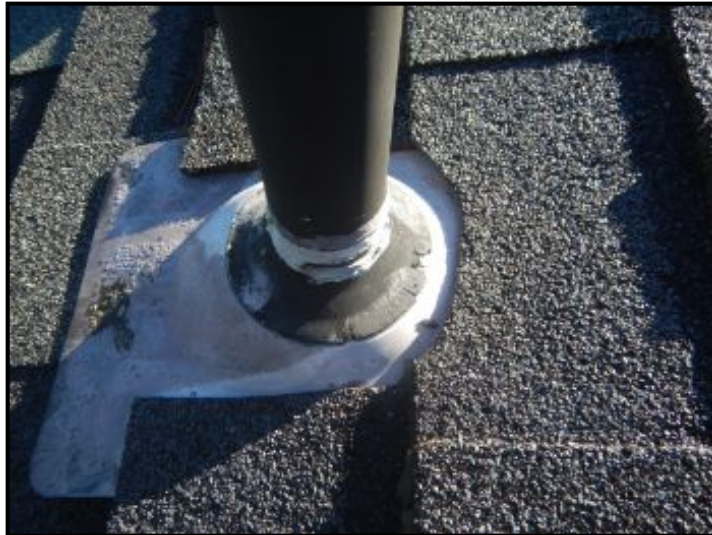
Some of the roof top plumbing vents are cracking and showing wear. Though functional future replacement of the storm collars is recommended. Typically the storm collars are expected to have a 10 year life expectancy.

Worn storm collars at plumbing vents.

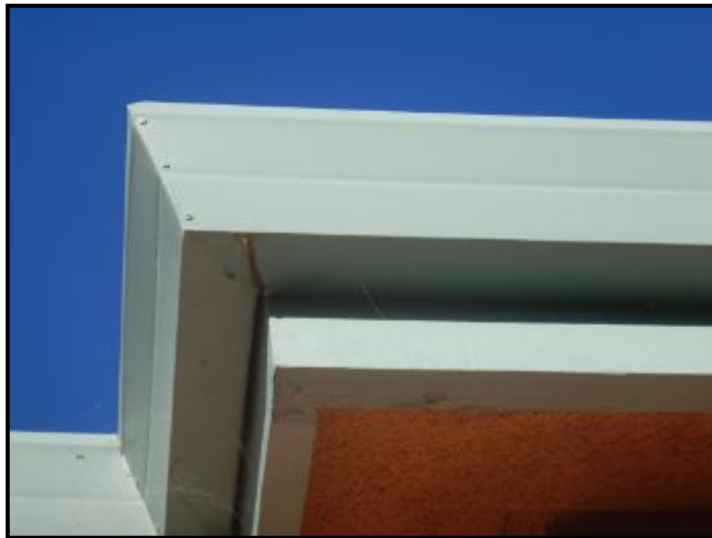
There is a gutter seam at the rear of the home that is leaking. It is recommended to caulk and seal the seams of the gutter to properly protect the structure and maintain intended drainage.

Leaking point at rear gutter seam.

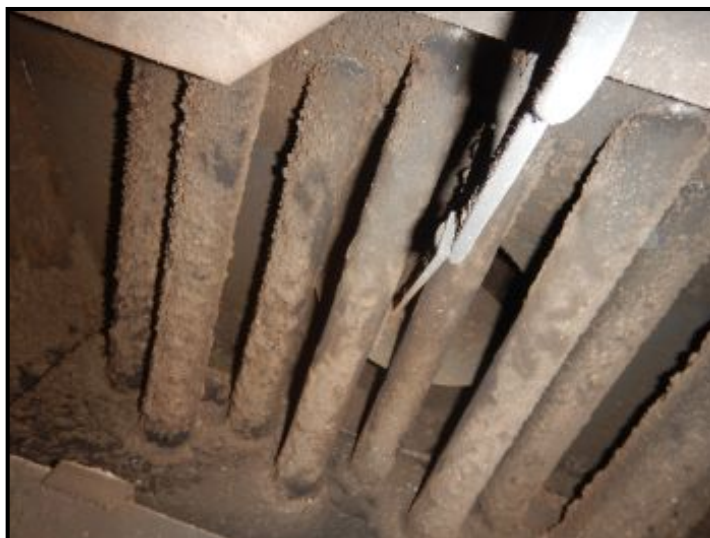
There is soot build up at the interior of the fireplace indicating cleaning is needed. Recommend contacting a qualified chimney sweep company for service.

Soot build up at fireplace.

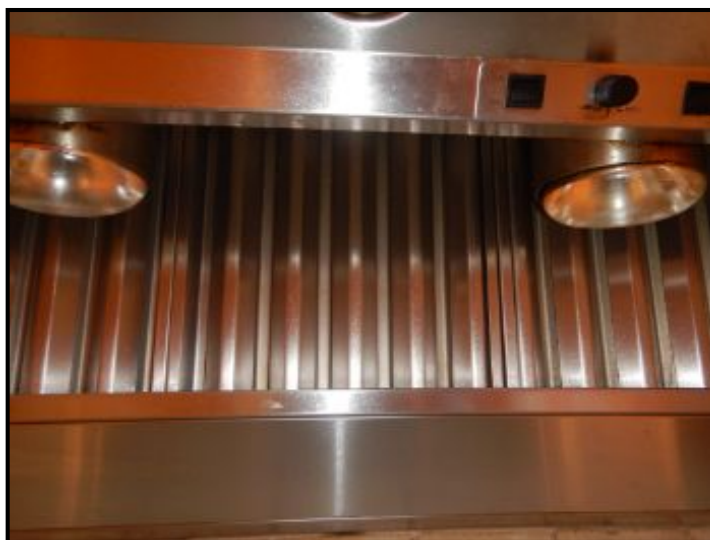
The stove top exhaust area is greasy. Recommend cleaning this area as a preventative measure.

Greasy stove top exhaust.

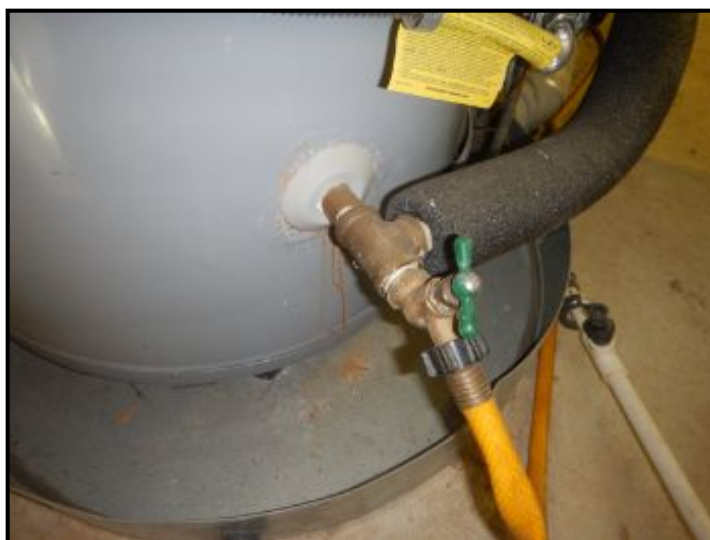
Rusting and encrustations was noted at the water heater at the drain line. At the time of the inspection the area was dry and no current active leak was noted. Recommend monitoring this area.

Encrustations at water heater

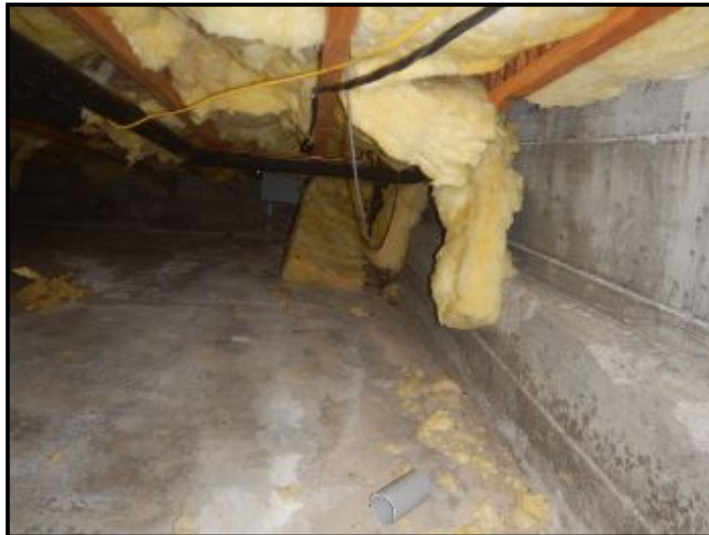
Some insulation has fallen in the sub area. It is recommended to reinstall insulation as needed and replace if wet or damaged.

Fallen insulation in the sub area.
