Inspected for:  
Travis Rowe  
3607 Wallace Rd.  
Santa Rosa, CA

**July 29, 2009**

Re: 3607 Wallace Rd.  
Santa Rosa, CA

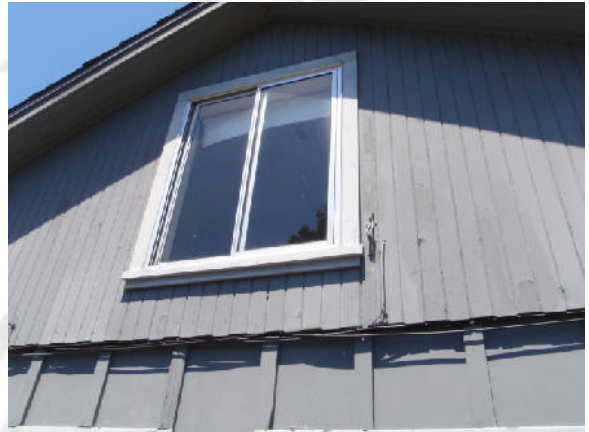
**Exterior paint is deteriorated.** Siding should be repainted to prevent damage to siding and structure. Surface preparation should include scraping or pressure washing to remove loose paint, caulking or filling of voids and seams, and priming with a good quality primer/sealer.

**Client is advised to have the paint tested for lead contact prior to commencing preparation for painting.** If lead is found, old paint should be properly addressed by a qualified lead abatement contractor.

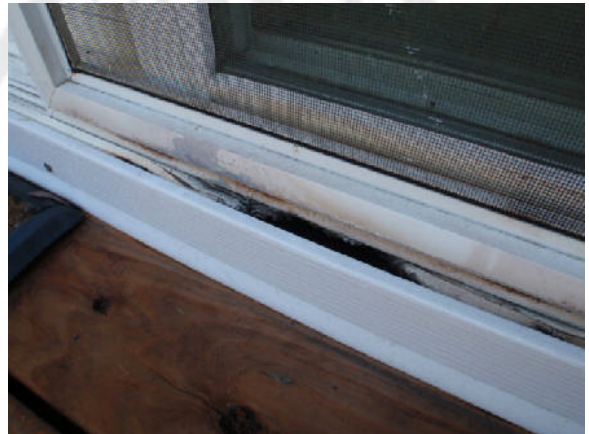
**The threshold/frame of the sliding glass door at the rear is damaged.** This appears to have been scorched/melted. I recommend removal of the trim along the base of the door to allow further inspection. The damage may be extensive enough that replacement of the door would be necessary.

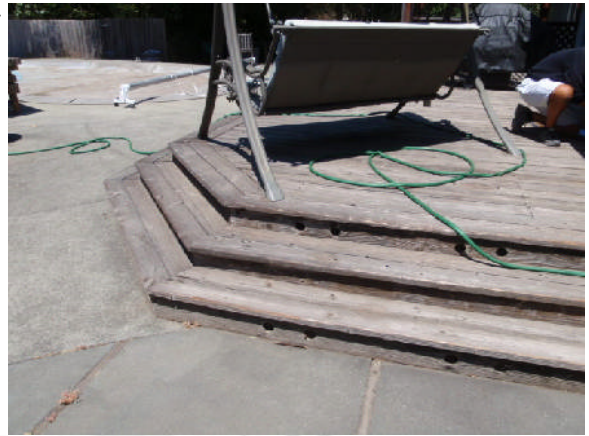
**Steps do not have a proper handrail.** While not required, I advise installation of an easily gripped handrail (cross section between 1¼ and 2 inches). Handrails are intended to help prevent an individual from falling when ascending or descending.

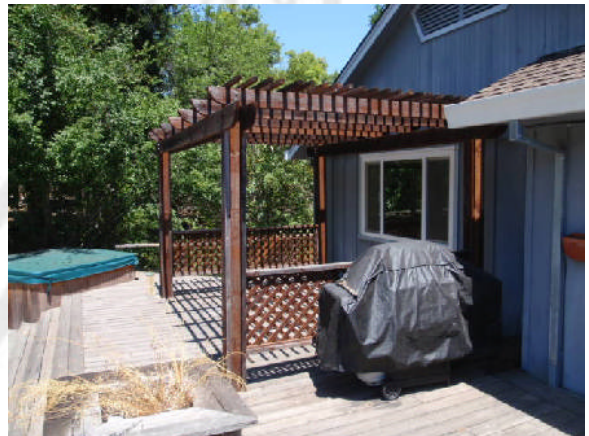
**The wood framed arbor is loose and wobbles when pushed.** This should be braced or reinforced to limit movement.

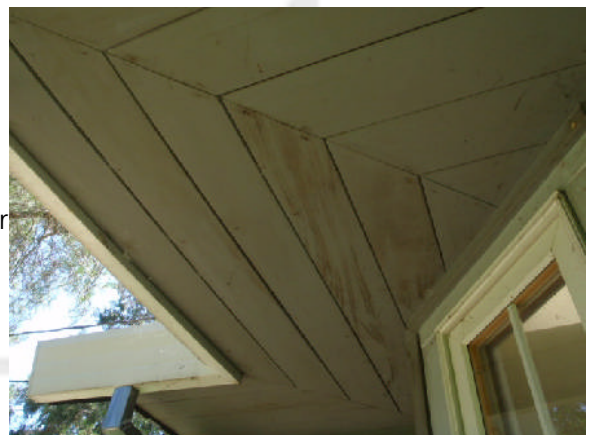
**Moisture/mildew stains noted under the roof eaves.** While these are typically cosmetic and can be controlled by cleaning and painting with a mildew resistant paint, the pest inspector should examine this area during a routine pest inspection.

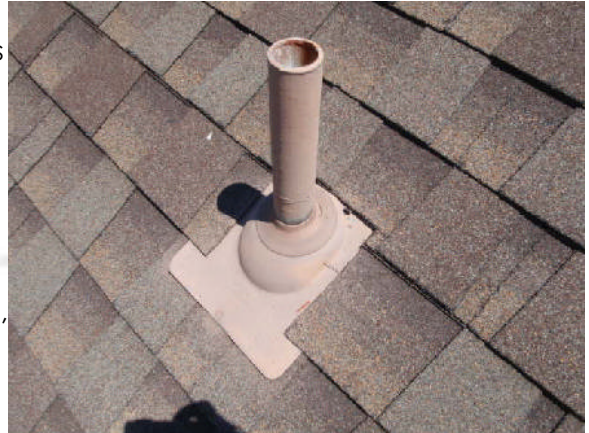
The type of plumbing flashing on this home relies on the rubber seal around the pipe and is more prone to failure than the two-piece/soldered sheet metal flashing. The rubber grommet will typically last approximately 15-20 years, whereas the roof is likely to last somewhat longer. The rubber seal around the pipe will crack over time and eventually leak to the interior of the home. While no evidence of cracking was observed at time of inspection, monitoring for cracks is recommended as a part of home maintenance.

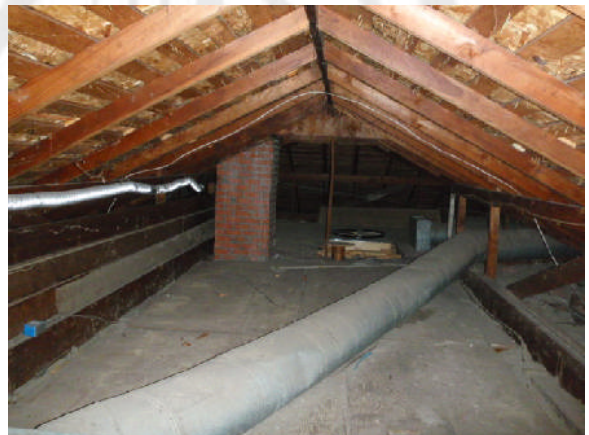
**Roof framing is sagging.** This is most likely due to the size of rafters used at time of construction. 2x4s were commonly used for rafters, but they would be considered undersized by current construction standards. Reinforcing of the roof does not appear to be necessary at this time; however, the roof structure should be monitored for any increase in sagging. If sagging does increase, a licensed general contractor should be hired to reinforce the roof structure.

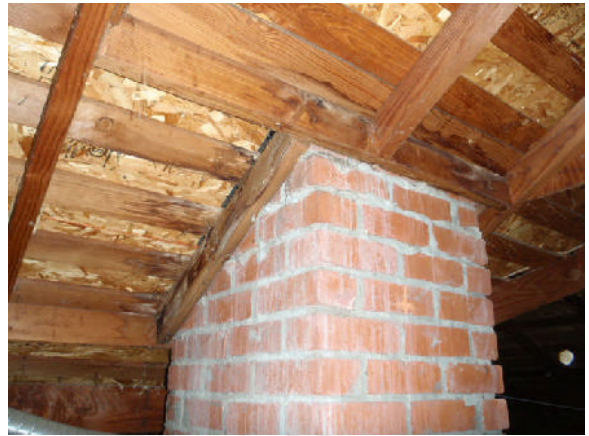
**Moisture staining was found on the roof sheathing.** This staining was found only on the older skip sheathing and not on the more recent sheathing. As such, this is likely due to leaking from a previous roof and no longer active. Seller should be consulted regarding the history of the roof and any related repairs.

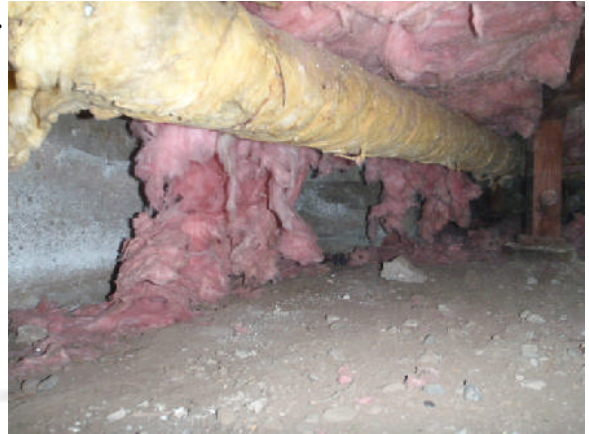
**Sections of the insulation have been damaged.**

This type of damage is typically caused by animals gaining entry to the crawlspace area. I recommend ensuring that all perimeter screen vents remain in good condition to prevent animals from causing further damage to the insulation. I also advise replacement of all loose or damaged insulation.

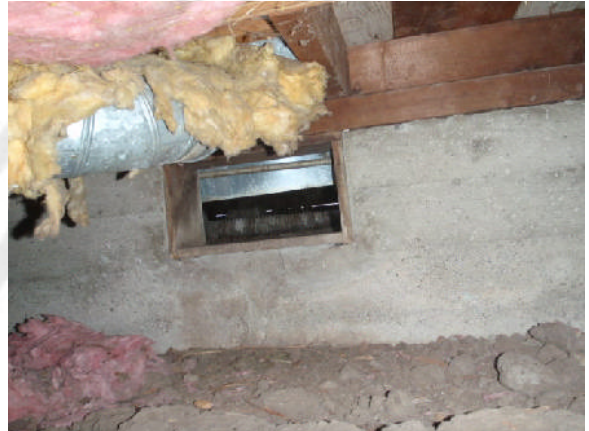
**Screens are damaged/missing.** Installation of new screens is recommended to prevent animals from gaining entry to the crawlspace area.

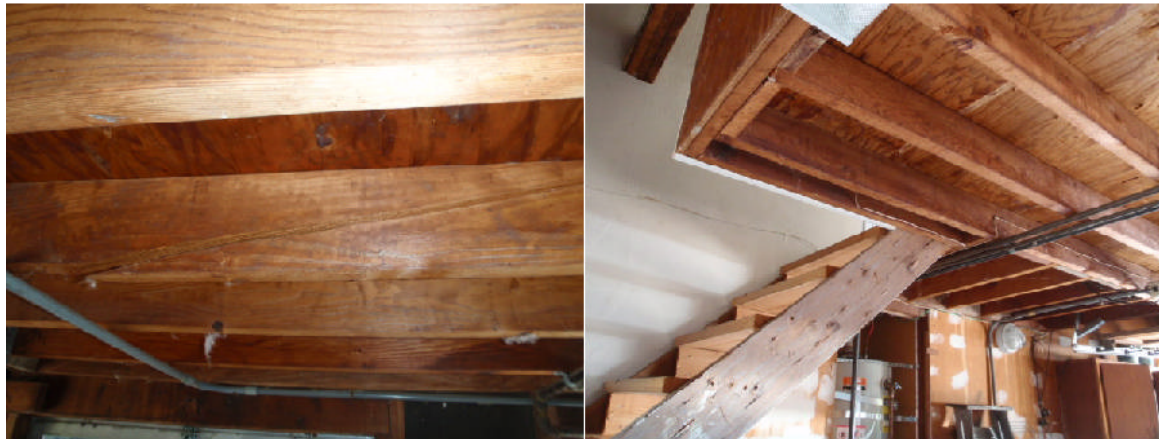
**Roof framing is being used to support a loft and a floor joist is cracked.** The floor framing for the loft is nonstandard and I was unable to determine how the floor is supported. The roof framing was not designed or intended to provide support for a loft area or for use as storage. In addition, as this is located within the garage, it should not be used as living or sleeping space, but might be acceptable for storage. I recommend properly resupporting this area with the addition of appropriate framing.

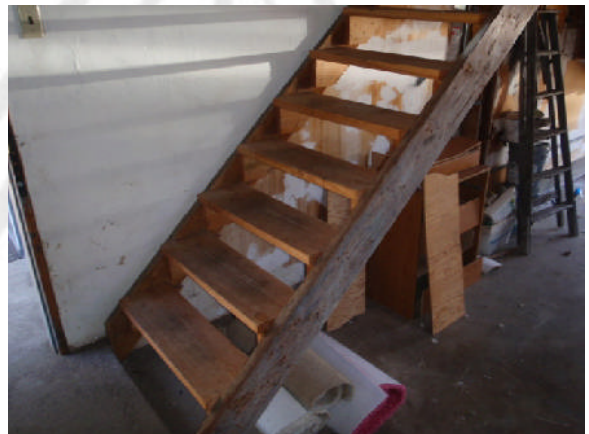
**The step at the rear of the garage is rather high and is a possible trip hazard.** I recommend construction of an additional step.

**The stairway to the loft is improper.** Treads are undersized, headroom is restricted and no guardrail or handrail is present. Corrections should be made.

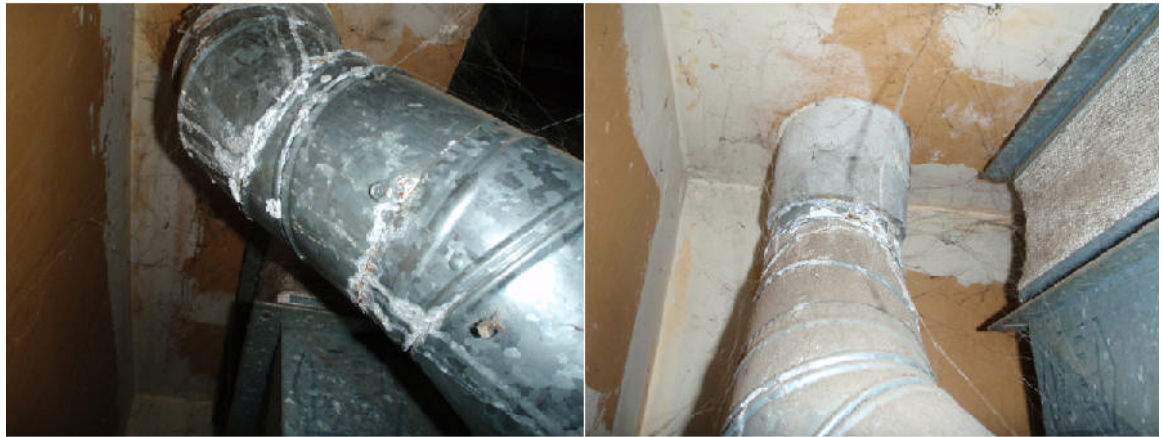
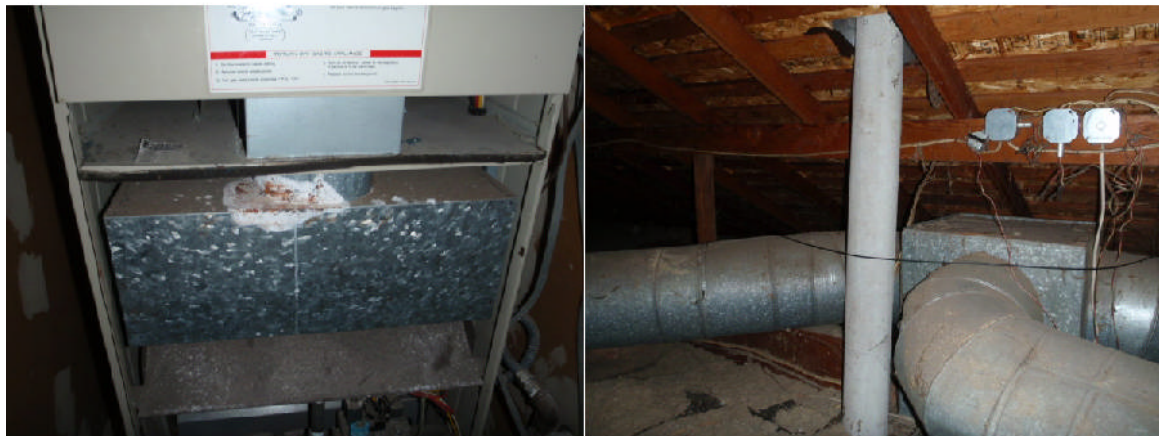
**The flue pipe is improper. Moisture stains and corrosion were observed on the metal flue pipe as well as the draft hood of the furnace.** The exhaust gas from the heater contains water vapor and this vapor will condense on the interior of a cold cement-fiber "transite" pipe where it will drain down until it reaches the connection with the metal flue pipe. As this moisture is corrosive, the inducer fan as well as the metal flue pipe can be expected to corrode. Correction of this condition can usually be achieved by replacing the "transite" pipe with a double walled, metal "B-vent". However, a licensed heating contractor should inspect the condition of the inducer fan and any related parts/equipment and make the necessary corrections/repairs.

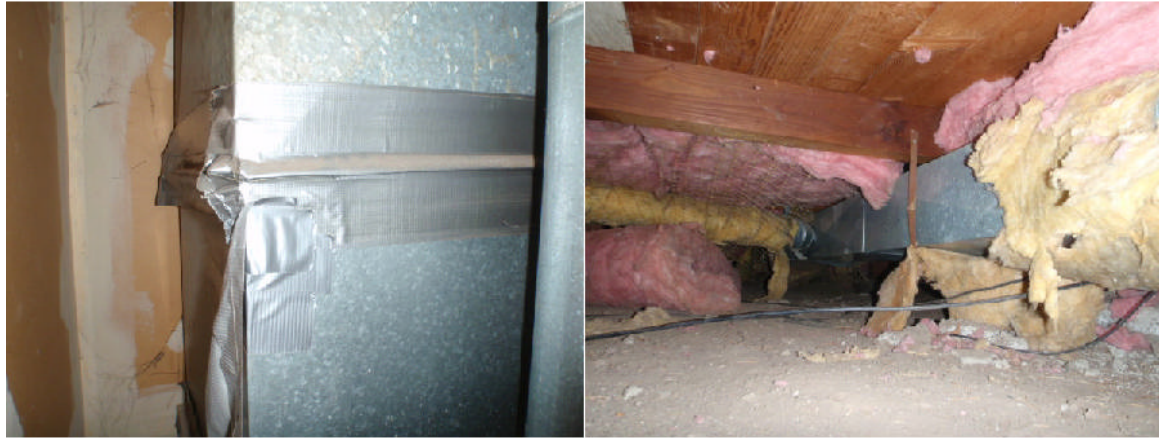
**A void is present at the perimeter of the connection to the supply plenum.** I recommend sealing or taping to prevent escape of air from the duct system.

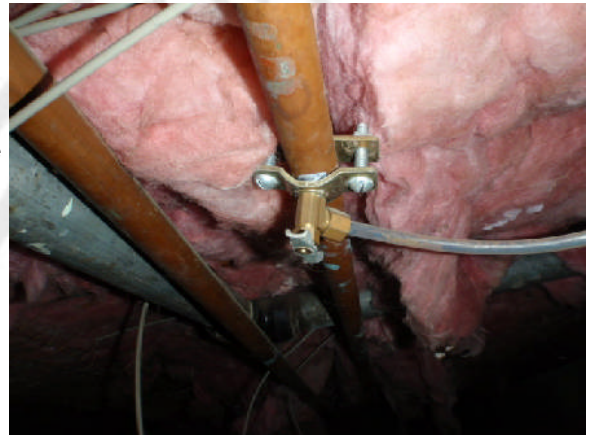
**A saddle valve is present on a supply pipe in the crawlspace.** Saddle valves penetrate the pipe, are more prone to leaking and should be replaced with standard valves whenever possible. No leaking observed at time of inspection.

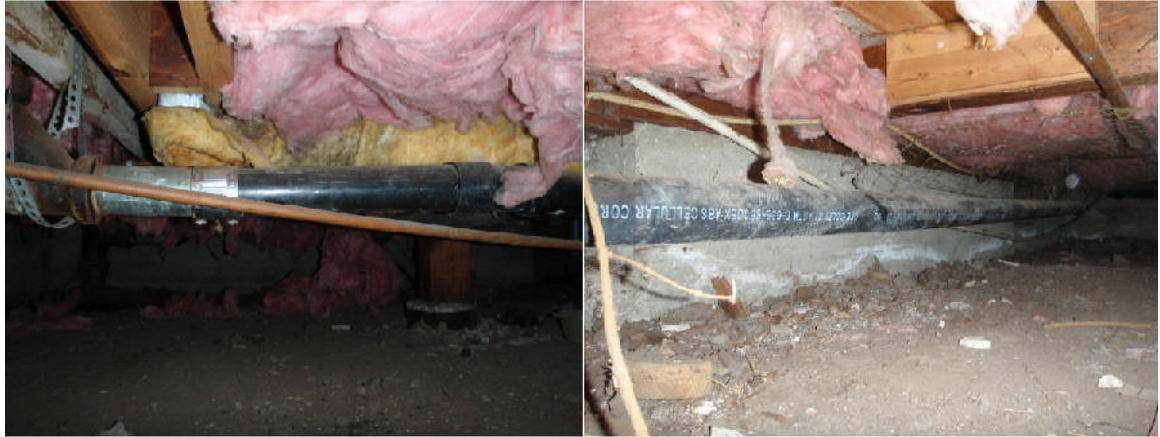
**Where visible, waste lines are cast iron, galvanized and ABS (plastic).** Older metal waste lines are more likely to be corroded and become clogged than other materials. Client is advised that slow drains and leaks are likely to develop over time due to the type and age of the material.

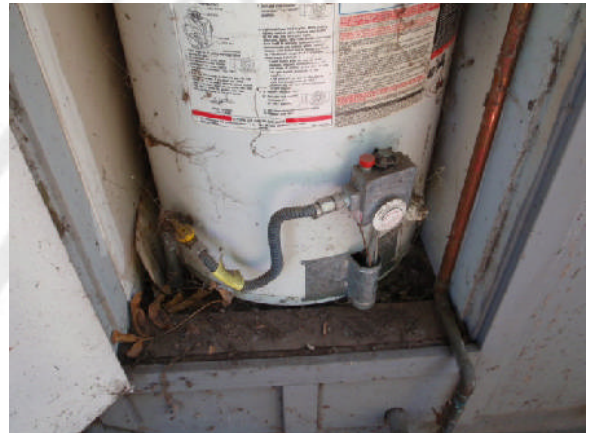
**No drain pan present under this tank.** If the tank were to leak, the water would flood the floor in this area. I recommend installation of a pan that drains to the exterior.

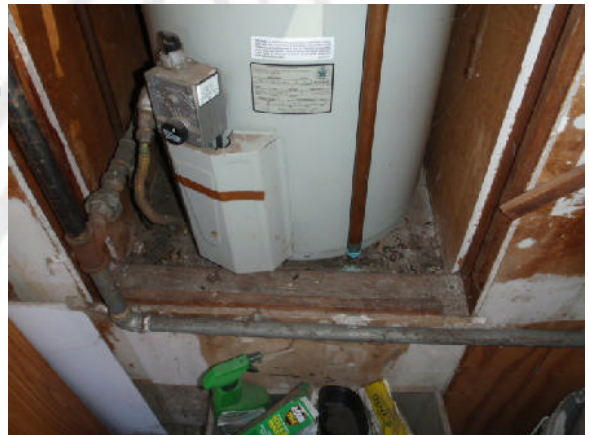
**No drain pan present under this tank.** Although located in a garage and not necessarily required, if the tank were to leak, the water would flood the floor in this area. As many people store personal property on the floor of the garage, I suggest installation of a pan that drains to the exterior.

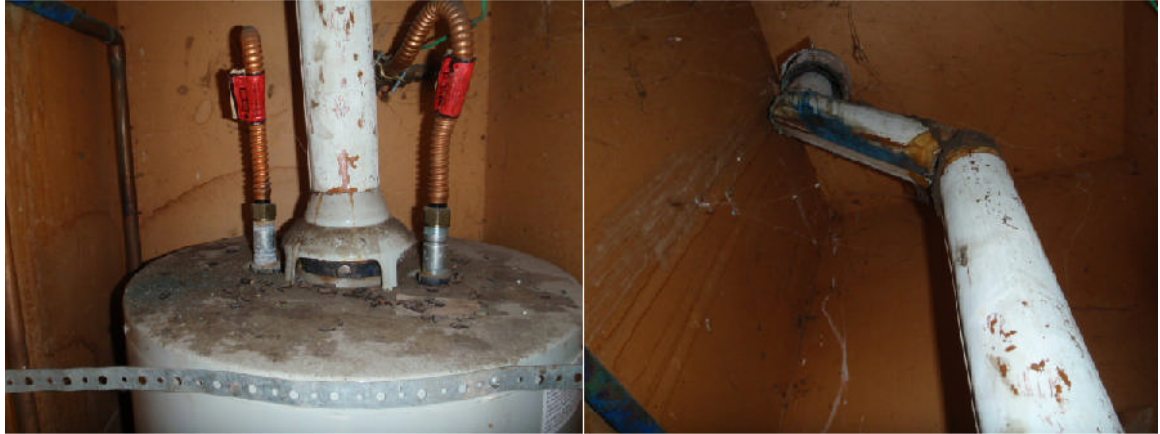
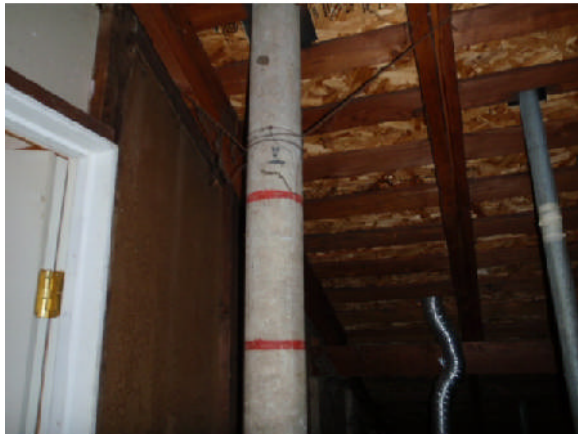
**Flue pipe is improper and damaged.** In addition, the flue pipe in the attic is a "transite" material. I recommend replacement of both sections of flue pipe with a new, metal "b-vent" flue pipe.

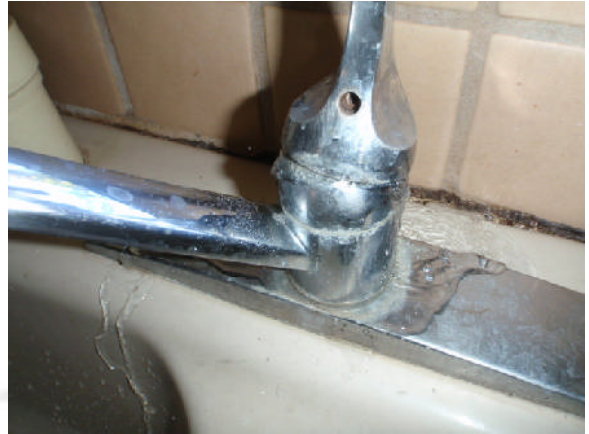
**The faucet will leak at the base of the valve handle when the faucet is operated.** This is typical of this design. Replacement of O-rings may correct this condition.

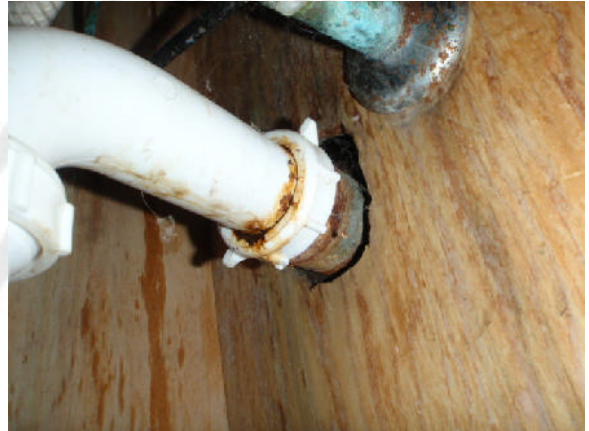
**A slow leak was observed at the sink drain.** Repairs should be made by a licensed plumbing contractor to prevent damage to cabinet and/or structure.

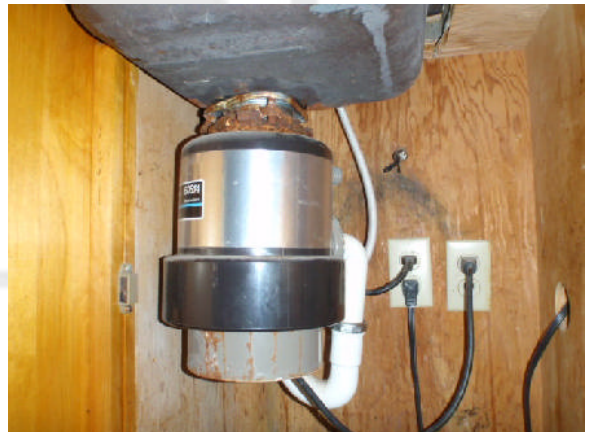
**The mounting ring and the exterior housing of the disposal is corroding.** This indicates an older unit. While the disposal did operate at time of inspection, no determination of remaining useful life could be made. Preventative replacement is advised.

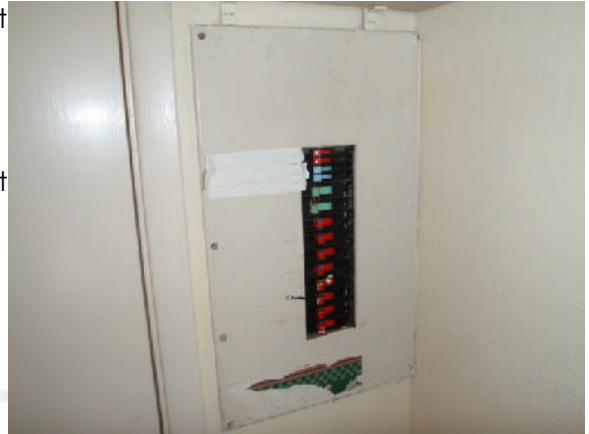
**Restricted clearance is available to access this panel.** Current construction standards require a minimum clear workspace of 30 inches wide by 36 inches deep to access the panel. Adequate workspace should be allowed for when replacing the panel.

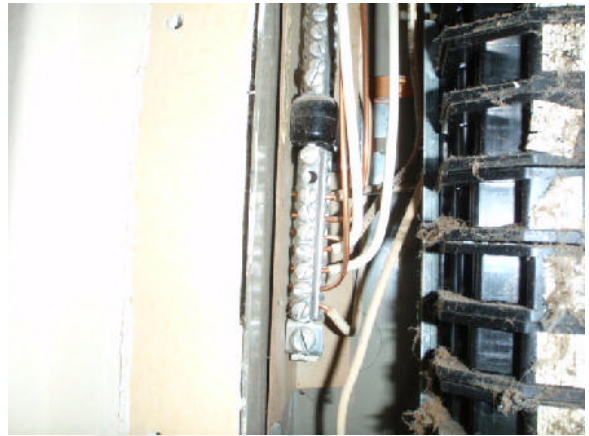
**Neutral and ground wires are connected together in this panel.** Current electrical standards require that the grounding circuit be separated from the "neutral" circuit. A separate grounding circuit should be provided back to the service equipment (main panel). Corrections should be made by a licensed electrical contractor.

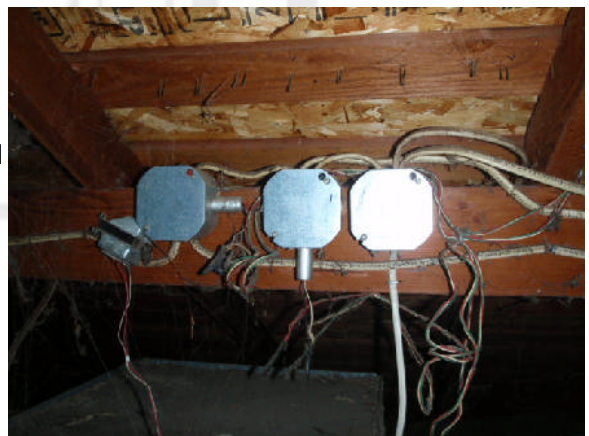
**Low voltage relay switching is present in this home.** This system consists of relays that are operated by momentary contact switches and some relays were found in the attic. This is an older system and reliability of the relays decreases as the relays age. I was unable to fully evaluate this system and was unable to determine which lights or receptacle outlets are connected to it. If a complete evaluation is desired, a licensed electrical contractor should be consulted.

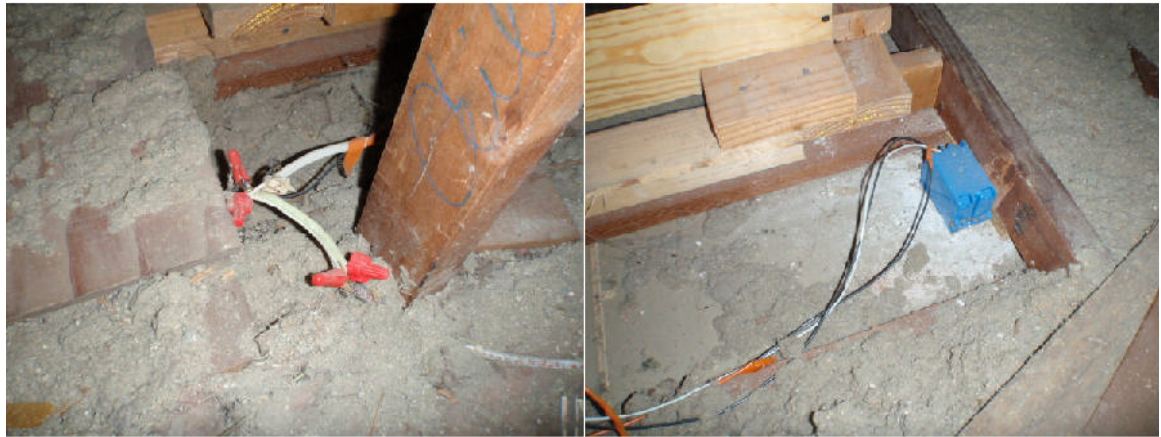
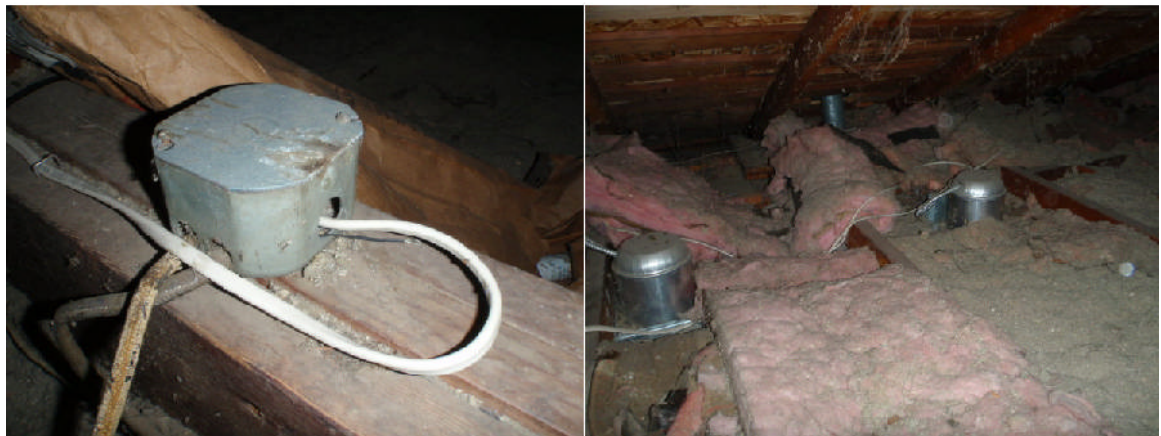
**Unprotected electrical splices present.** Electrical splices should be enclosed in a covered junction box to help prevent separation of the splices.
