Buyers Protection Group

**1415 Leslie Road  
Healdsburg CA 95448**

**Client(s): Zissis  
Inspection Date: 4/24/2015**

**Inspector: Jose Gonzalez #**

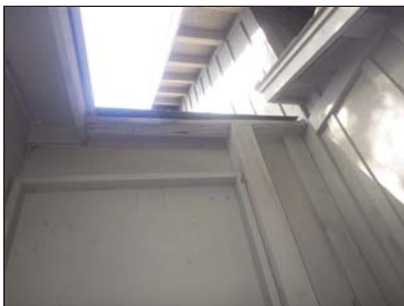
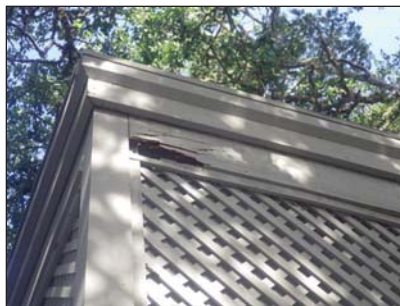
- ☒ ◆ Deterioration noted to some trimwork, fascia and support post at the right side of the structure. We suggest further review by a licensed pest inspector; repair or treatment should be made, as necessary.

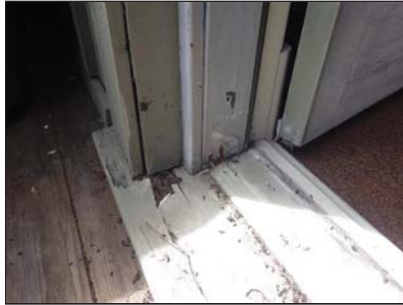
- ☒ ◆ Doors and shutters, including but not limited to; those of the windows, are severely weathered. Some decay was noted to various doorframes and corresponding thresholds. Some of the doors display signs of moisture intrusion. Proper preparation and a good coat of paint or stain can protect and extend the useful life of the siding and trim. We recommend consulting a pest inspector for further review and recommendations and that correction of moisture source be verified.

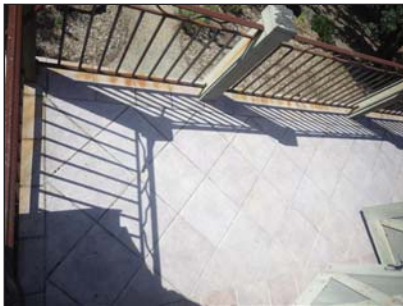
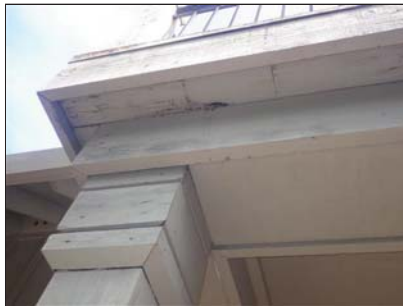
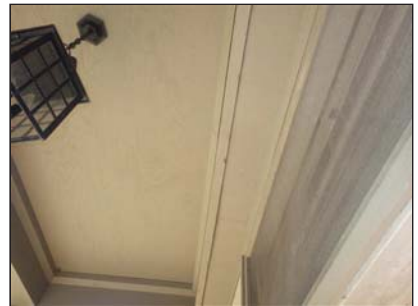
- ☒ ◆ The front deck consists of a sealed membrane surface with a layer of tile installed over it. The membrane surface could not be viewed to establish its condition. However tile surface is damage and sealed membrane displays signs of leaking. Moisture stains and decay were evident on the wood sheathing under this deck. We recommend review and repair/replacement, as necessary, by a qualified waterproofing technician or licensed roofing contractor.

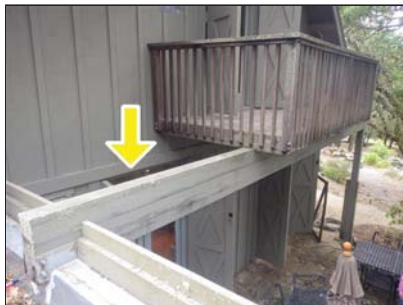
- ◆ The sides decks are attached to the structure with a ledger board. Moisture intrusion can sometimes occur through the fasteners used to secure the ledger to the exterior wall. Ideally, a flashing or spacers should be installed to deter this from occurring. At minimum, the top of the ledger board should be periodically caulked.
- ☒ ◆ Sporadic organic/fungus growth noted to the decks at the sides of the structure. The glulam support beam at left deck is severely deteriorated; this is a safety concern. THE USE OF THIS DECK (AND PATIO BELOW) SHOULD BE DISCONTINUED UNTIL REPAIRED. We suggest further review by a licensed general contractor and/or structural pest inspector; repair or treatment should be made, as necessary.

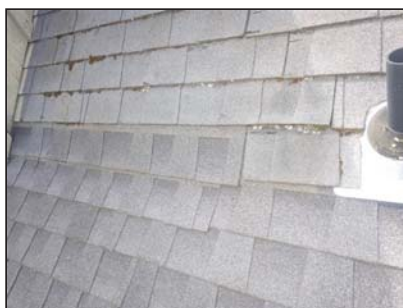
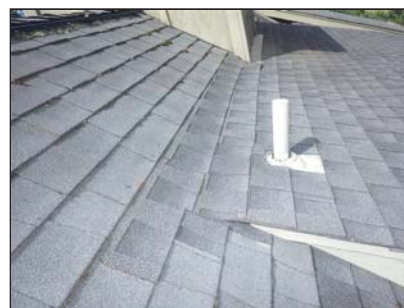
- ◆ Roof appears to be nearing the later stages of its useful life. Dislodged and/or improperly installed shingles noted near ridges and front/left field. Due to the above noted and signs of past leaking observed inside the home, we suggest consulting a licensed roofing contractor for further review.

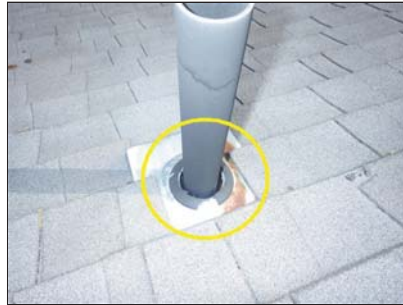
- ✘ ◆ The rubber seals around some of the plumbing vents are cracked. This can allow moisture intrusion down the outside of the vent pipe and into the attic space. We recommend damaged seals be repaired or replaced, as needed.

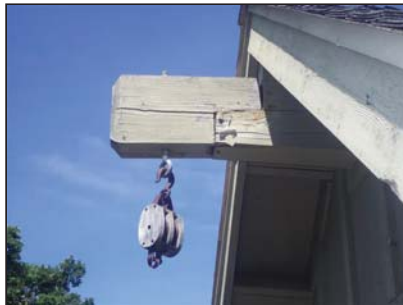
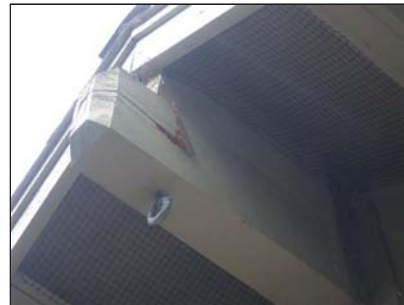
- ☒ 8. Wood deterioration noted to both of the exposed gable beams. We recommend affected materials be repaired or replaced, as necessary.

- ◆ The air-space between the roof and the ceilings was not accessible for review due to construction design. These types of roofs do not normally have an entry scuttle due to prohibiting clearance.
- ✘ ◆ Wood deterioration noted to both of the exposed gable beams. We recommend affected materials be repaired or replaced, as necessary.

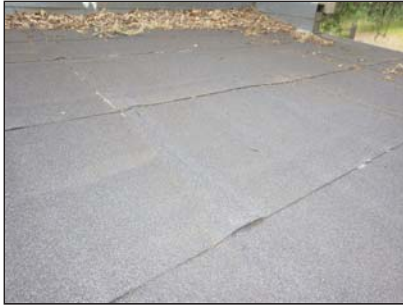
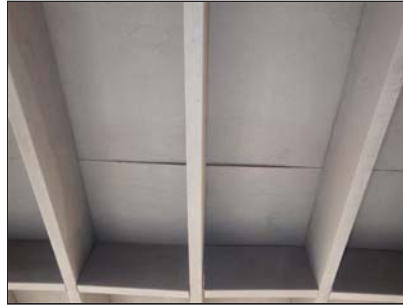
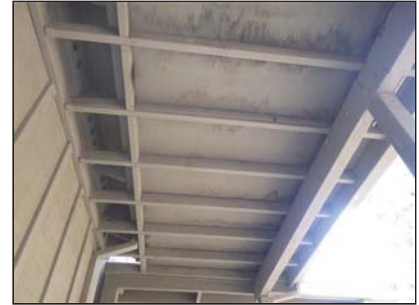
- ✘ ◆ The carport/breezeway roof cover is in need of replacement. Air-pockets noted in the membrane. The discoloration and decay observed at the sheathing below indicate the roof leaks. The plywood sheathing is buckled and the far/ left support beam somewhat displaced. Client is advised to seek further review by a licensed roofing contractor.

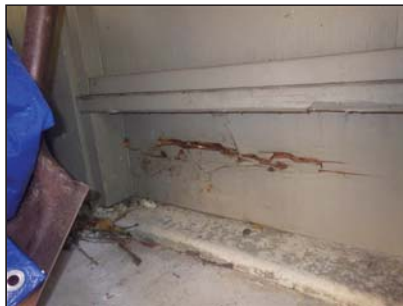
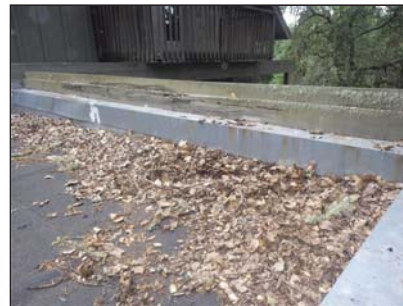
✘ ♦ Deterioration noted to the carport wood division wall and/or roof framing. We suggest further review by a licensed pest inspector; repair or treatment should be made, as necessary.

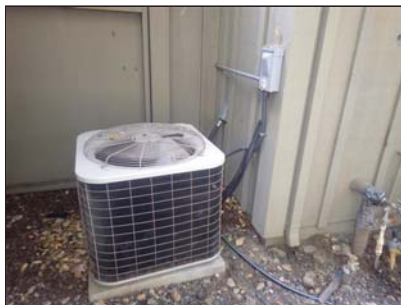
- ◆ Based on our estimate of its age, this air conditioner is nearing the later stages of its designed life. The unit did operate when tested, but we cannot estimate its remaining life or efficiency. Client is advised to service the unit regularly and to plan and/or budget for replacement, accordingly.

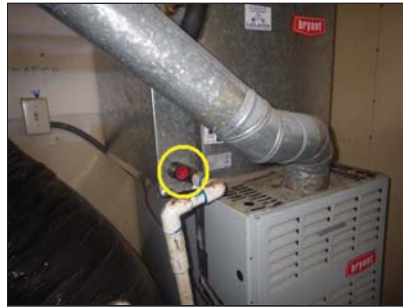
- ☒ ◆ Air conditioner coil box at the furnace lacks a secondary drain. Depending on the manufacturer specifications and local requirements, these should be present to allow safe drainage of condensate in the event the primary drain becomes blocked. The drainpipe should terminate in a readily observable location such as over a window or door. We suggest review of the heating system by a licensed HVAC contractor.

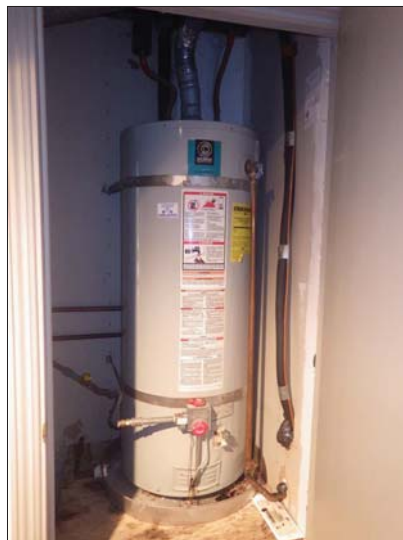
- This is an older water heater that has exceeded its designed life. Although operable at the time of inspection, water heaters can go out suddenly. While this unit could last for an indefinite period of time, we cannot predict its remaining life. Client is advised to plan and/or budget for replacement, accordingly. Periodic observation, for signs of leaking, is further advised.

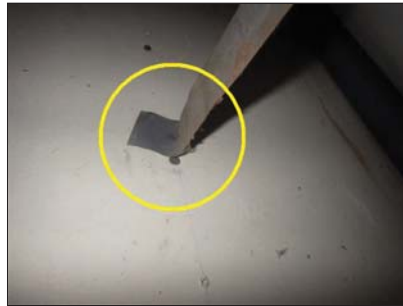
- Earthquake straps were installed around the water heater tank, but were not installed correctly. We recommend straps be secured to the wood framing with threaded lags. At minimum, all water heaters should be secured in

accordance with California building code, or modifications made thereto by local city and/or county building departments. As water heater bracing requirements can vary from city to city, current requirements can be obtained from the local city or county building departments. We suggest strap manufacturer's instructions be referred to for proper performance of these restraints.

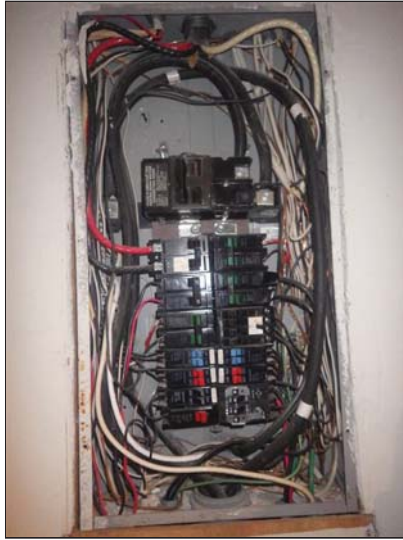
- 🔍 ◆ The panel is equipped with breakers fabricated by a maker other than the panel manufacturer. The use of dissimilar breakers can void the manufacturer's warranty. Determining product compatibility is beyond the scope of a general home inspection. If client has concerns, we recommend consulting a licensed electrical contractor.

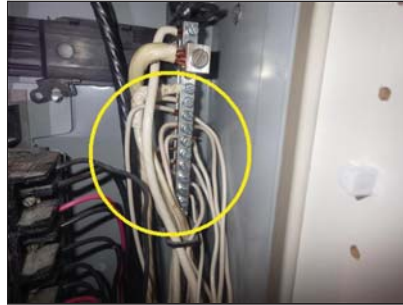
- ⊗ ◆ Doubled-up circuitry noted at neutral bar (i.e. 2 neutral wires on a single terminal). This condition can cause wiring to become loose, leading to arcing and overheating. Each grounded conductor should terminate within the panel board in an individual terminal that is not also used for another conductor. We recommend review by a qualified professional electrician for correction, as necessary, to ensure proper operation and safety.

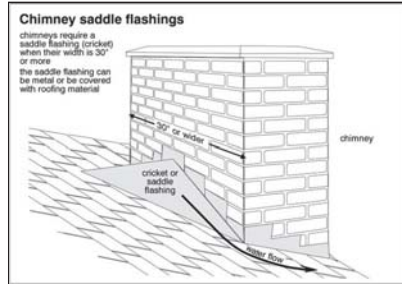
- ◆ When chimneys are wider than 30 inches, it is recommended that a cricket be present to divert roof run-off away from the base of the chimney. This will also help keep debris, which could damage the roofing materials or cause leaks, from collecting against the chimney. This should be considered when reroofing is done.

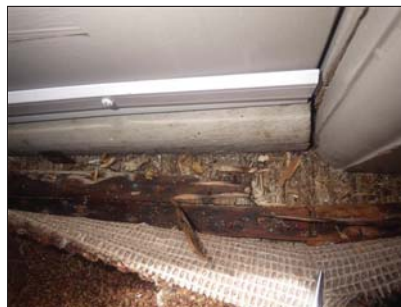
- ☒ ◆ Some deterioration was noted to the floor adjacent to some of the upstairs French doors. We suggest maintenance and repairs, as necessary.

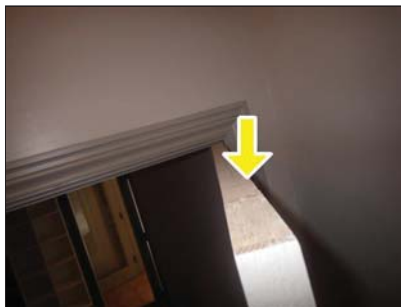
- ◆ French doors with weather exposure were noted at multiple locations. These types of doors are known to have a tendency to leak during periods of wind-blown rain. Evidence of leaking was observed at the upstairs doors at the time of inspection. These doors should be properly flashed or caulked, as necessary, to prevent further moisture intrusion and damage to wood framing members.
- ◆ The top edges of the doors in this house are not painted. Door manufacturers recommend the top edges of doors be painted to seal wood and deter swelling.

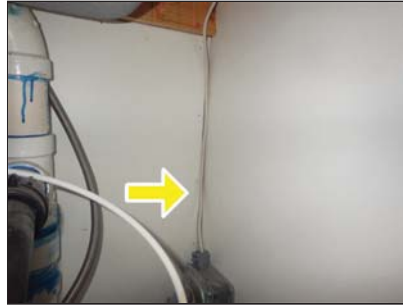
- ◆ Ground fault interrupter is provided for safety. We suggest periodic testing to ensure proper working order.
- ◆ Exposed romex (NM Non-metallic cable) wiring noted under the sink. This may be a safety concern if used where it could be subject to physical damage. We suggest consulting an electrician for further review.

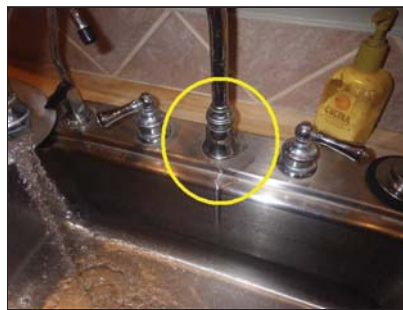
♦ The faucet is leaking at the base of the spigot. We suggest repair or replacement, as needed.

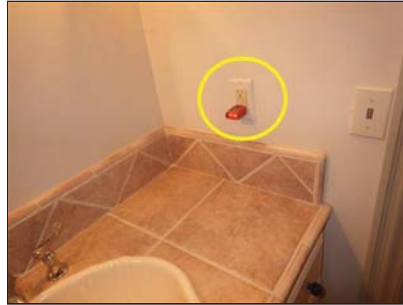
- ◆ When tested, the front ground fault interrupter breaker (GFI) failed to interrupt power at the test outlet box. This type of problem is typically due to improper wiring or a faulty device. We recommend correction, as necessary, (to provide the recommended protection), by a licensed electrician.

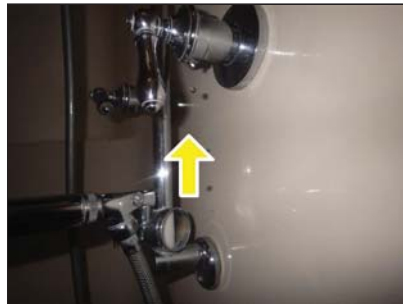
- ◆ Leak noted around the front or cold water valve. We suggest adjustment or repair, by qualified personnel.
