WOOD DESTROYING PESTS AND ORGANISMS INSPECTION REPORT

Building No. 1415	Street Leslie Road	City Healdsburg	Zip 95448	Date of Inspection 8/10/2015	Number of Pages 6
----------------------	-----------------------	--------------------	--------------	---------------------------------	----------------------

North Coast Termite Control 8890 Starr Road Windsor CA 95492 Tel (707) 837-2860 Alt (707) 328-4008 northcoasttermite@comcast.net	Report # : 5971 Registration # : PR4280 Escrow # : <input type="checkbox"/> CORRECTED REPORT
----------------------------------------------------------------------------------	---------------------------------------------------------------------------------------------------------------------------------------------------------------------------------	-------------------------------------------------------------------------------------------------------

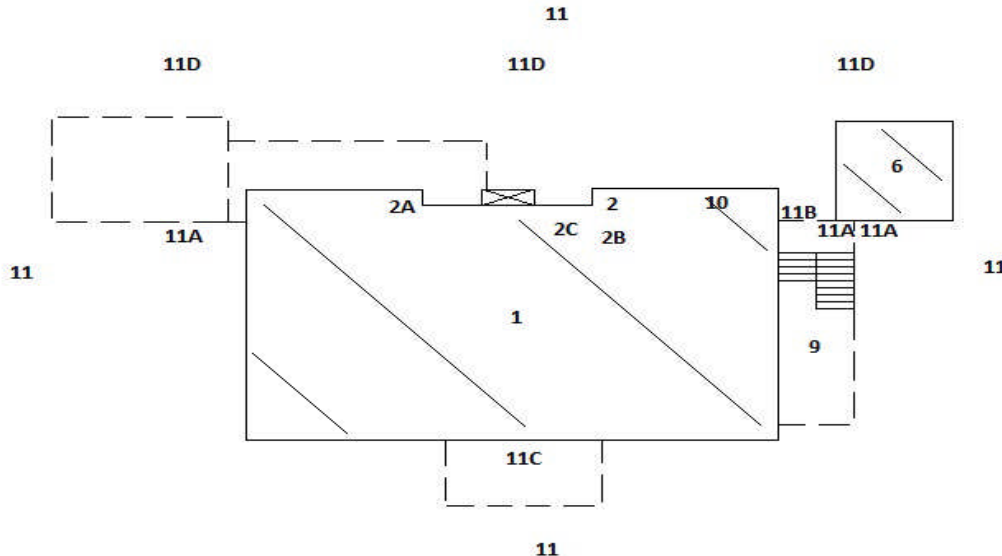
Diagram Not To Scale

#11A Fungus and excessive moisture has caused damage to the framing, trims boards and/or band boards in the approximate areas indicated on the diagram.
RECOMMENDATION: Remove and replace the damaged wood.
(SECTION I)
