Inspected for:
Daveen & Stephanie Chopra
2142 Vintage Circle
Santa Rosa, CA

04/29/2015

Report Highlights

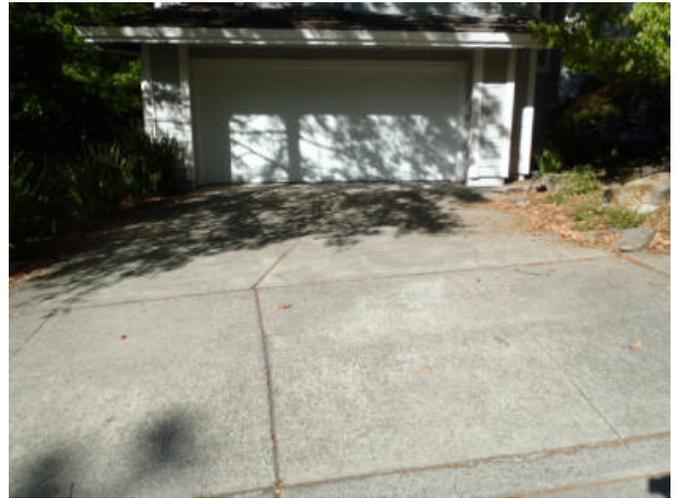
Driveway:

Concrete. Cracks are present in driveway surface. Cracks of this type are not uncommon and usually due to curing, expansion/contraction and/or soil movement/settling. Patching cracks can help to prevent excess moisture from gaining entry under the driveway and causing further cracking. Corrective measures should be taken if surface becomes uneven or damaged.

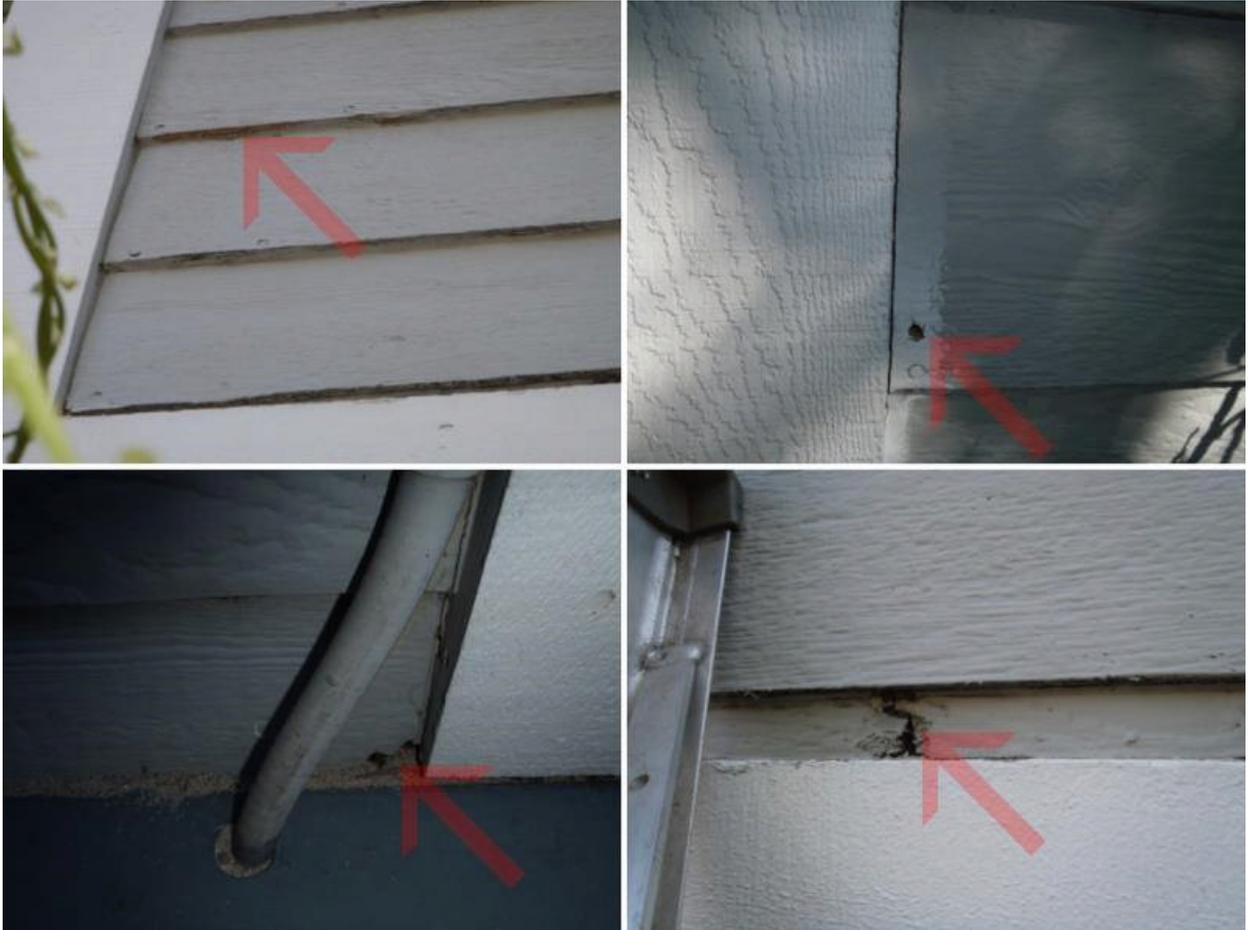
Lap Siding:

Decayed/damaged sections of siding were observed at various areas. As this is not a pest inspection and other areas of damage may be present, a licensed pest inspection company should inspect this building for wood destroying organisms and repairs should be made, as needed.

Voids/gaps were found at various areas. While siding installation should include priming/painting any cut ends, in actual practice this is rarely done. As a result, moisture can penetrate into the cut ends, which will lead to damage over time. Sealing all cracks/voids between siding and trim as well as penetrations and holes is recommended to prevent moisture intrusion. I recommend not caulking under the lower edge of horizontal siding members to allow any water that might get behind the siding a path out. I also suggest the use of a flexible and paintable caulking, such as Sikaflex 15 LM or equivalent.

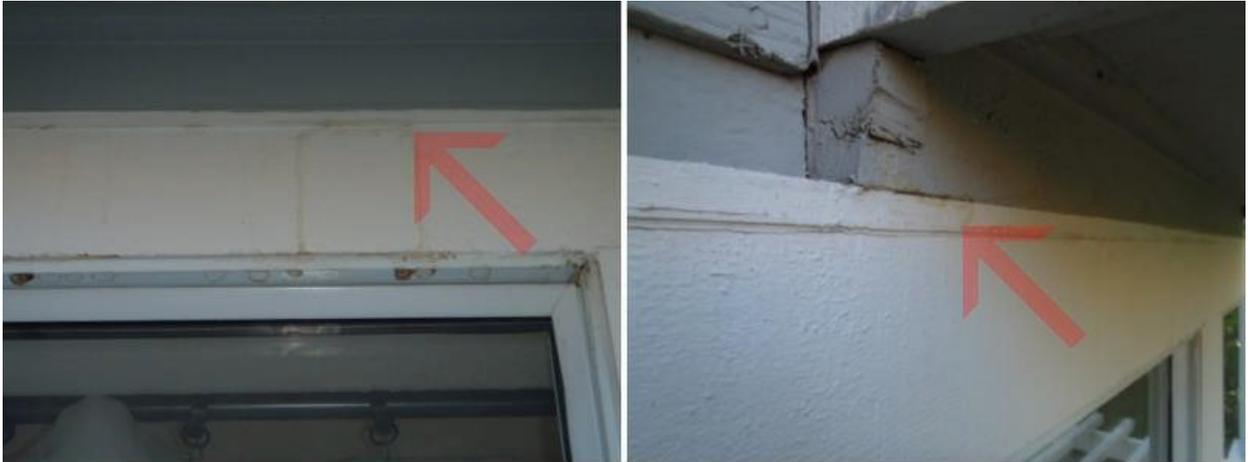
Other
Observations:

Stains are present under the rear cantilevered chimney. It appears that moisture is traveling along the top of the metal flashing, and over the top of the door. I recommend sealing this area to prevent damage to the trim. Corrections should be made by a licensed contractor.

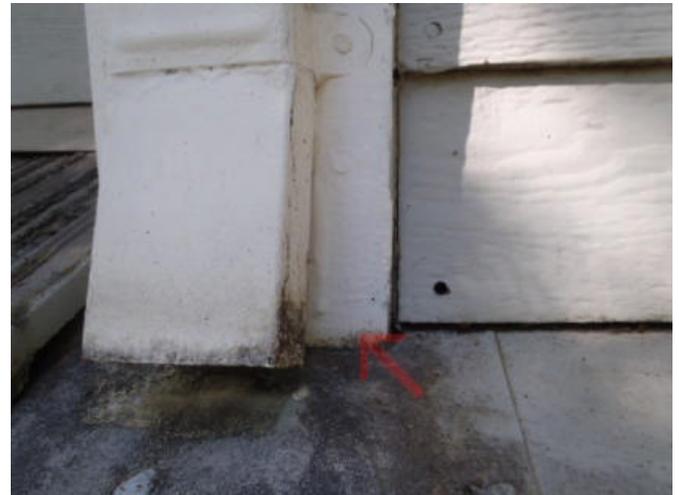
Unprotected horizontal trim can retain moisture on the trim and against the siding. Water can penetrate between the trim and siding, which will often lead to damage to the siding, trim, and possibly enclosed framing. I am unable to determine the condition of the siding behind the trim. My primary recommendation is to install metal flashing over the top exposed edge to protect the wood from moisture and damage. At a minimum, horizontal trim should be kept well caulked and painted to protect it, and the adjacent siding, from moisture damage.

Sections of the trim are close to the roof shingles. As this can promote moisture damage, I advise cutting trim to provide a minimum of 1 inch gap between the base of the trim and the roof. The cut edge should be painted to retard water penetration into the material.

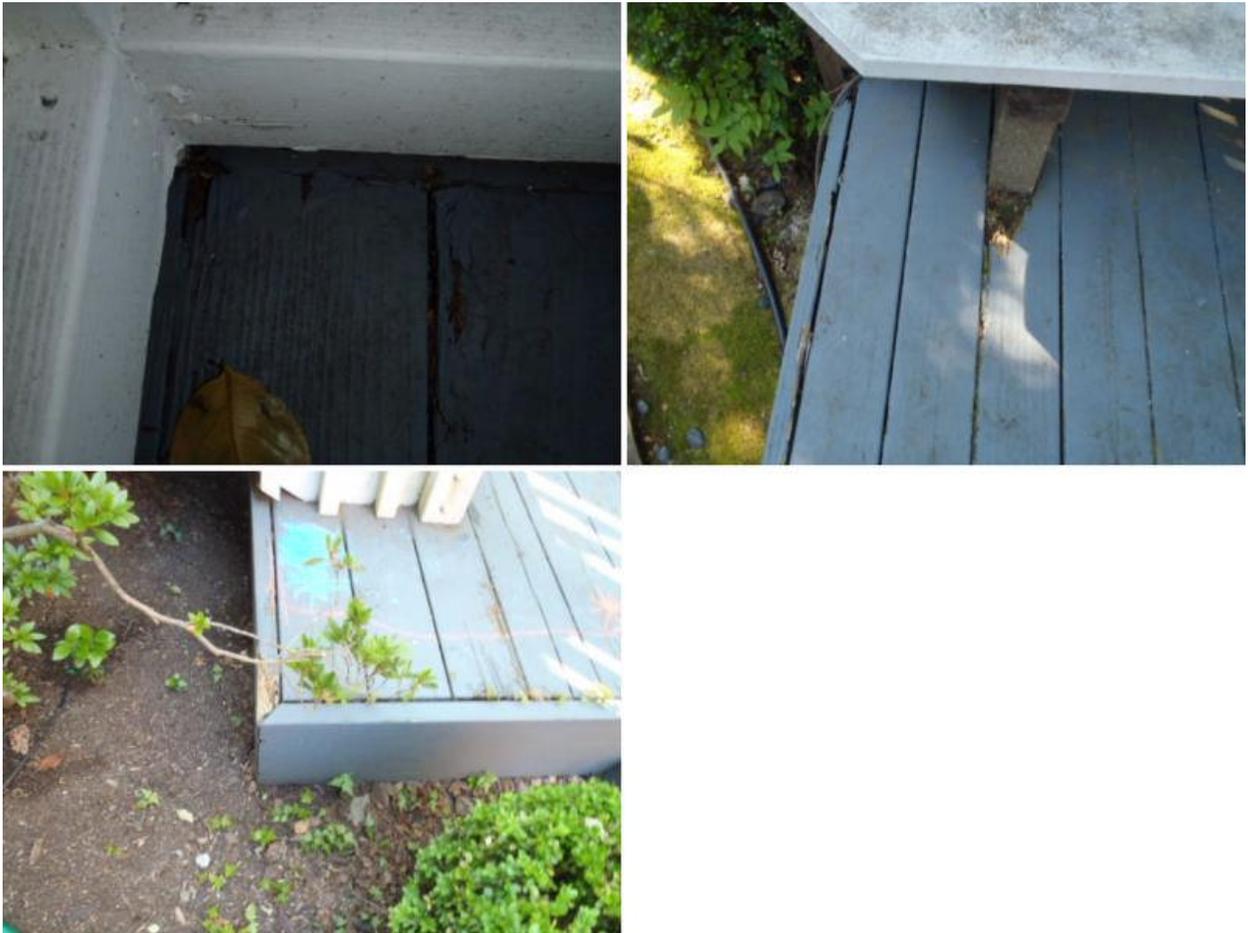
Deck:

Decayed/damaged deck boards were found. Exterior decks are subject to the weather and therefore have a limited life. Decay/damage of this type is specifically described as having been caused by a wood destroying pest or organism in the California Business & Professions Code §8505 and is the responsibility of a pest inspector licensed by the California Structural Pest Control Board. This should be inspected by a licensed pest inspector and any damaged lumber replaced with new material or treatment made, as needed.

Rear deck has been supported directly from the house with a wood ledger board. Moisture can/will penetrate behind the ledger and become trapped for extended periods. This can lead to hidden moisture damage to the siding and structure. I was unable to determine the condition of wood behind the ledger board. A licensed pest inspection company should review this area for damage as a part of a routine pest inspection. There are several methods to correct this condition. One is to completely detach the deck from the house and support with post & piers. Another method is to separate the ledger from the house with metal hardware that is designed to provide a separation between the house and deck. Any modifications should be made by a licensed and qualified contractor.

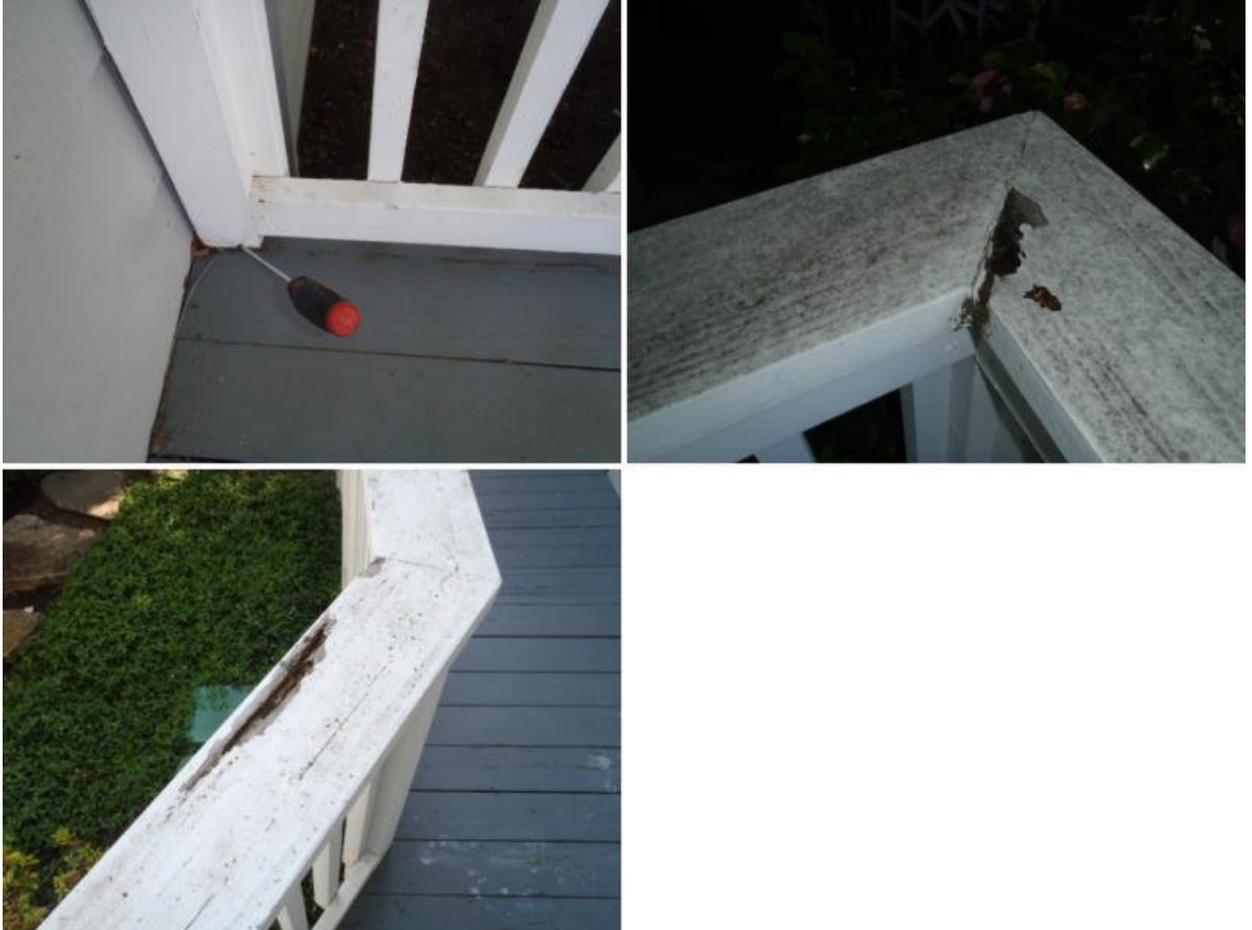
Railing:

Railing is lower than allowed by current construction standards. The minimum height of a railing from the level of the deck has recently changed from 36 inches to 42 inches. While not required, raising the railing will help to increase safety.

Wood is decayed/damaged. Damage may extend into inaccessible areas. As this is not a pest inspection and other areas of damage may be present, a licensed pest inspection company should inspect this building and repairs should be made, as needed.

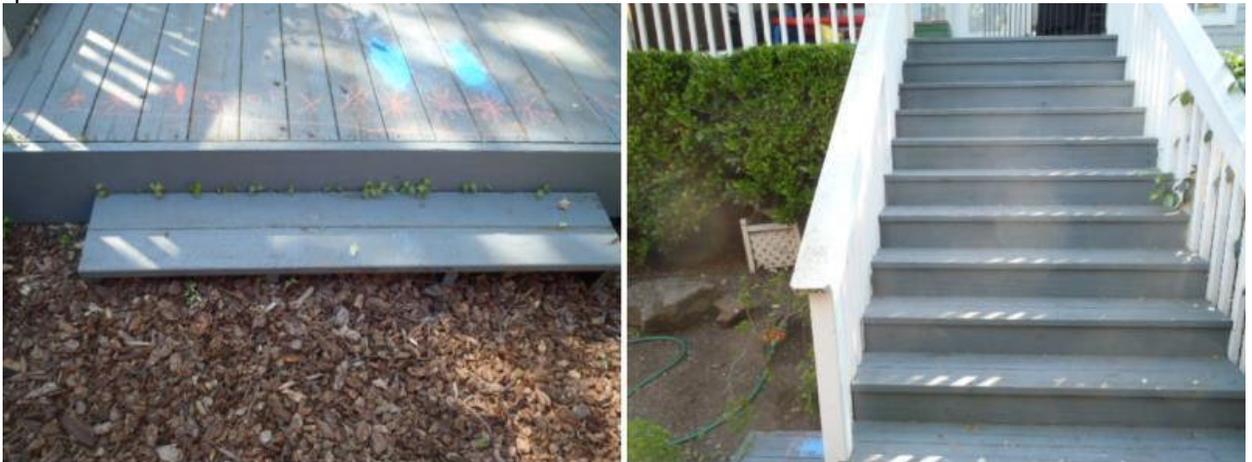
Steps/Stairs:

Step treads/risers are inconsistent. Typically, the maximum difference in riser height or tread depth for any stairway is $\frac{3}{8}$ ". Current construction standards require that risers not exceed $7\frac{3}{4}$ inches in height and that tread depth be no less than 10 inches. This could lead to an individual tripping/falling and should be corrected.

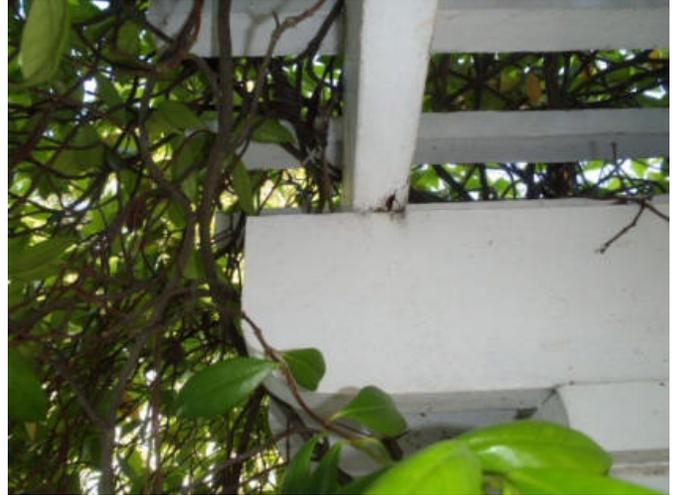
Cover:

Wood framed cover present. Wood support members are decayed/damaged. Damaged wood members should be replaced with new material.

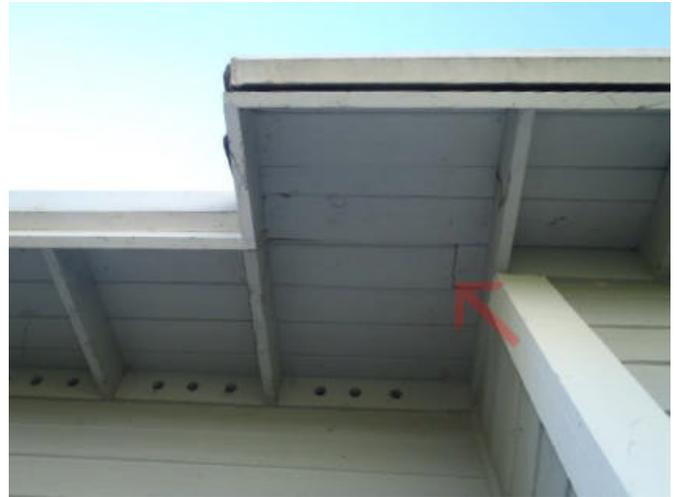
Eaves:

Sheathing at the front is not properly supported. The sheathing should have bearing over a rafter. Blocking or other support should be added for proper support.

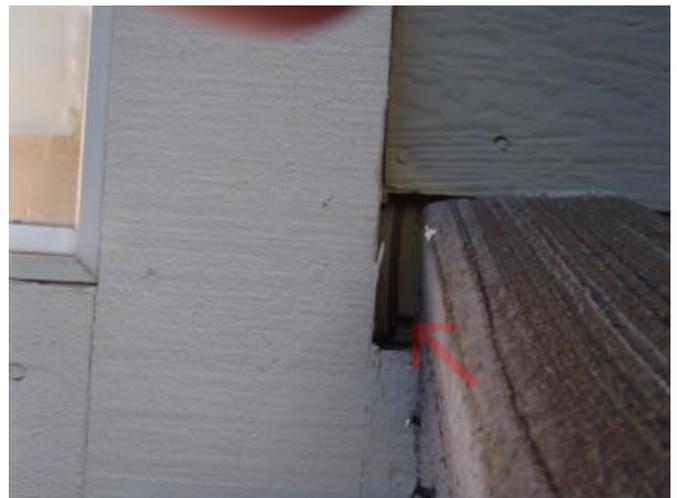
Roof/Wall

Roof/wall flashing is not complete. This installation will allow water to flow down the exterior siding/trim, which will likely lead to moisture damage to the siding and any other adjacent wood framing or trim members. Flashing should direct water away from the wall or any wood members. I recommend installation of a diverter flashing to direct water back onto the roof where it can be picked-up by the gutters.

Voids are present at the left chimney roof to wall connection. This should be properly flashed or sealed to prevent moisture intrusion. A licensed roofing contractor should review and make corrections as needed.

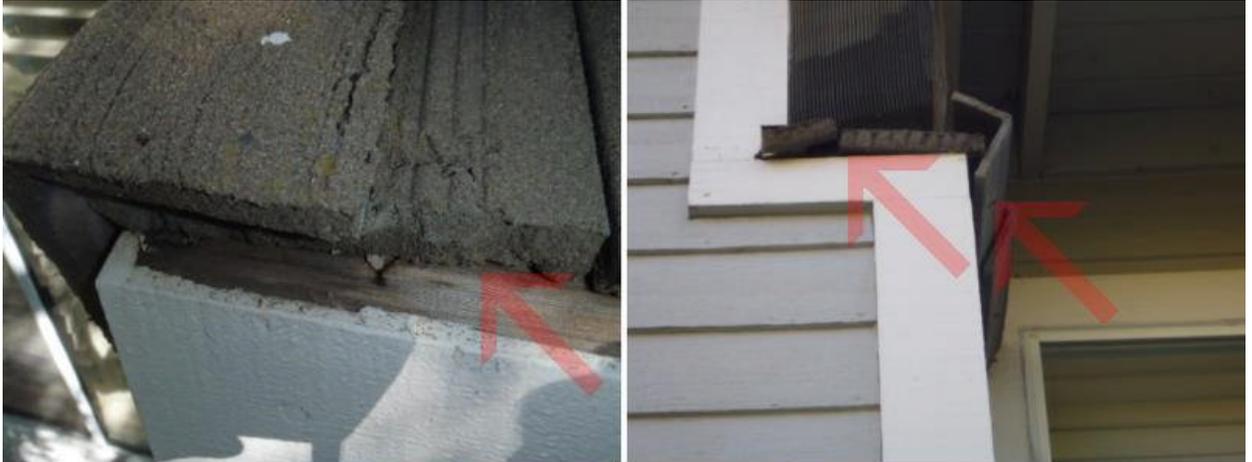
Condition:

The wear observed on the roof tiles is typical of material that is more than 50% through its useful life. Cracks are not uncommon in tile roofs and annual review of the roof is advised. This can often be achieved by viewing from the ground with binoculars.

Loose tiles were found at the rear chimney. These should be properly secured by a licensed roofing contractor.

Roofing at the shoulder of the left chimney is improper. The trim was cut above the roof line to raise the first run of shingles. If any moisture gets under the tiles, it will be trapped behind the trim, causing damage. corrections should be made by a licensed roofing contractor.

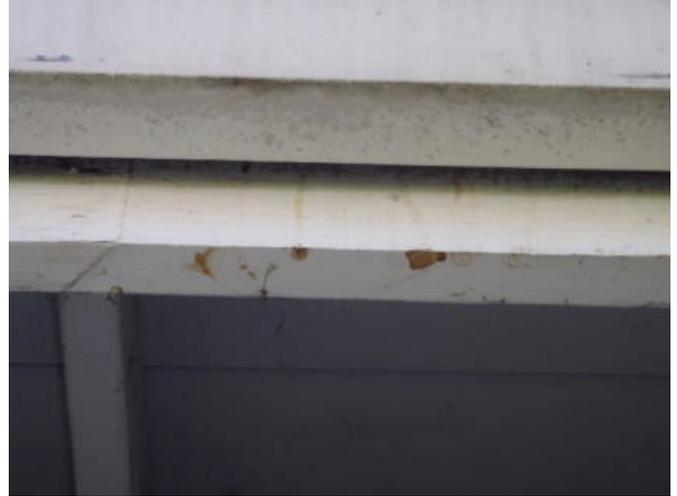
Moisture stains on the eave boards indicate water will flow between the gutter and the fascia. This can allow moisture to damage the fascia board. Installation of flashing under the leading edge of the shingles can help to direct water into the gutters and away from this vulnerable area.

Stains/corrosion indicate that gutters will leak at connections. This is common and requires periodic sealing as a part of home maintenance.

Debris is present in the gutters. Debris should be routinely cleaned from the gutters. Debris build up can cause overflows and damage to gutters.

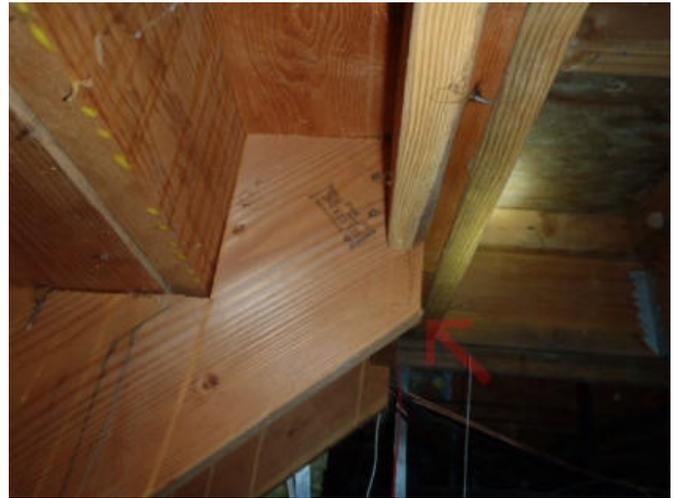
Stair framing in the crawlspace is not properly supported. The bottom edge of the stair stringer should have full bearing. While no sagging or cracking was found, I recommend installation of proper support.

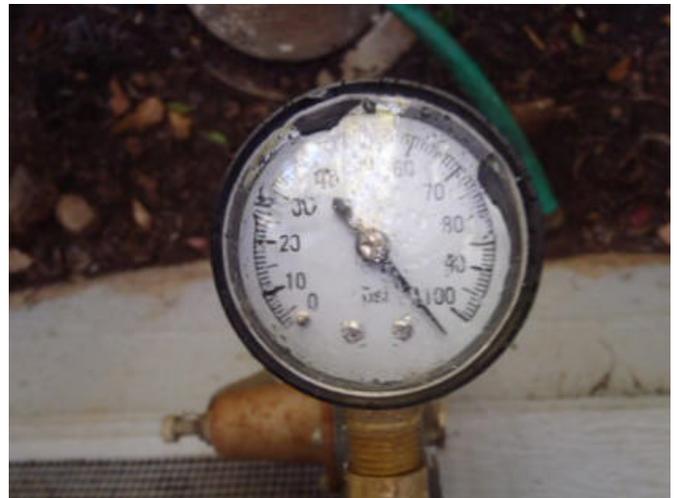
Water Pressure:

Water pressure at time of inspection was approximately 110 psi. This is above acceptable levels. Water pressure over 80 psi can damage fittings and fixtures, which can lead to leaks and water damage. A pressure reducing valve was present but I did not test or adjust this valve. The pressure reducing valve should be adjusted or replaced by a licensed plumbing contractor. However, adjustment of the water pressure may adversely affect water flow at shower heads and other plumbing fixtures. Water flow at plumbing fixtures should be evaluated concurrently with adjustment of the pressure reducing valve.

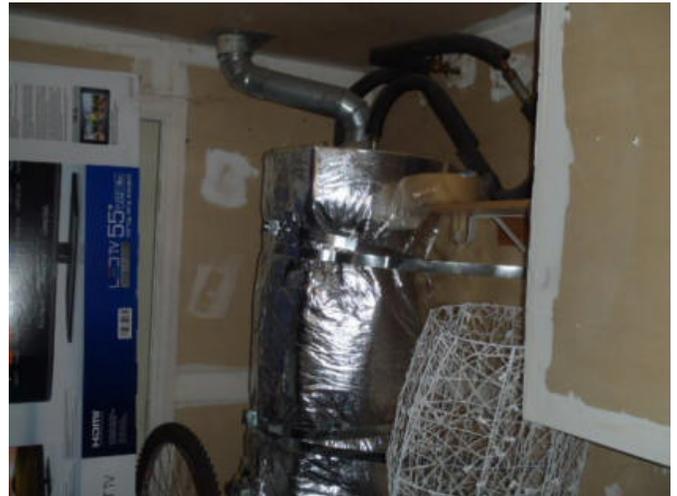
No sediment traps found adjacent to the gas-fired appliances. Often confused with "drip legs" (used when the gas has a high moisture content), sediment traps are typically required to be installed immediately adjacent to specific gas-fired appliances (generally furnaces and water heaters), and are intended to prevent debris within the pipe from entering and obstructing the orifice or control valve of the appliance. This has apparently not been enforced by the local building departments until recently. I recommend review of the installation instructions for each gas fired appliance and installation of sediment traps, as needed.

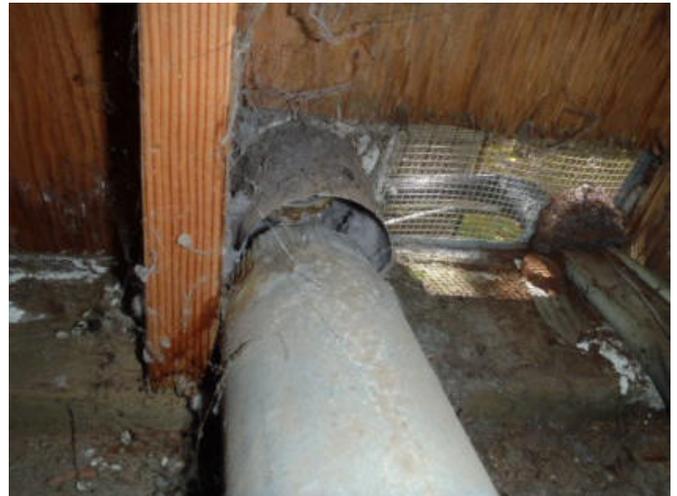
Lint/debris adjacent to the dryer exhaust duct indicates that this will leak warm/moist air into the foundation crawlspace area. I recommend cleaning, sealing or repairs, as needed to direct the air and lint to the exterior.

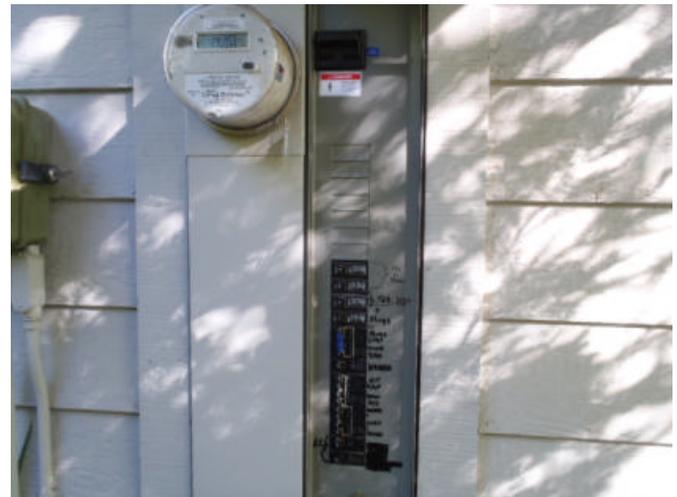
Circuits are not properly and clearly labeled. While the circuits are partially labeled, the labeling is vague/incomplete. Accurate and complete identification and labeling of all individual branch circuits is advised.

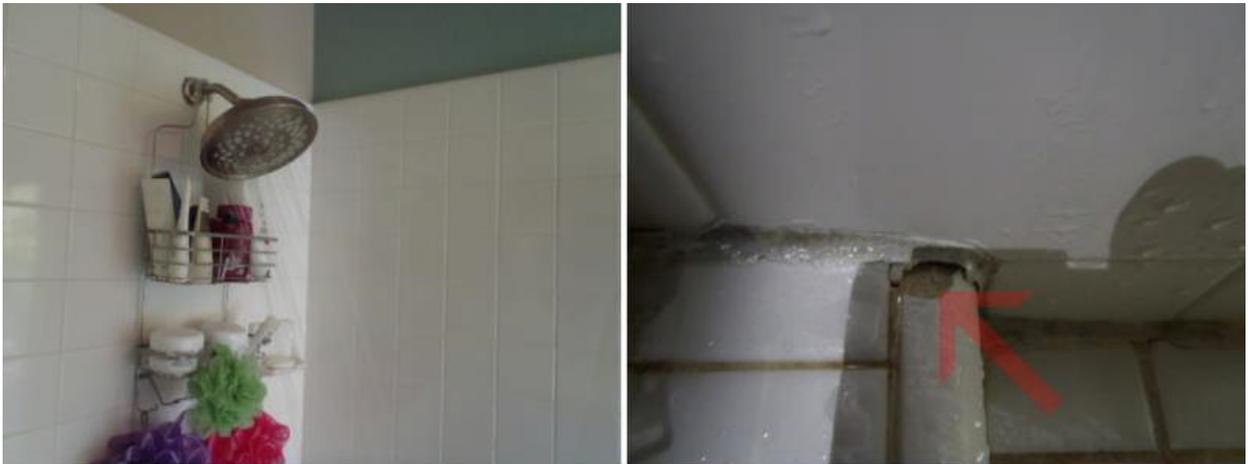
Shower & Surround:

Tile surround walls and pan.

Cracks/voids present in grout. While missing grout is common and often recurs, this should be patched, regouted or caulked, as needed.

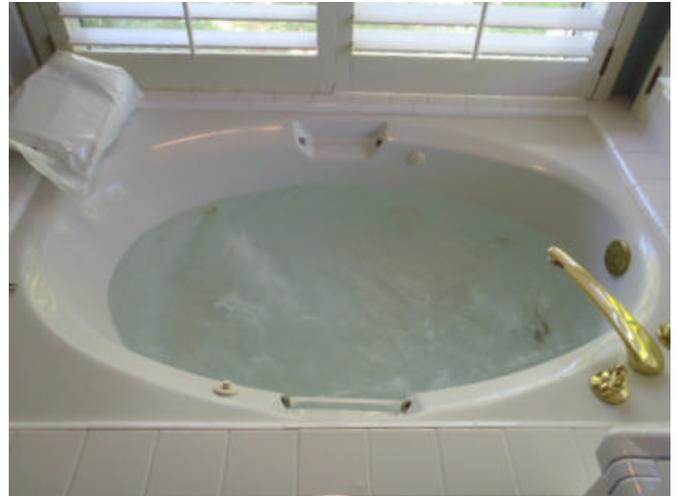
The entire base of this tub is not supported with mortar. The bottom of this type of tub unit is typically required by the manufacturer to be supported on a mortar base. The rim of the tub is usually not strong enough to support the weight of a tub full of water. While no stress cracks were observed in the surface of the tub at time of inspection, cracks may begin to appear due to the limited support. Additional mortar should be placed to fully support the tub unit.

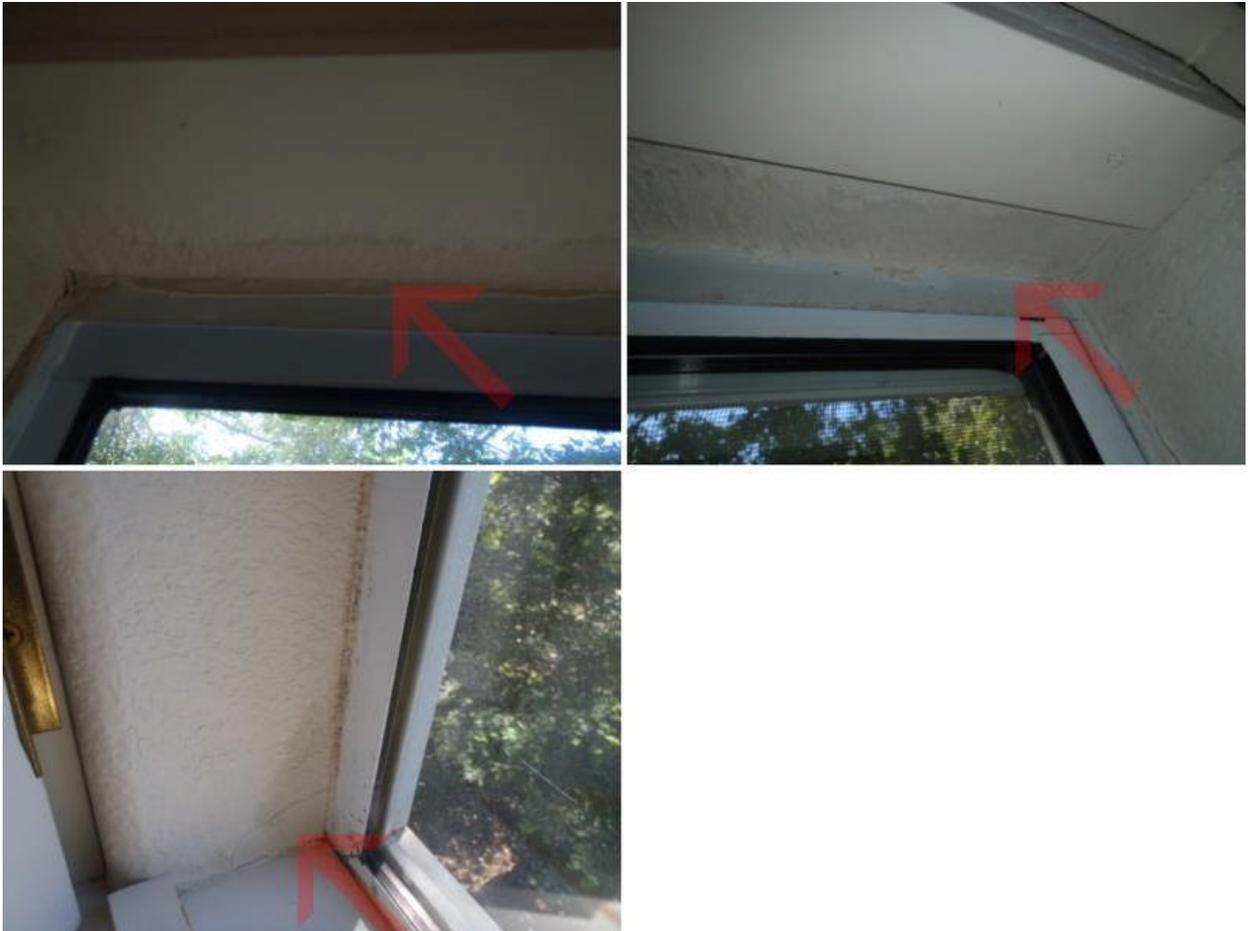
Windows:

Evidence of leaking was observed adjacent to the family room window. I suspect this is due to an active leak. The exterior of this window should be reflashed or resealed, as needed. Unable to determine the condition of enclosed framing without destructive testing. The enclosed framing should be examined for damage concurrently with repairs. If damage is found, any damaged wood should be removed and replaced with new material.

Signs of moisture were found at other windows. It is difficult to determine if some of the stains are from condensation, or are leaking. I recommend review by a licensed window contractor. Further inspection could involve placing a "moisture meter" on this area while "leak-testing" the exterior with sprayed water to determine if this is caused by a leak at the window flashing. If found to be leaking, the exterior window flashing should be corrected or replaced by a licensed and qualified contractor.

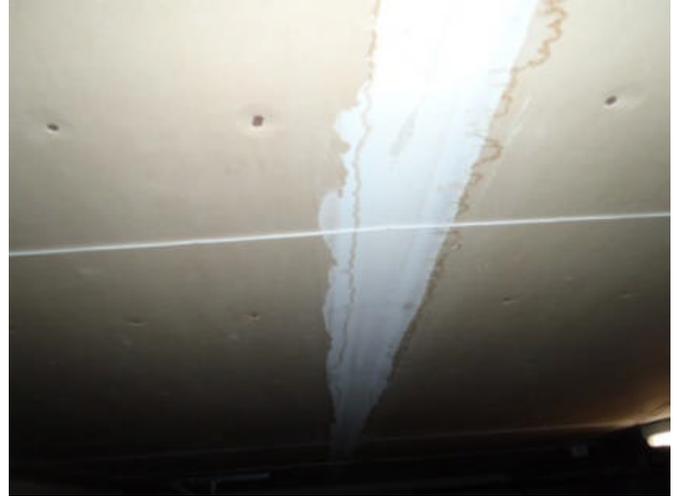
Moisture staining observed on the ceiling. This area was dry at time of inspection, however no determination could be made as to whether this is due to active leaking. Client should consult with the seller regarding this staining and any related repairs. If no documentation can be provided, a licensed plumbing contractor should review the upstairs plumbing and make repairs, as needed.
