Inspected for:
Luke & Ioana Brooks
10643 Chalk Hill Road
Healdsburg, CA

Full Circle Inspections, Inc.

06/19/2013

Re: 10643 Chalk Hill Road
Healdsburg, CA

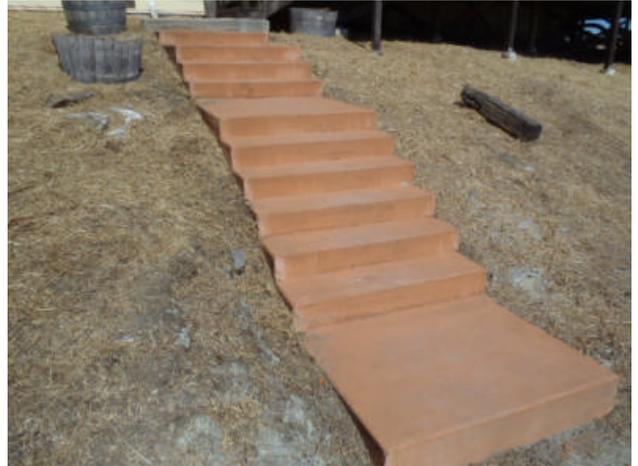
Steps:

Steps do not have a proper handrail. Handrails should have a minimum clearance from the wall or guardrail of no less than 1½ inches, should not project into the stairway more than 4½ inches, should be between 34 and 38 inches above the nosing and the ends of the handrail should "return" back to the wall or newel post. Circular handrails should be between 1¼ and 2 inches in diameter. Handrails are intended to help prevent an individual from falling when ascending or descending.

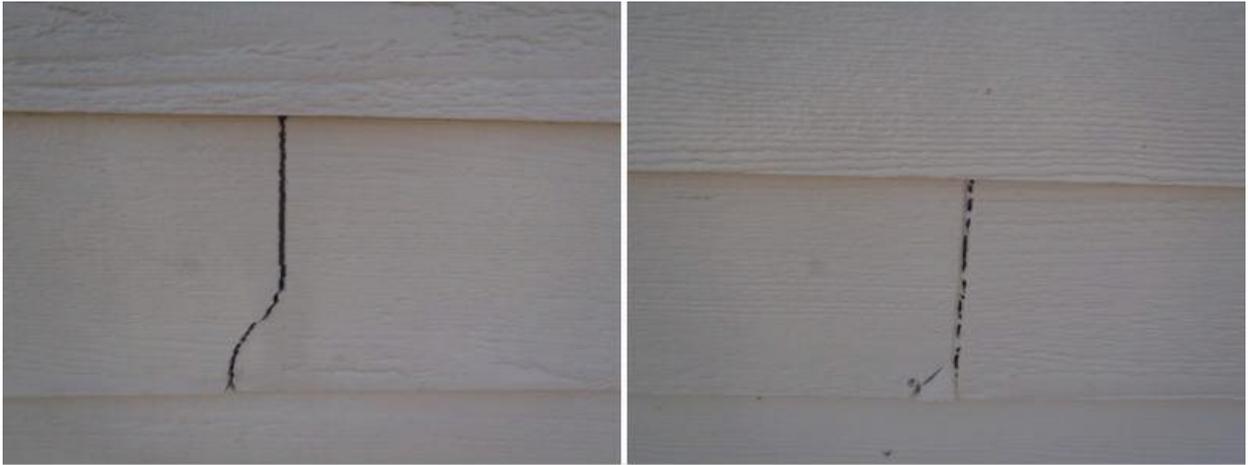
Lap Siding:

Caulking was cracked/separated at some seams. Past installation instructions allowed either caulking or installation of flashing under the seams at the field butt joints. Current instructions now require flashing under all seams. I was unable to positively verify if any of the butt joints were flashed. Ideally, flashing would be installed under all of the seams; however, this may not be practical without removing the siding. Seams of the siding panels will expand and contract with changes in weather and will require periodic reapplication of caulking. A good quality flexible caulking (such as a polyurethane caulking) should be used to seal any open seams and at the perimeter of plumbing and window/door openings. The installation instructions available on the manufacturer's website should be reviewed for recommended types of caulking.

Cracked corners were found at some butt seams. The manufacturer should be consulted for repair recommendations. In the meanwhile, I recommend caulking or patching as a temporary measure.

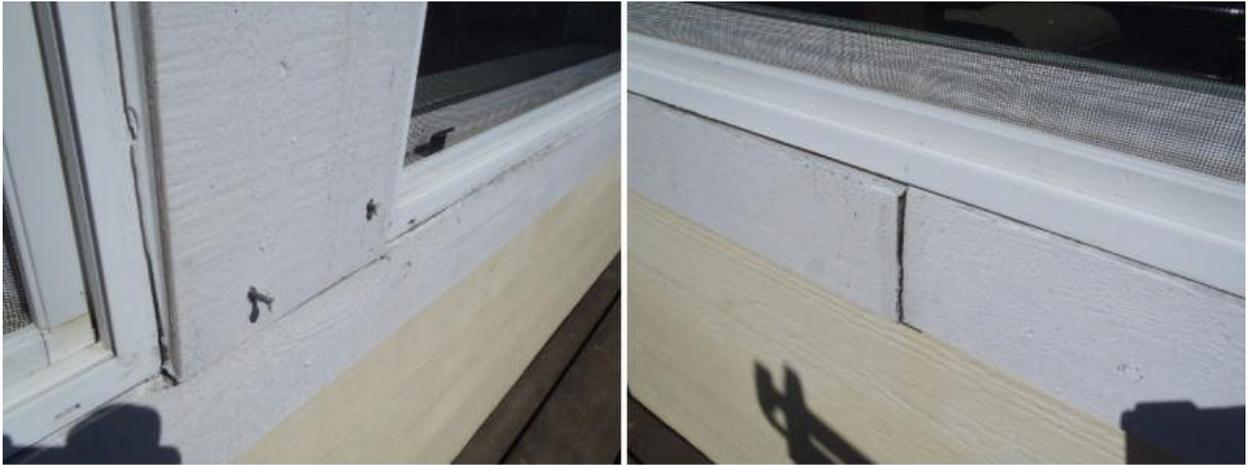
Trim:

Cracks are present in sections of trim. This is typically caused by weathering and shrinking of wood and can allow moisture to intrude to the interior surfaces of the wall. Severely cracked trim should be replaced with new material. Smaller cracks can be patched and painted to help prevent any increase in cracking.

Loose nails and open seams were observed at various areas. Nails should be reset or replaced, as needed. Sealing all cracks/voids between siding and trim is recommended to prevent moisture intrusion to the interior surfaces of the wall. I recommend not caulking along the lower edge of window trim (under the window) to allow any water that might get behind the trim a path out. I also suggest the use of a flexible and paintable caulking, such as polyurethane.

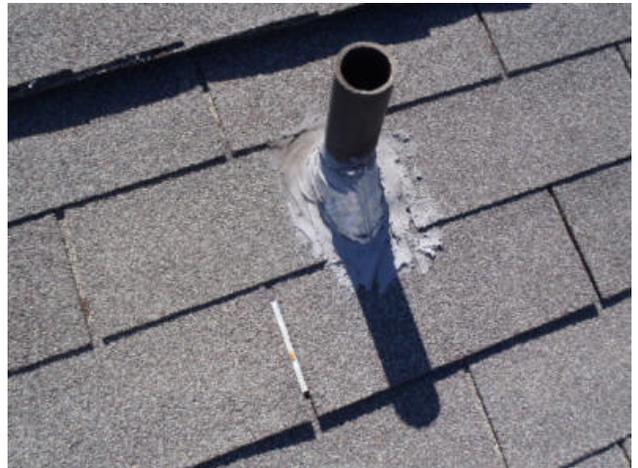
Penetrations:

Plumbing flashing at above the approximate area of the hall bathroom is not correctly installed. Typically, the lower tail of the metal extends over the shingles. No evidence of leaking observed as a result of this. I recommend corrections concurrently with other repairs noted in this report.

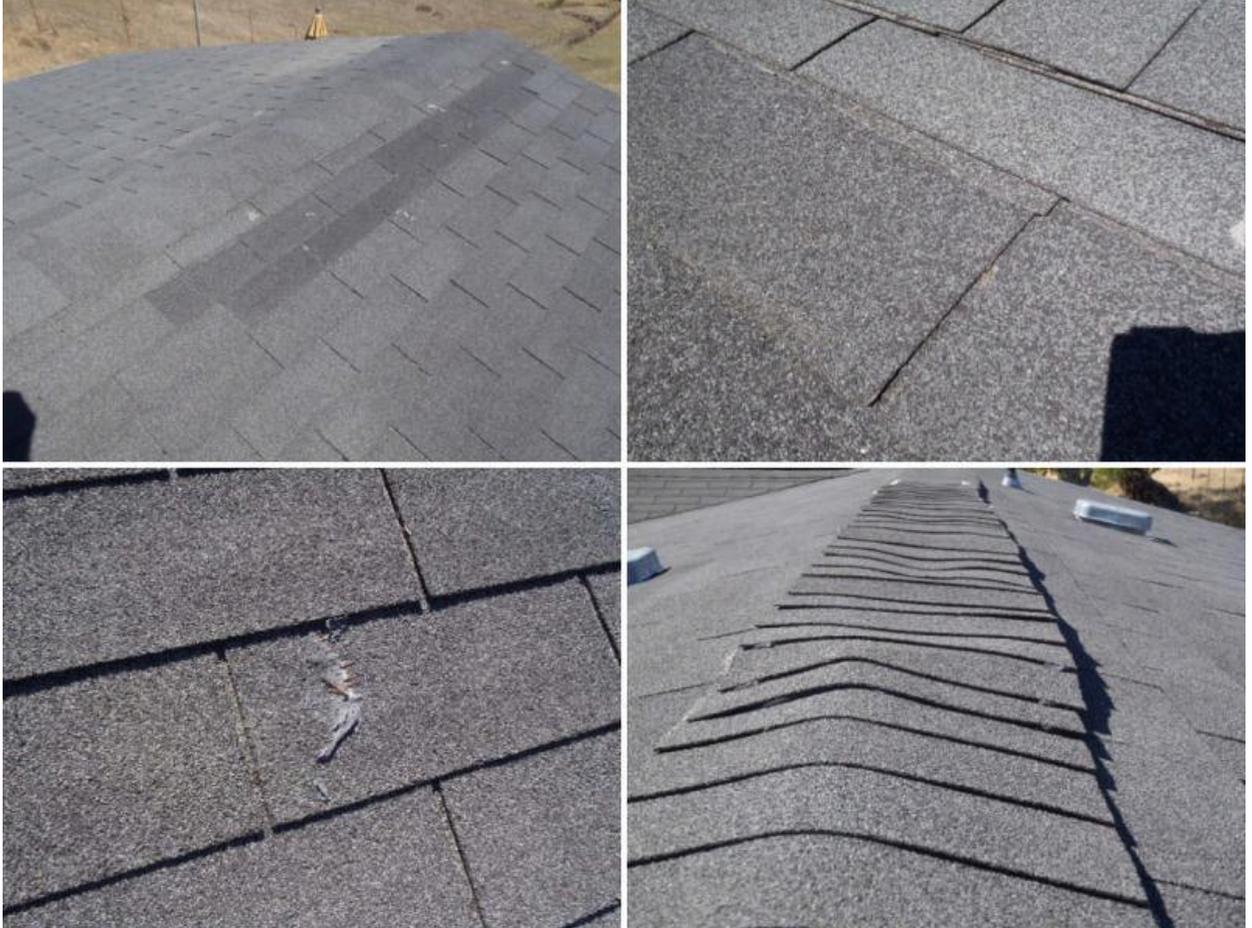
Condition:

Some damaged/patched shingles were observed above the living/dining area. Ridge cap shingles are flat to the peak of the roof. As this home is located in an area that likely experiences high winds, I recommend patching/repairs to prevent leaks.

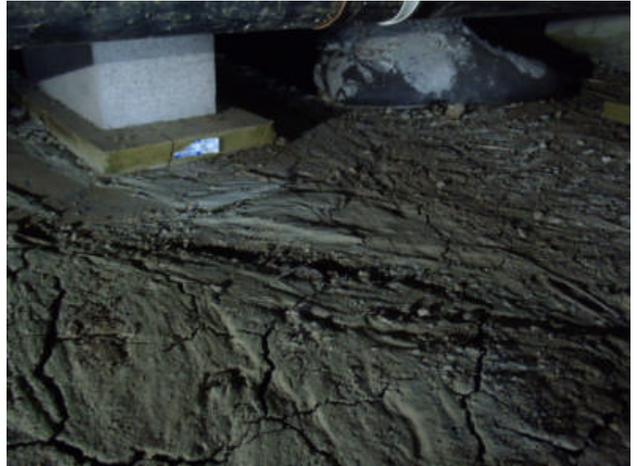
Soil was dry at time of inspection. Indications were observed that water will flow through the crawlspace during periods of rain. This can usually be corrected by installing a drainage system uphill from the house and extenders on the roof gutter system. A licensed landscape contractor should be consulted regarding installation of drainage.

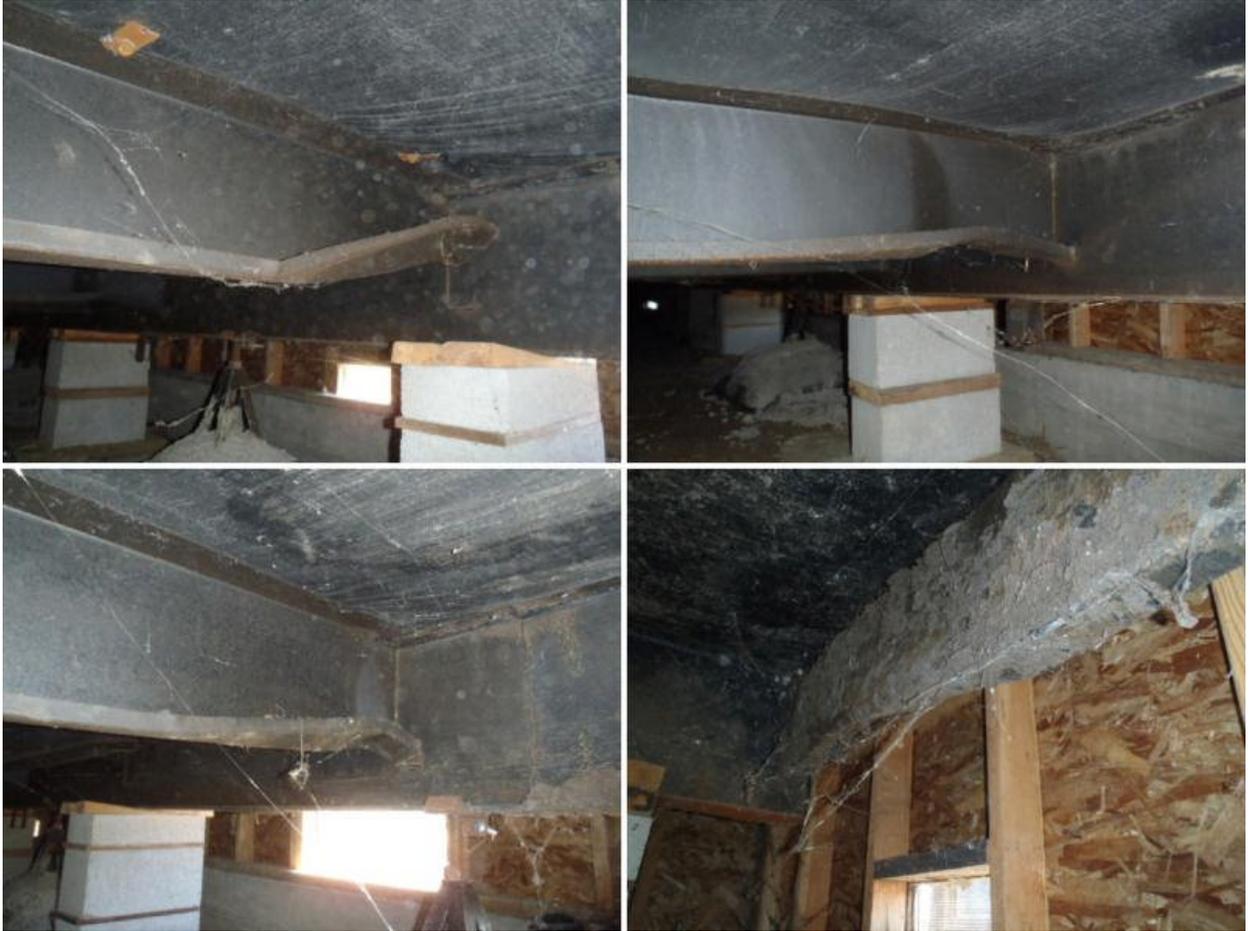
Chassis:

Metal girders.

Metal channels under the master bedroom area are bent/distorted. This is the likely cause for the sloped/uneven floors noted in the interior rooms section of this report. Repairs will likely be impractical. If more information is desired, a licensed and qualified structural engineer should be consulted.

Floor in the master bedroom and the living room is sloped uneven. This has likely been caused by the bent/distorted metal channels noted in the foundation crawlspace area.

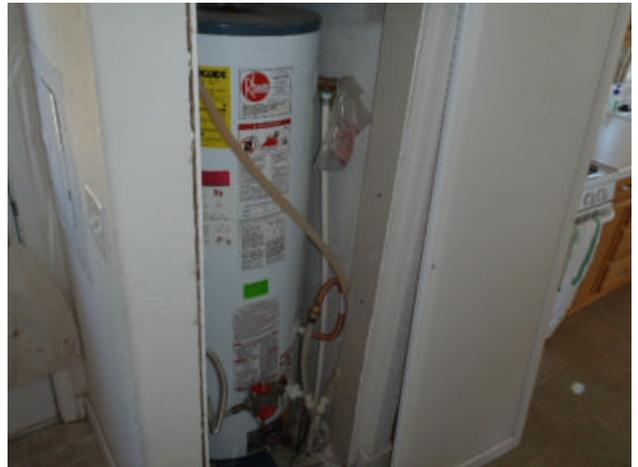
No drain pan present under this appliance. If a leak were to develop, the water would flood the floor in this area. A properly sized pan should be installed with an adequately sized drain pipe that discharges at the exterior of the building, preferably to a location that is readily visible so that any leaking will be easily noticed.

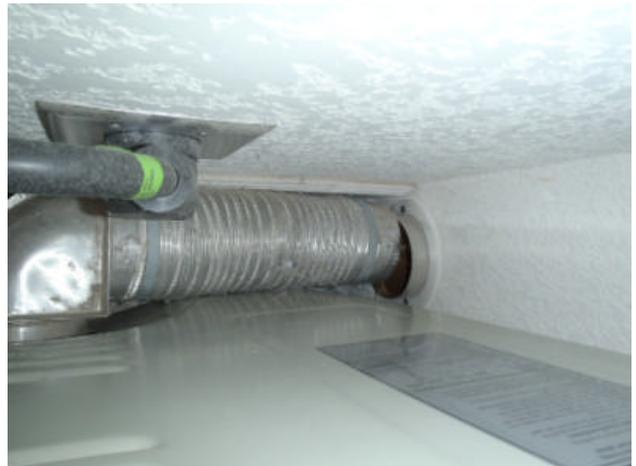
Exhaust duct is disconnected. I recommend patching or repairs, as needed.

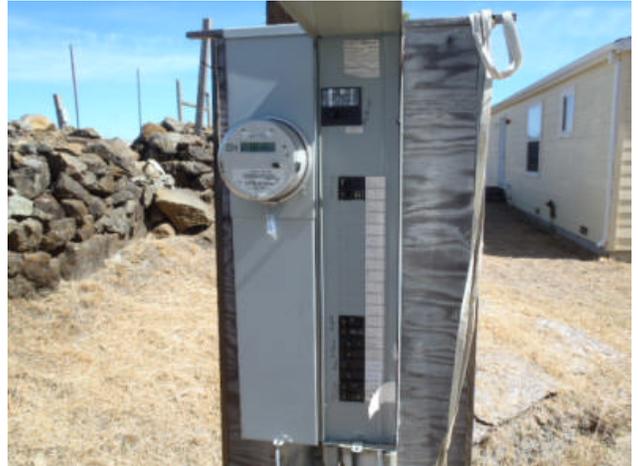
Knockouts are missing at the dead front panel. These openings present a potential safety hazard as they provide access to the energized electrical wiring and buss bars of the panel. This is typically corrected by inserting covers specifically designed to close these openings.

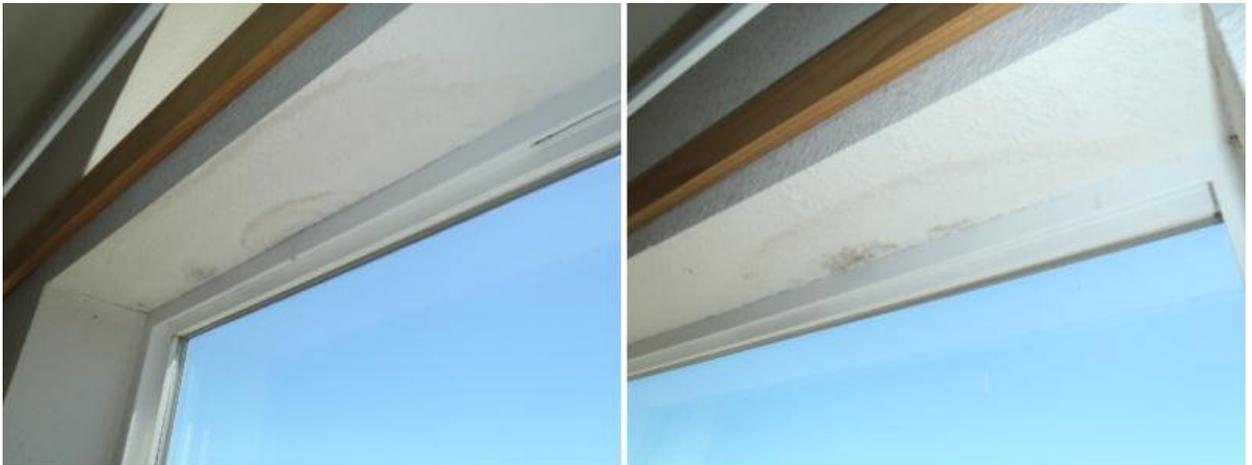
**Windows:**

Perimeter of the living room window has been caulked. Stains on the interior wall indicate this was done to repair a leak at the exterior of the window. While keeping the exterior seams well caulked is good practice, Windows should be properly flashed to prevent leaks. My primary recommendation is to remove any trim and/or siding necessary to properly flash the windows.

Evidence of leaking was observed adjacent to the living room window. This is likely due to an intermittent or active leak. The exterior of this window should be reflashed or resealed, as needed. Unable to determine the condition of enclosed framing without destructive testing. The enclosed framing should be examined for damage concurrently with repairs. If damage is found, any damaged wood should be removed and replaced with new material.
