**6405 Enterprise Road
Glen Ellen CA 95442**

**Client(s): Delaney
Inspection Date: 5/15/2018**

Inspector: Paul Brand #

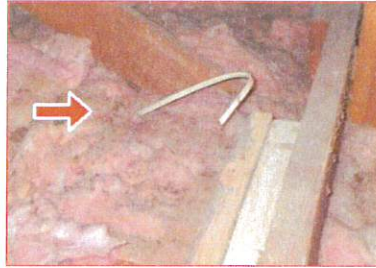
Item 5 - Picture 1

5. Terminated wiring with exposed leads noted above the hall. This is a safety concern. Whenever a wire is cut, the end should be enclosed in a junction box. We recommend correction or removal of these wires.
