WELL TESTING SERVICE

Ray's Well Testing Service Inc.
4853 Vine Hill Rd, Sebastopol Ca 95472
Phone 707 823 3191 Fax 707 317 0057 Lic# 903708

WATER SYSTEM INSPECTION

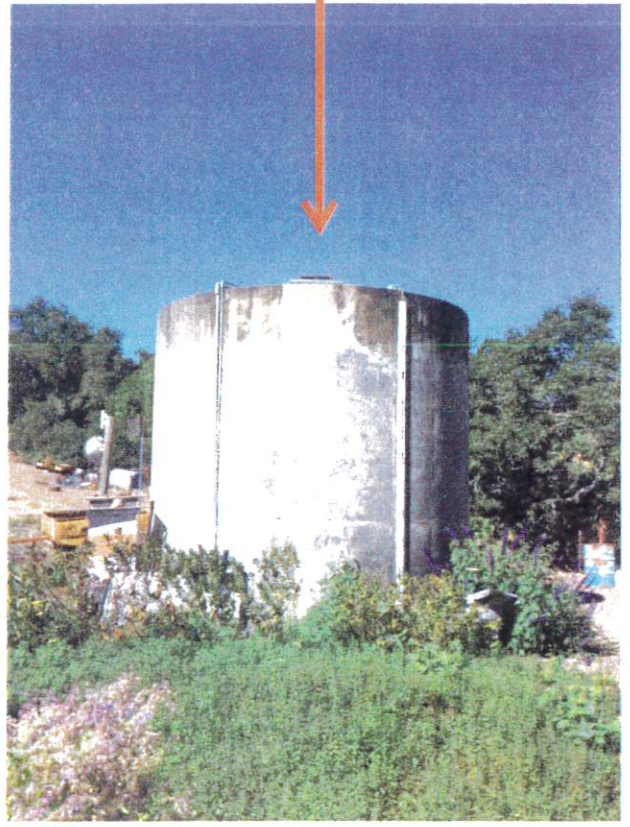
Concrete Storage Tank

3. The 3 HP 230V submersible well pump fills the concrete storage tank (tank water was visibly clear). The well pump is controlled by an electric float switch.

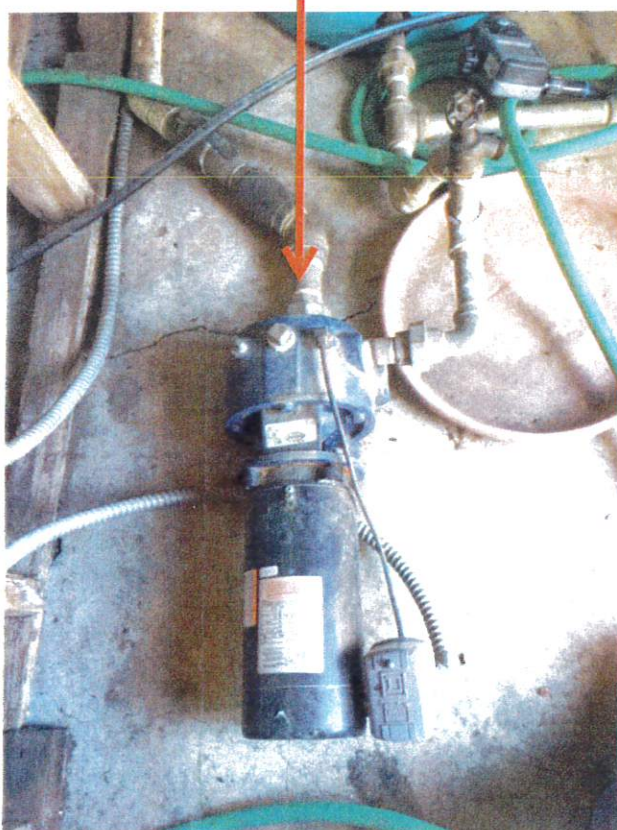
Domestic Booster Pump

4. The 1 HP 230V Jacuzzi 1RM2-S domestic booster pump pressurizes two 85 gallon Well-Rite WR260 pressure tanks (tanks dated 2000/2000, 35/36 PSI air charges). The operating pressure is set 40 to 60 PSI. The domestic booster pump is protected from dry running by an electric float switch hung approximately 1/2 down the concrete tank. There is a toggle switch in the pump house that bypasses the float switch in an emergency. Note: when float is bypassed the booster pump is not protected from dry running.

1. There is not a check valve at the well head, recommend installation.
2. If the domestic booster pump electric float switch is bypassed the booster pump is not protected from dry running, recommend installing another float switch at the bottom of tank to prevent damage to pump in an emergency.
3. The electric fill float switch does not have a weight, recommend installation.
4. There is not a sediment pre filter plumbed before the ultraviolet unit. There is not a flow control plumbed after the ultraviolet unit. Recommend installation.
5. Water test results and possible follow up recommendations pending.

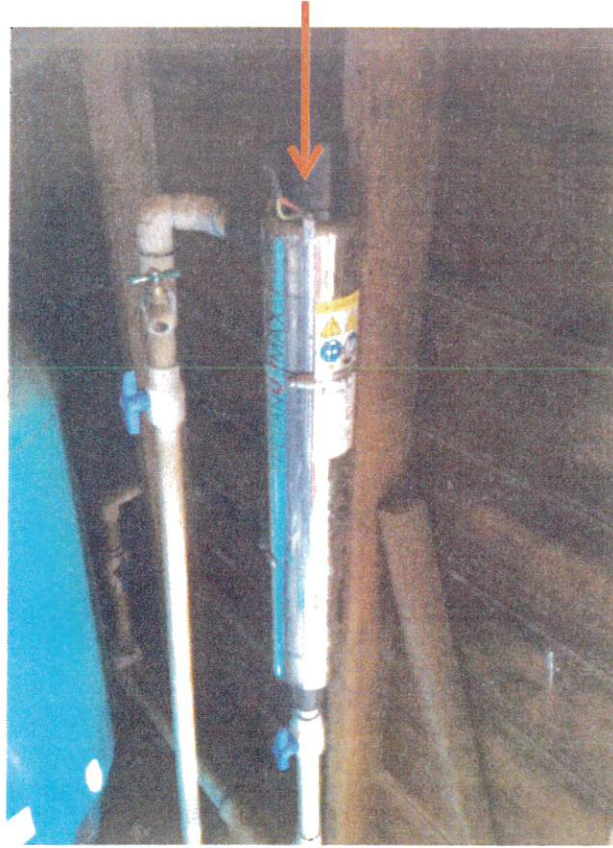
Ultraviolet Unit

5. The domestic water is treated by a Trojan UV Max model E4 ultraviolet unit with controller. At the time of the test the controller indicated the lamp should be changed in 51 days. The treated water lines serve the main house, guest house and local irrigation around houses. There is also a 2"x10" cartridge filter that serves a drinking tap at the main house kitchen sink.

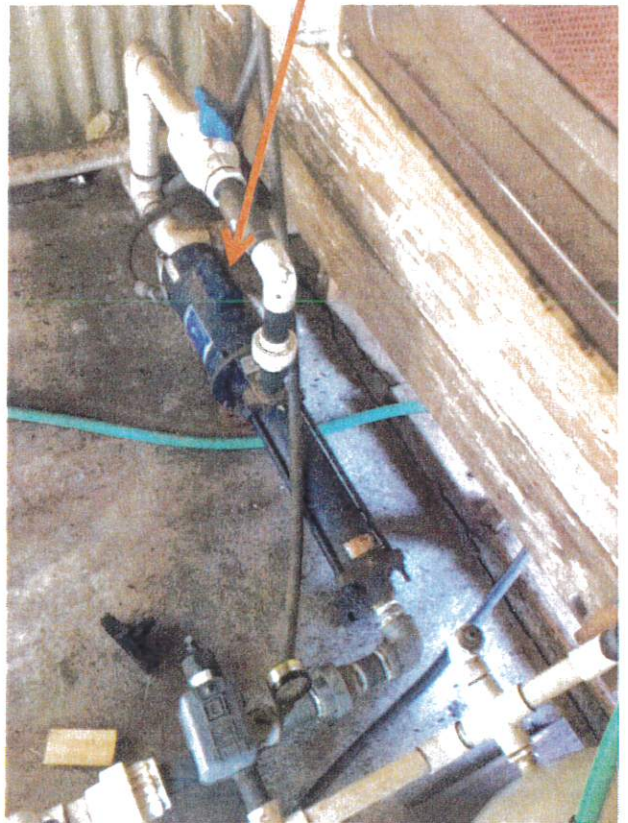
Vineyard Irrigation Booster Pump

6. The 1 HP 230V Jacuzzi 15H425-9/S vineyard irrigation booster pump pressurizes 7.6 gallon Well-X-Trol WX 103 expansion tank (tank dated 2014, 43 PSI air charge). The operating pressure is set 50 to 70 PSI. The vineyard booster pump is protected from dry running by an electric float switch. The float switch is hung slightly higher than the domestic booster pump float switch in order to give the houses priority if the tank runs low. There is a 1.25" cycle stop constant pressure valve and a 2" Wilkins Zurn backflow preventer plumbed on the outlet of the booster pump.

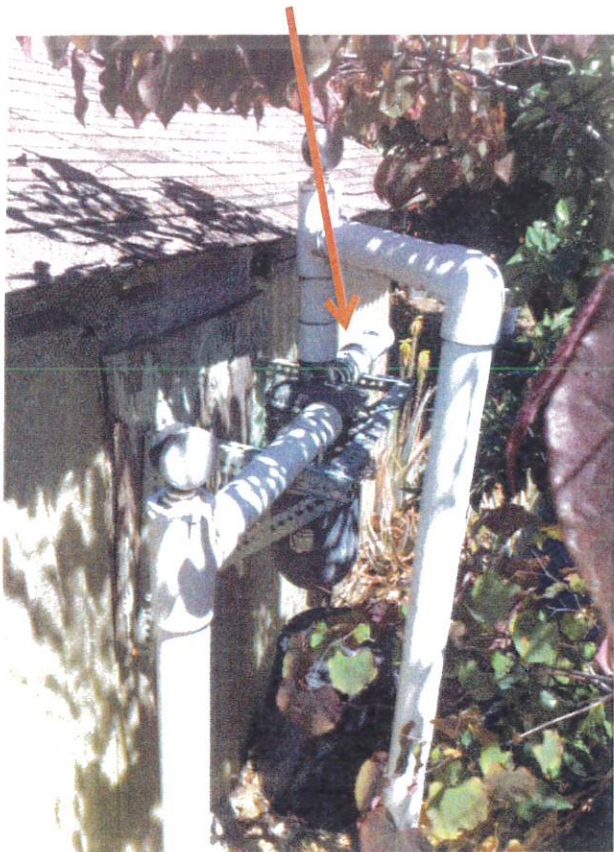
Upper Vineyard Irrigation Filters

7. The upper vineyard irrigation line is treated by a 2" Arkal sediment filter and the lower vineyard irrigation line is treated by a two 2" Arkal sediment filters plumbed in parallel.

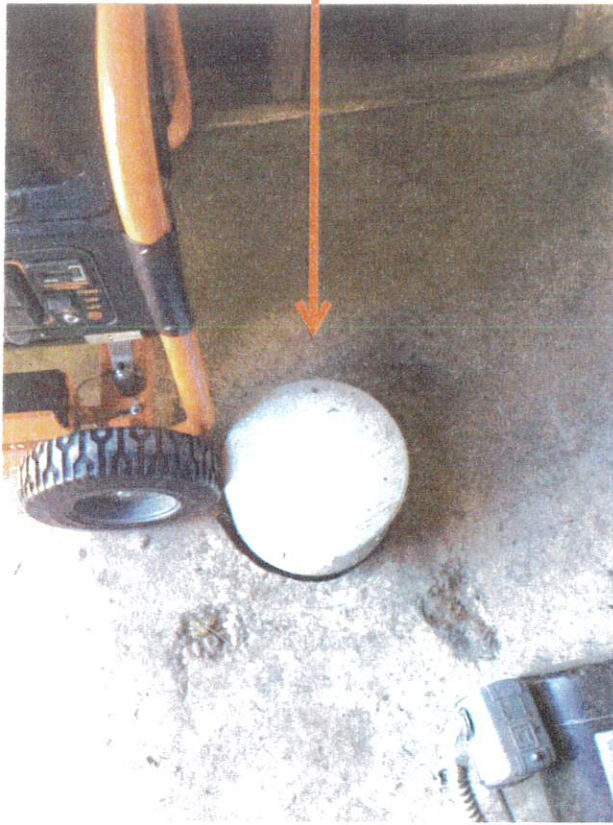
NOT INSPECTED
Old Well

9. There is bypass valve that allows for the vineyard booster pump to serve the domestic water lines or vice versa in an emergency.
10. There is an older well in the pump house that was not inspected or tested.
