WOOD DESTROYING PESTS AND ORGANISMS INSPECTION REPORT

Building No. 6405	Street Enterprise Road	City Glen Ellen	Zip 95442	Date of Inspection 05/15/18	Number of Pages 7
----------------------	---------------------------	--------------------	--------------	--------------------------------	----------------------

Report #: 14277

CORRECTED REPORT

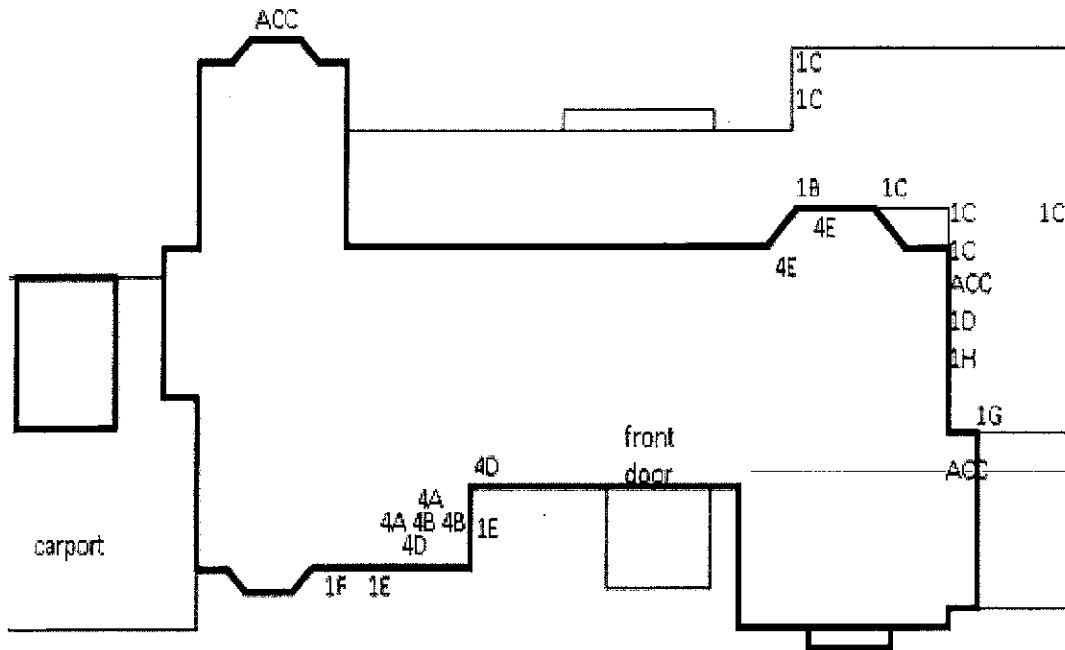
Diagram Not To Scale

1B. Dry rot fungus-damaged wood was noted to the window trim at the areas marked on the diagram.

1D. A minor amount of dry rot fungus-damaged wood was noted to the door trim at the areas marked on the diagram.

1F. Dry rot fungus-damaged wood was noted to the bottom house trim at the areas marked on the diagram.

4B. Subterranean termite-damaged wood was noted to the floor beam beneath the front left bathroom, and associated wood members at the areas marked on the diagram.

RECOMMENDATION: Cut out damaged wood and replace with new wood materials. Areas with a minor amount of dry rot can be patched as deemed necessary. (SECTION 1)
