Inspected for:
Wendy or Andrew Welling
88 Calistoga Road
Santa Rosa, CA

Full Circle Inspections, Inc.

09/03/2020

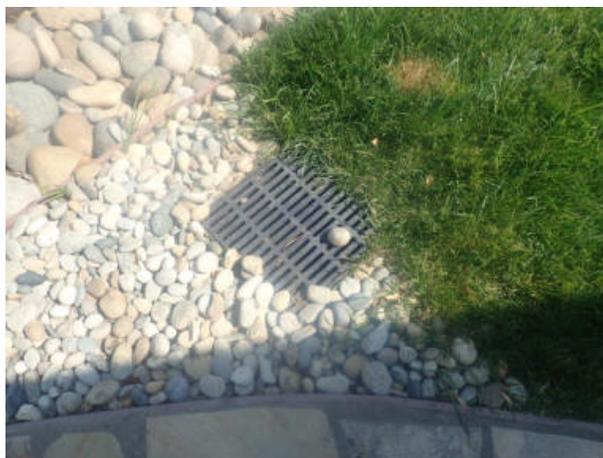
Surface drains are present. Verification of drainage systems is beyond the scope of this inspection. Drainage systems should be regularly cleared of debris to ensure continued operation. Client is advised to consult with the seller for any available information regarding this system.

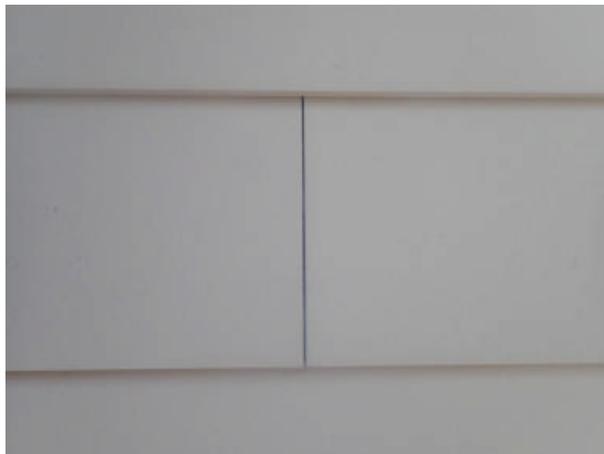
Voids were observed at the butt joints of the siding. Installation instructions of this type of siding generally allow the choice of either caulking or installation of flashing under the seams at the field butt joints, but flashing under all seams is the recommended treatment. In my experience, the weather barrier under unflashed seams of the siding can become damaged over time as the caulking ages and separates. I was unable to positively verify if any of the butt joints were flashed or the condition of the weather barrier. I recommend consulting with the builder for the installation instructions for this specific siding and information as to which detail/method was used at the butt seams. Seams of the siding panels will expand and contract with changes in weather and will require periodic reapplication of caulking. A good quality flexible caulking that conforms to ASTM C920 Grade NS, Class 25 or higher (such as Sikaflex 1A or equivalent) should be used to seal any vertical seams, at the perimeter of plumbing penetrations, and at the sides of window/door openings. The installation instructions available on the manufacturers' websites should be reviewed for specific information.

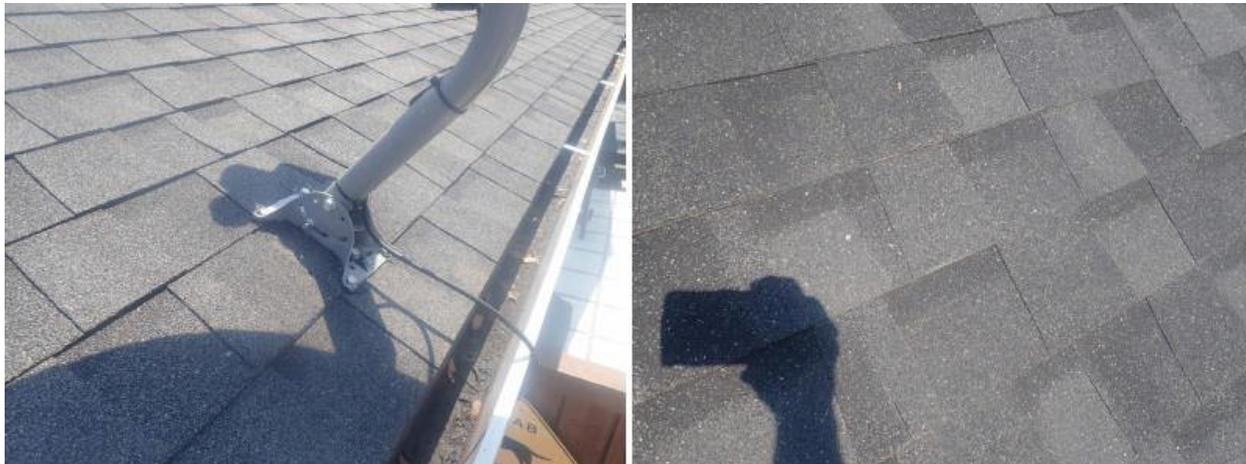
The "dish" antenna bracket has been attached to the roof through the shingles. My primary recommendation is to relocate the hardware and repair the roof or to install proper flashing to prevent moisture damage to the roof sheathing. At a minimum, bolt penetrations should be kept well sealed/coated with mastic (asphalt patching compound).

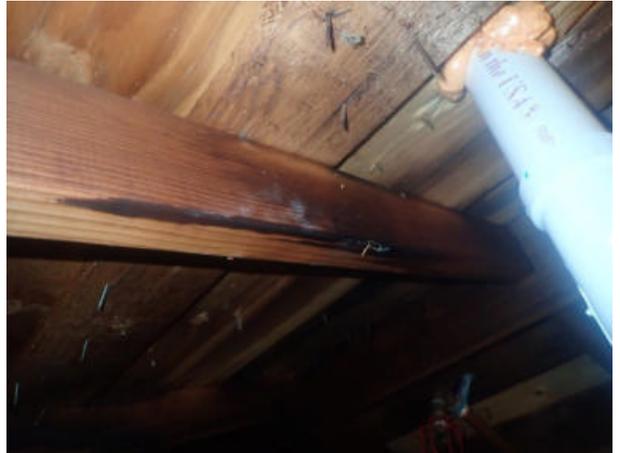
A scorched rafter was found adjacent to the furnace gas vent pipe. I suspect this is older and may be from the previous furnace. No evidence of excessive heat observed at the plastic gas vent pipe.

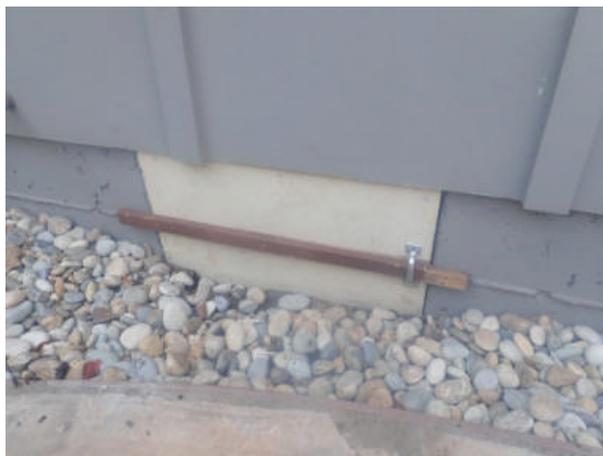
The foundation crawlspace area is difficult to enter. I suggest excavation of soil adjacent to the access opening and installation of a box or curb surrounding the opening to prevent soil and water from flowing down into the foundation crawlspace area. Installation of a cover/roof over the opening will help to prevent rain from entering this area.

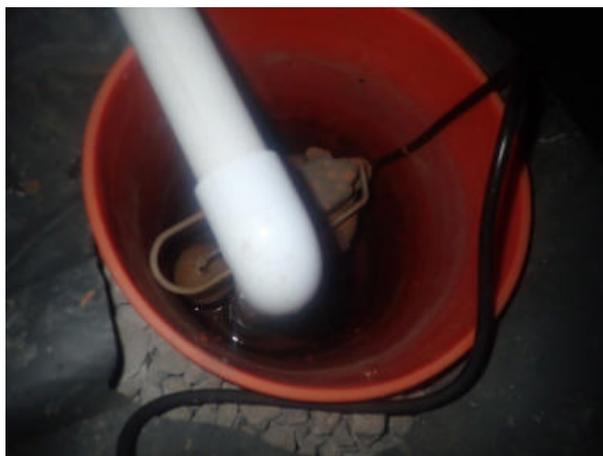
No check valve present on discharge line of the sump pump. A check valve should be installed on the drain line to prevent water from flowing back into the sump after the pump turns off.

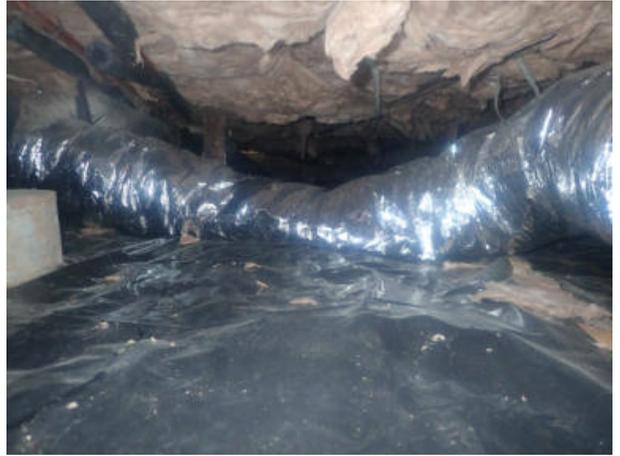
A section of the ducting has been damaged. The ducting under the front of the living room is partially crushed. This will reduce the air flow through the ducting and the efficiency of the heating system. Ducting should be repaired or replaced, by a licensed heating contractor.

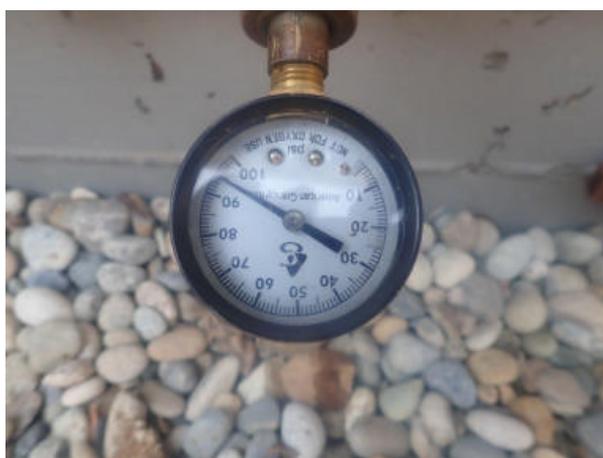
Water pressure at time of inspection was approximately 95 psi. This is above acceptable levels. Water pressure over 80 psi can damage fittings and fixtures, which can lead to leaks and water damage. This is normally corrected by installing a pressure reducing valve near the main shutoff. A licensed plumbing contractor should be consulted for installation or corrections, as needed.

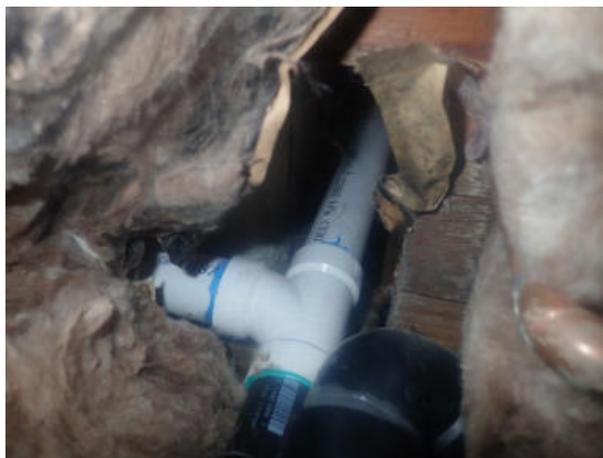
PVC and ABS drain piping have been connected together at the hall bathtub. While it appears that a conditionally approved solvent/cement has been used to make the connections, mixing different types of plastic piping is generally not approved without the use of special "transition" fittings. To the best of my knowledge, mixed use of these two materials does not commonly lead to leaks or related problems, and no leaking or loose fittings were found at time of inspection as a result. However, I cannot warranty that leaks will not develop in the future and the most prudent course of action would be to have this corrected by a licensed plumbing contractor.

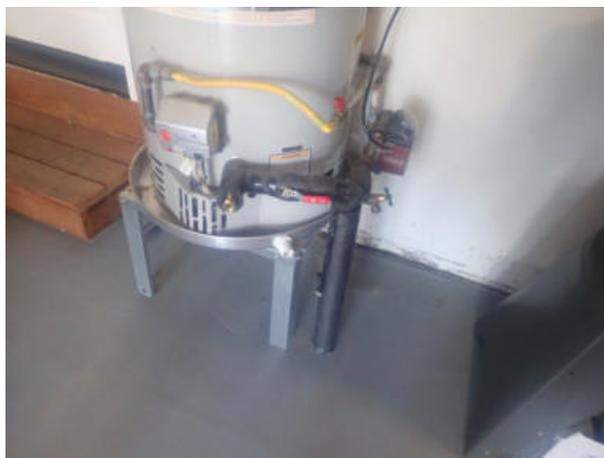
This appliance is unprotected. Normally, when a water heater is located in an area where it can be damaged by a vehicle, protection is provided in the form of a bollard (concrete filled metal pole) or similar device. Installation of a bollard or other protection is advised.

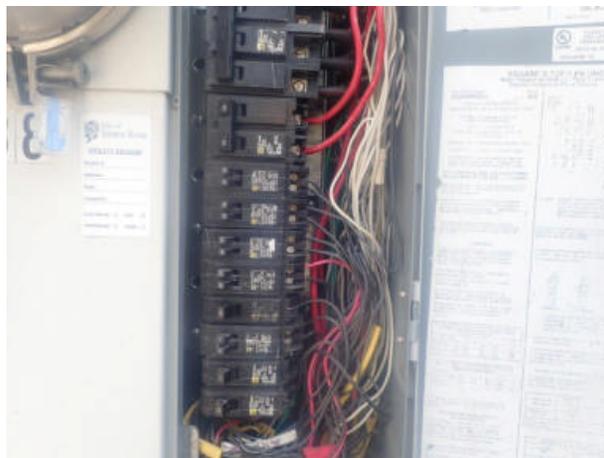
Numerous conductors in the panel make review of the wiring and connections difficult. Review was limited.

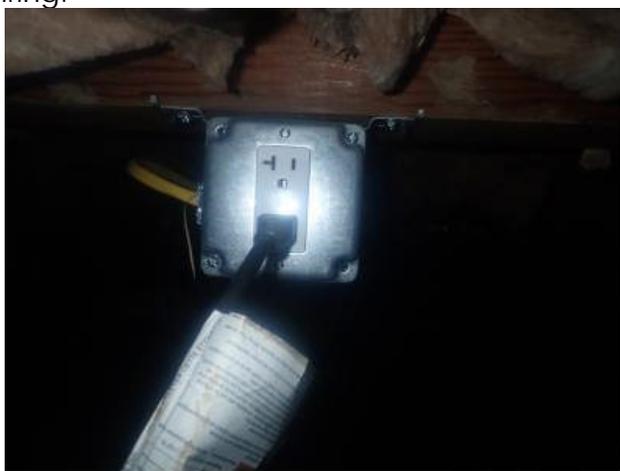
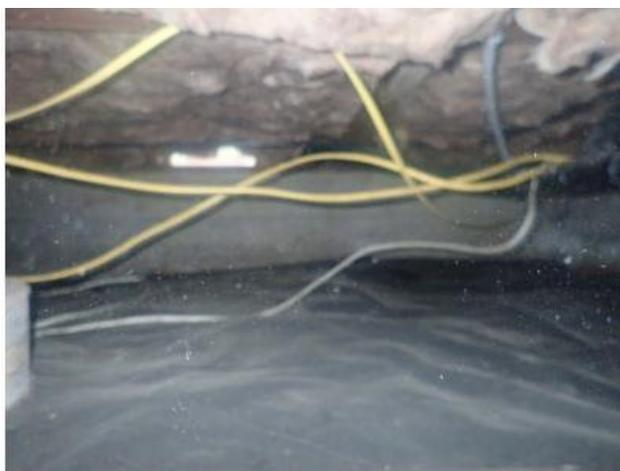
The sump pump receptacle outlet is not GFCI protected. Ideally, this would be supplied by a GFCI device to help increase safety. The device itself can be installed in a convenient, interior location to allow easy reset and have an indicator that will light-up if the device has been "tripped".

Electrical cable is lying on soil. Cables are not secured to the underside of the floor framing. This cable should be raised and attached to the substructure framing to prevent damage to the insulation and/or conductors. The cable sheathing should be examined for damage concurrently with raising/attaching. If damage is found, the cable should be replaced by a licensed electrical contractor. Typically, nonmetallic sheathed (romex) cables are required to be secured every 4 ½ feet. Securing cables is advised.

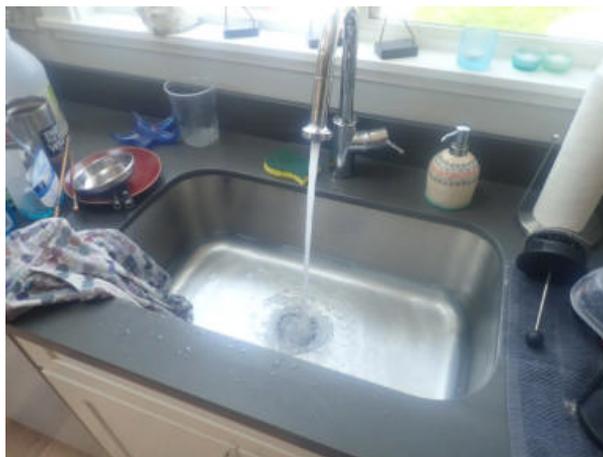
No airgap present on the dishwasher drain line. Installation of an airgap is advised.

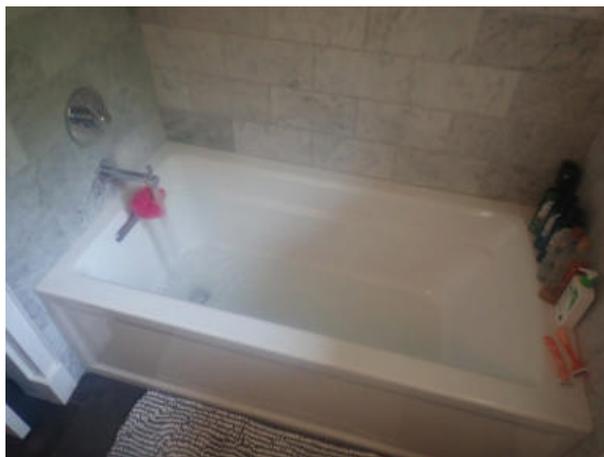
Valve handle rotates freely past the off position without stopping. Single lever faucets normally will stop rotating when the valve is at the "off" position. Oftentimes this can be corrected by adjustment under the valve handle. If this does not correct operation, a licensed plumbing contractor should be hired to review this valve and make the necessary repairs.
