Inspected for:
Paula Skinner
Karen Pearlman
5820 Enterprise Road
Glen Ellen, CA

09/03/2020

Re: 5820 Enterprise Road
Glen Ellen, CA

Gunnar Alquist
Full Circle Inspections, Inc.
122 Calistoga Rd. #196
Santa Rosa, CA 95409
707 528-7010
Gunnar@FullCircleInspect.com

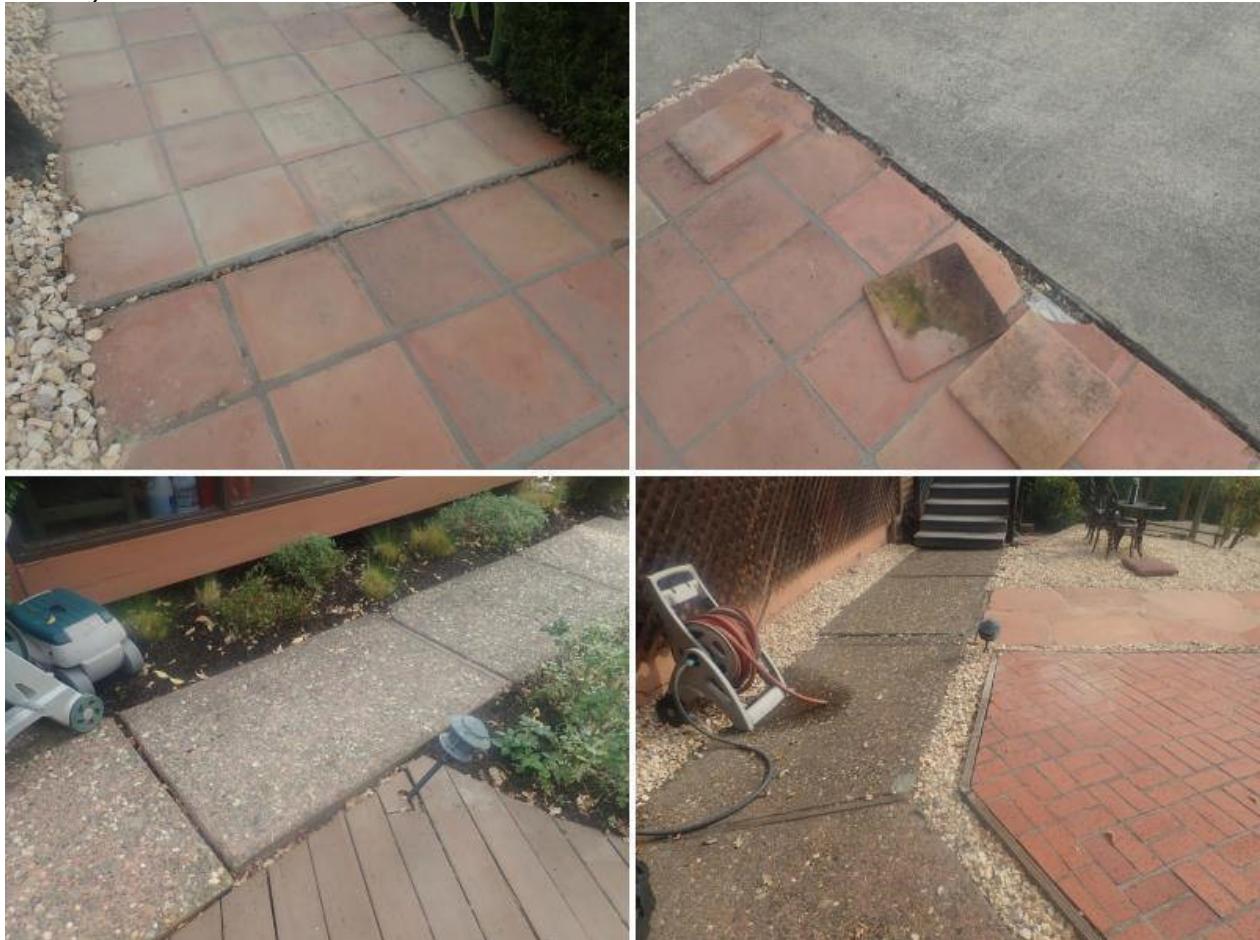
The concrete walkway is cracked and uneven. In addition, some of the tile pavers are cracked/damaged. Displaced/uneven surfaces can cause an individual to trip/fall and I recommend patching or repair, as needed.

Walkway slopes toward the structure. Improperly sloped walkways will direct water against the foundation. Corrections will require installation of a channel/slot drain or removal and replacement with properly sloped walkways.

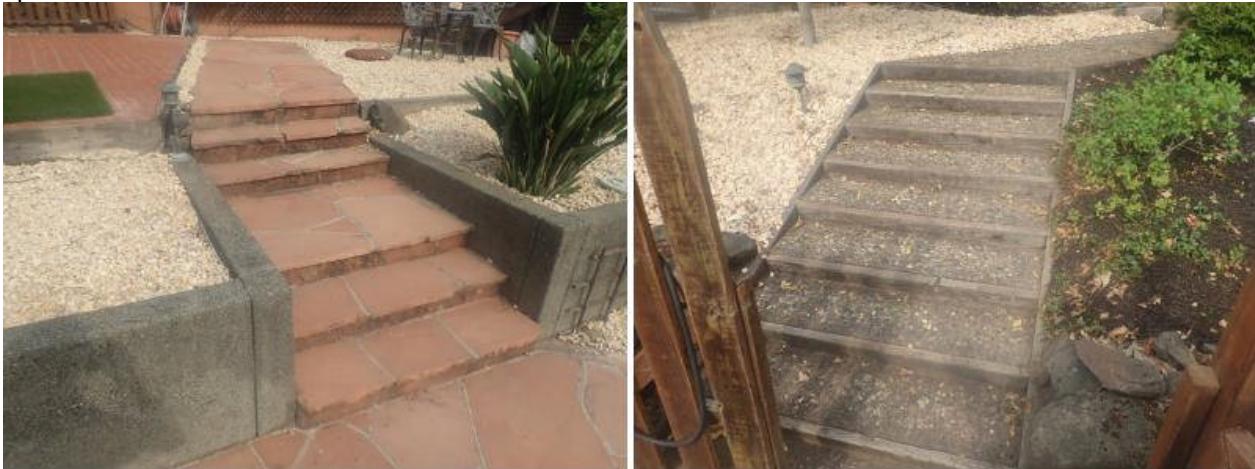
Steps do not have a handrail. While likely not required by the local building department, I suggest installation of an easily gripped handrail as many people need some assistance, even with a single step. Handrails are intended to help prevent an individual from falling when ascending or descending and should conform to current construction standards. Specific information can be obtained through the local building department.

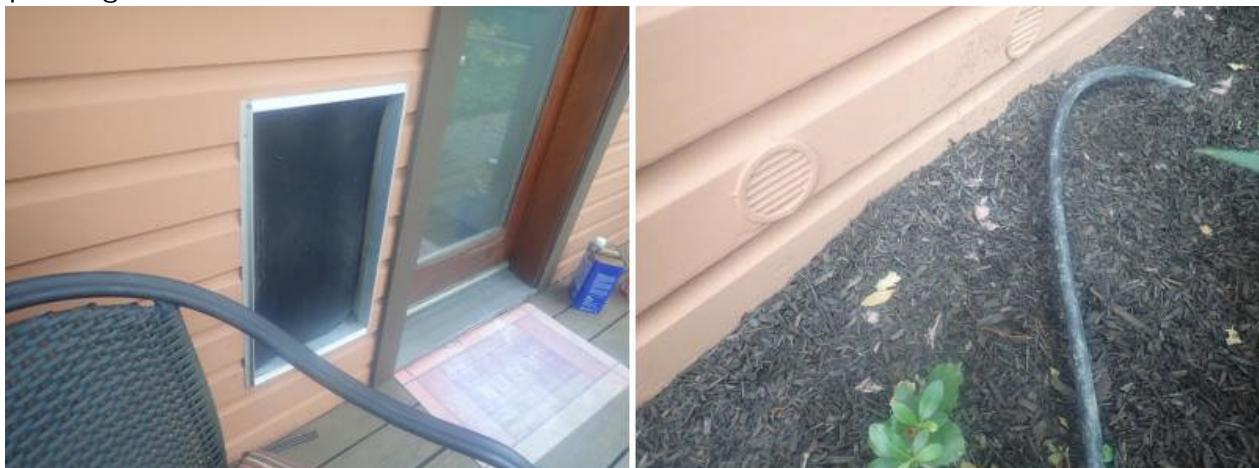
A pet door has been installed through the exterior wall and siding. This can allow water to penetrate into the interior and the wall cavities as well as allow unwanted animals access to the interior. My primary recommendation is to remove the pet door and repair/replace the siding. Any work should be done by a licensed and qualified contractor.

Cracks observed in wood siding. Cracks and voids in siding can allow moisture to intrude into the interior surfaces of the wall. Patching or any necessary repairs are advised, to prevent damage to wood framing.

Siding is in contact with soil at the front. Soil should be cleared away from siding and examined for damage. Soil should be kept a minimum of 6 inches away from the siding to prevent moisture damage.

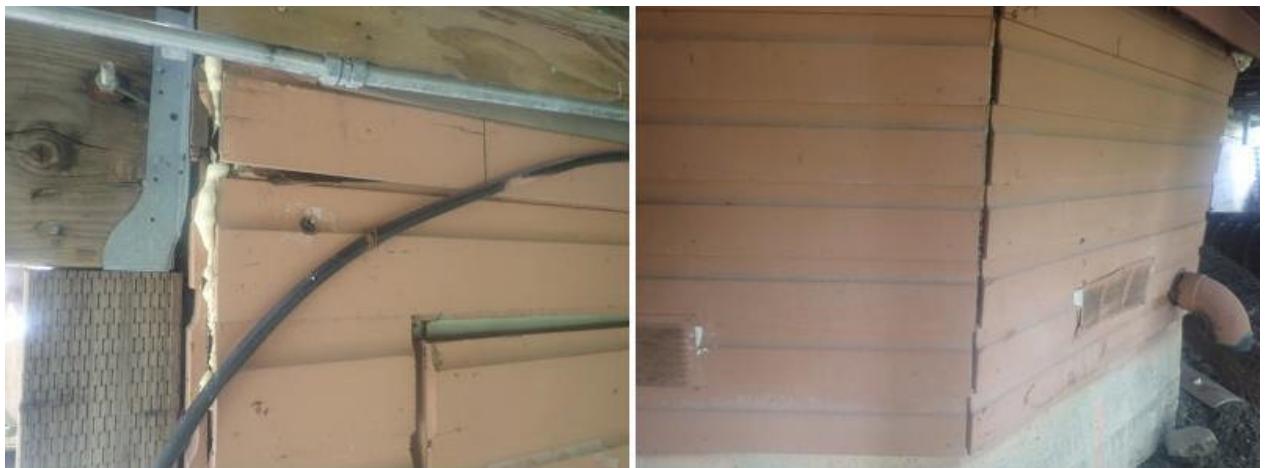
Trim is missing under the left side deck. Foam has been sprayed into gaps/voids. Trim should be installed to help prevent water from gaining entry to areas behind the siding.

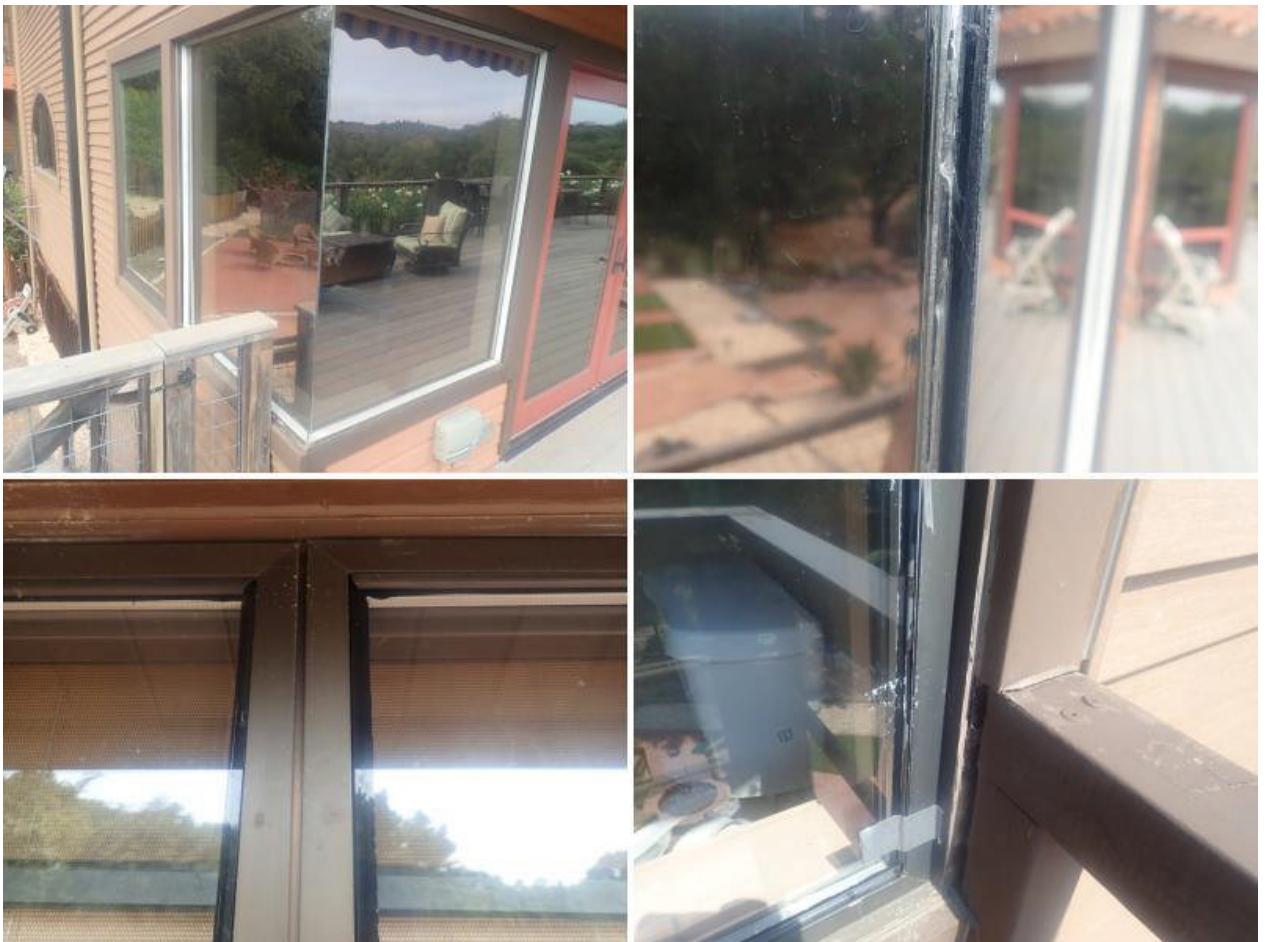
Caulking at the edges where the glass corner windows meet is aged and voids were observed between the panes. I recommend recaulking to prevent leaking. (Upper photos)

Loose/damaged plastic window stops were observed at some of the metal windows. I recommend replacement of damaged or loose stops, as needed. (Lower photos)

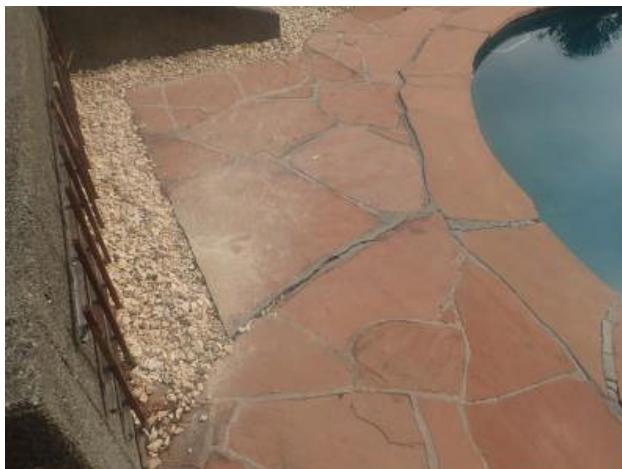
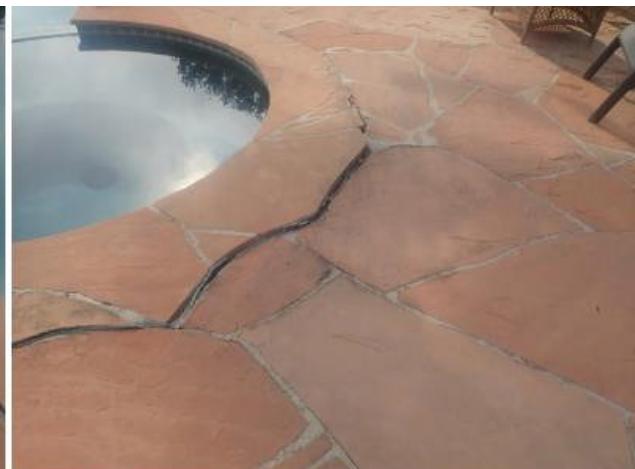
The surface is uneven. This indicates inadequate site preparation prior to installation of the patio surface. An uneven surface could cause an individual to trip/fall. I recommend corrections to prevent injury.

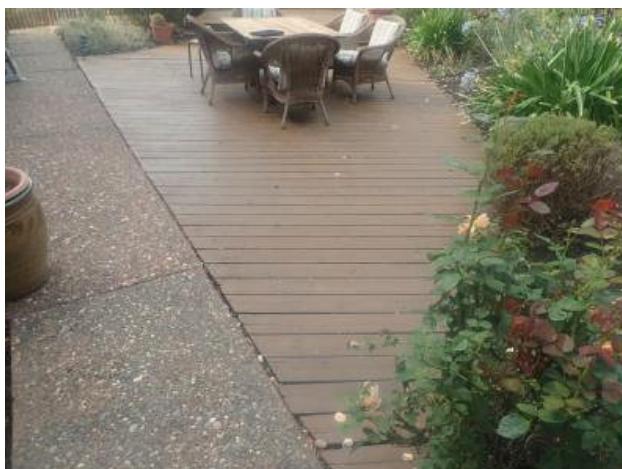
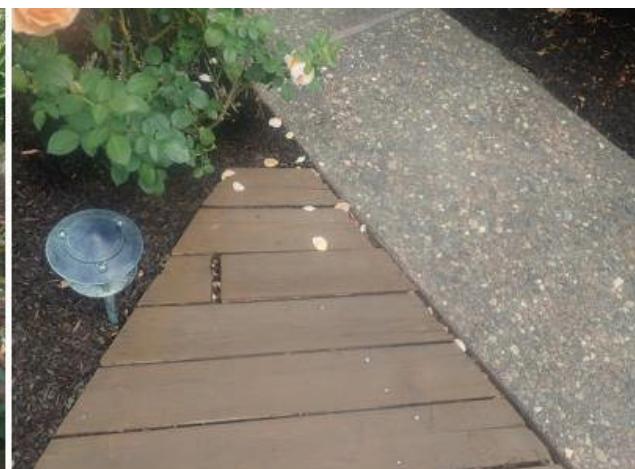
Much of the wood deck is sitting directly on the soil and some boards are loose. Contact with soil will accelerate decay/deterioration of the wood.

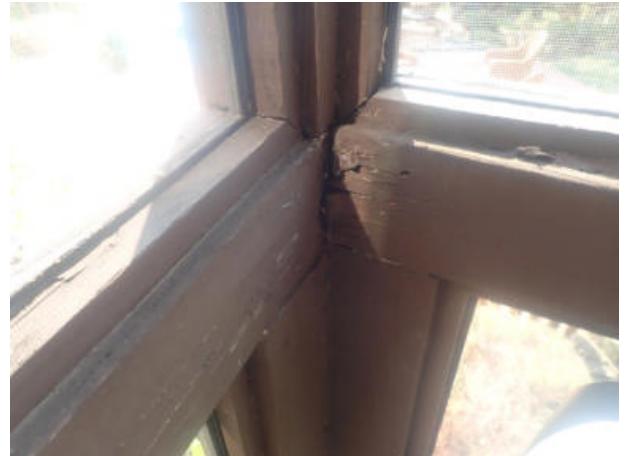
Wood is decayed/damaged. Damage may extend into inaccessible areas. As this is not a pest inspection and other areas of damage may be present, a licensed pest inspection company should inspect this building and repairs should be made, as needed.

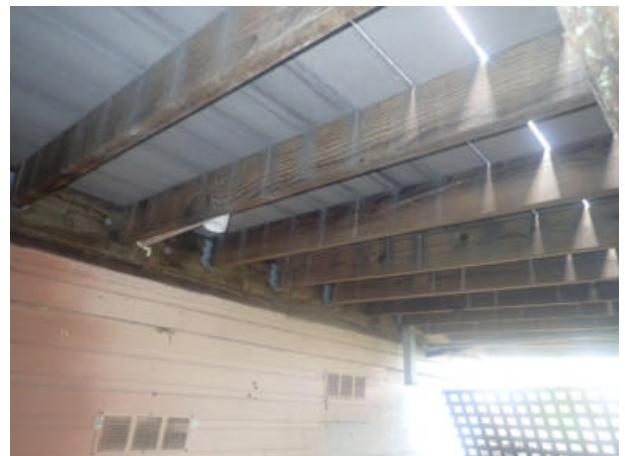
Not all of the deck framing connections have been made with hardware. As decks are subject to many of the same forces that an interior floor is subject to, as well as some forces that interior floors are not subject to, I recommend installation of additional framing hardware to properly secure the guardrails, joists, girders, posts and piers together as well as securing the overall deck structure to the building. Specific information can be obtained through a hardware manufacturer, such as the Simpson Strong-Tie website at <http://www.strongtie.com/>, <https://www.strongtie.com/products/deckcenter>, or an equivalent manufacturer. Any corrective work should be performed by a licensed and qualified contractor.

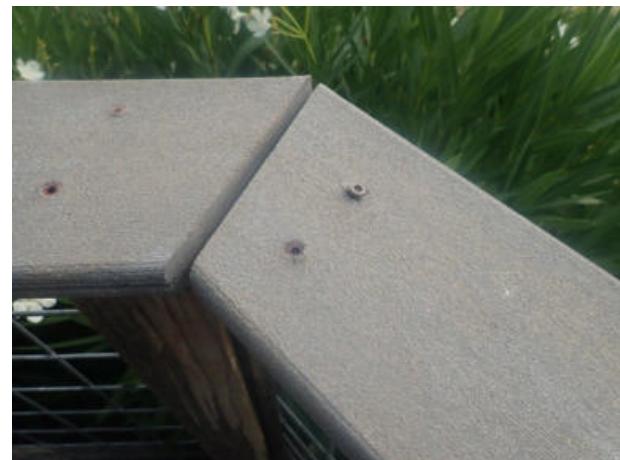
Some loose/elevated screws were found at the rail cap.

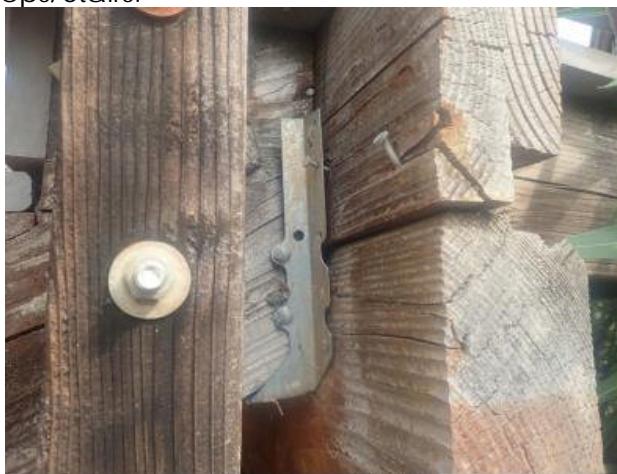
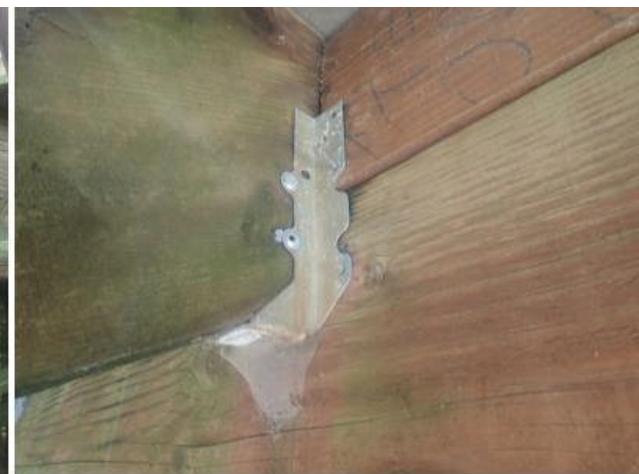
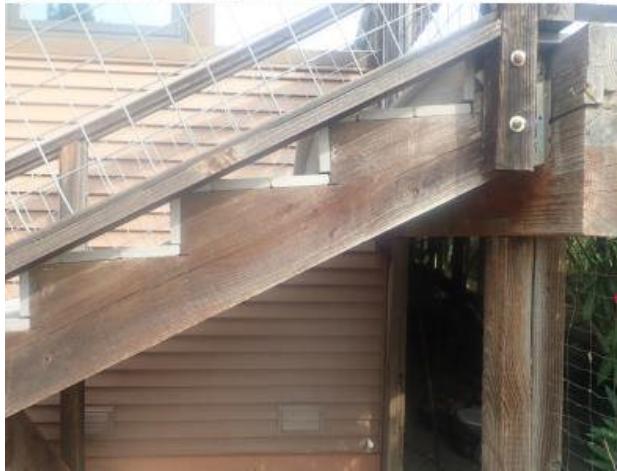
The stairway framing is not adequately attached to the deck framing and the treads are sloped. The metal hardware at the top of the stairway is not securely attached and nails are pulling-out. I was unable to determine why the treads are sloped. My primary recommendation is to replace this stairway with one that conforms to current construction standards, including having a handrail that is easily grasped. Any corrective work should be performed by a licensed and qualified general or carpentry contractor.

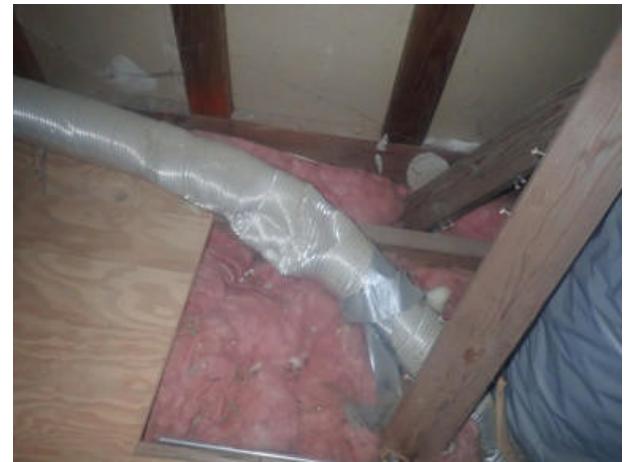
A crushed exhaust duct was found. I recommend replacement.

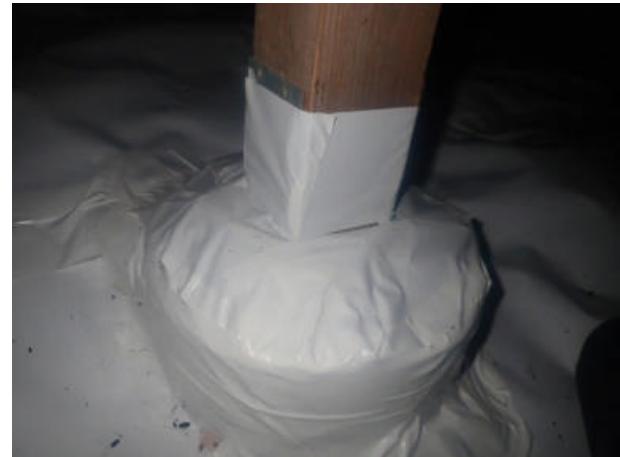
The plastic has been wrapped around the base of posts. This will direct moisture to the wood, which can lead to decay/damage of the wood post. I recommend sealing the plastic to the concrete pier.

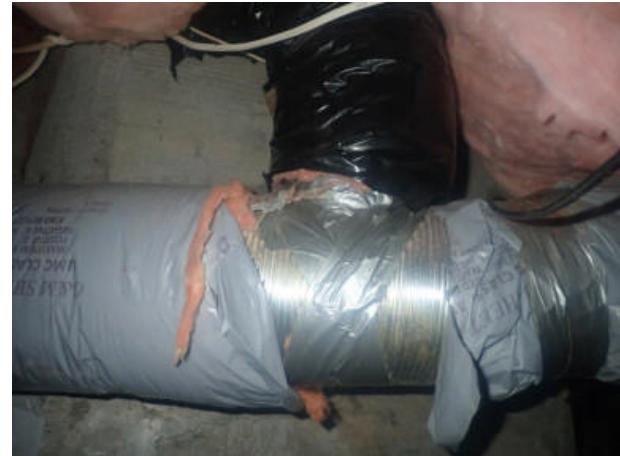
A nonstandard duct connection was observed. One duct was directly connected to another without the use of a wye fitting. This intersecting duct will have limited airflow. I recommend review by a licensed and qualified heating contractor and corrections, as needed.

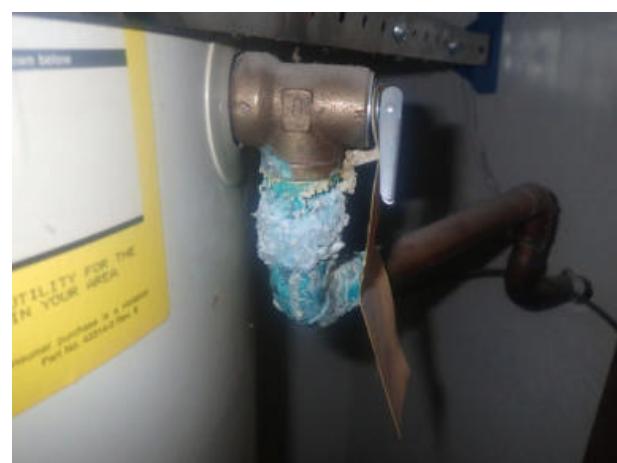
Oxidation observed at the temperature pressure relief valve. This indicates a leak at the valve. I recommend review by a licensed and qualified plumbing contractor and corrections, as needed.

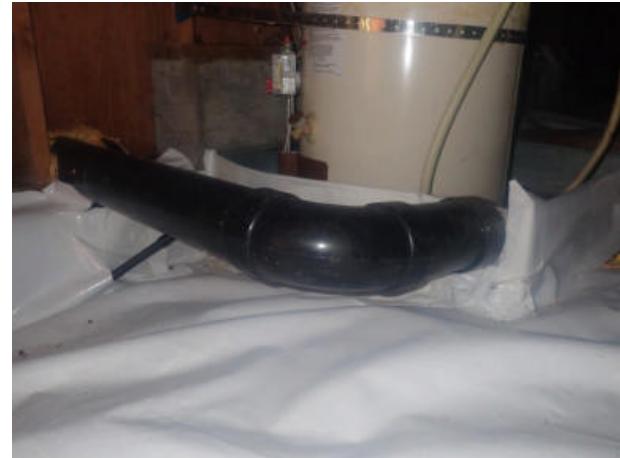
The "smitty" pan drain pipe does not slope properly. This should slope to the exterior to provide a path for any propane gas that might leak from the water heater burner or gas line. Corrections are advised.

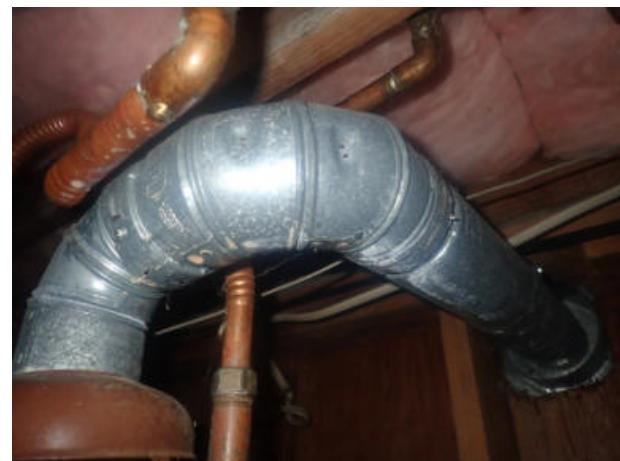
Mineral deposits were found adjacent to connections on the gas vent pipe. This indicates moisture has condensed on the interior of the gas vent pipe and may be due to the single-walled gas vent pipe or possibly improper venting of combustion gases. As this can result in corrosion/damage of the gas vent pipe and unsafe operation of the water heater, this system should be reviewed and corrections made by a licensed plumbing contractor.

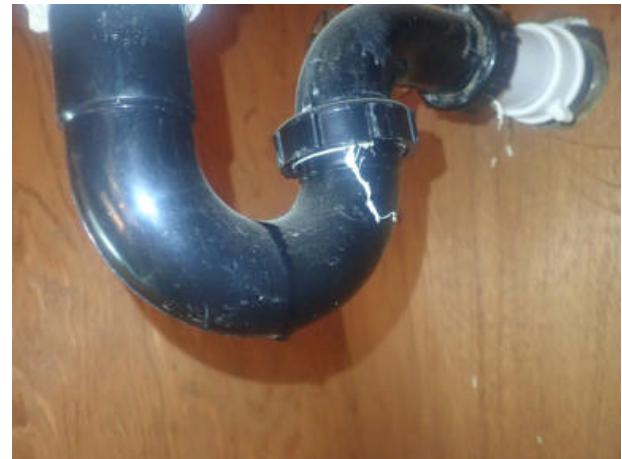
A leak was observed at the upstairs hall bathroom sink drain. Repairs should be made by a licensed plumbing contractor to prevent damage to cabinet and/or structure.

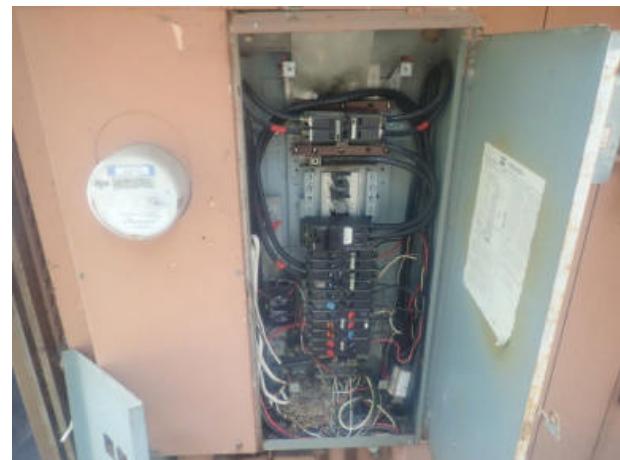
Some of the circuit breakers are a different brand from the panel. While this is a "universal" panel and circuit breakers from several different manufacturers will fit, only specific brands/types of circuit breakers are approved by the manufacturer to be used in their panels. Manufacturers test panels under controlled conditions and with specific circuit breakers. When circuit breakers are used that are not manufactured by the same company as the panel, compatibility must be verified from the manufacturer. As I do not have lists of approved circuit breakers for all manufacturers, I am unable to verify if these breakers are approved for use in this brand of panel. I suggest verification of breaker/panel compatibility by a licensed electrical contractor concurrently with other work noted in this report.

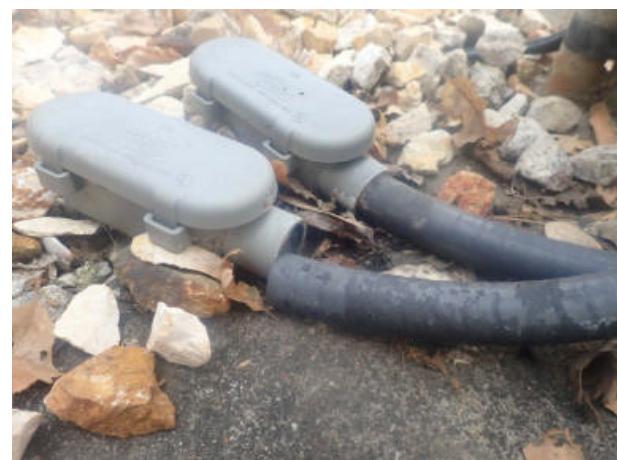
A conduit is separated from an elbow. The insulated conductors are exposed and subject to damage. Corrections/repairs should be made by a licensed electrical contractor.

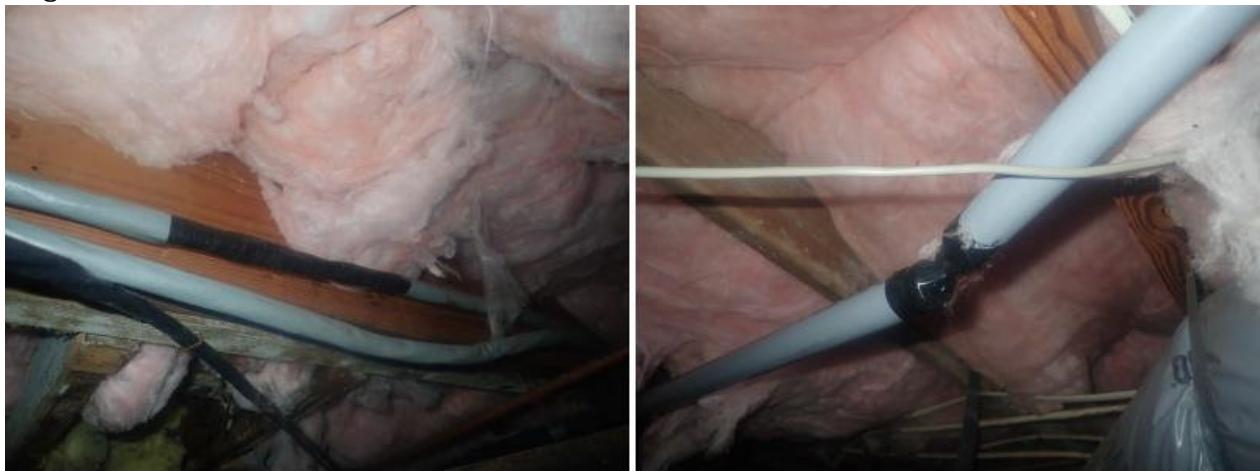
An section of electrical cable under the approximate area of the bathroom has been wrapped with electrical tape. I suspect the cable has been damaged by animals and the cable taped as a temporary patch. If the cable is damaged, this should not be relied upon as a permanent repair. I recommend review by a licensed and qualified electrical contractor and corrections, as needed.

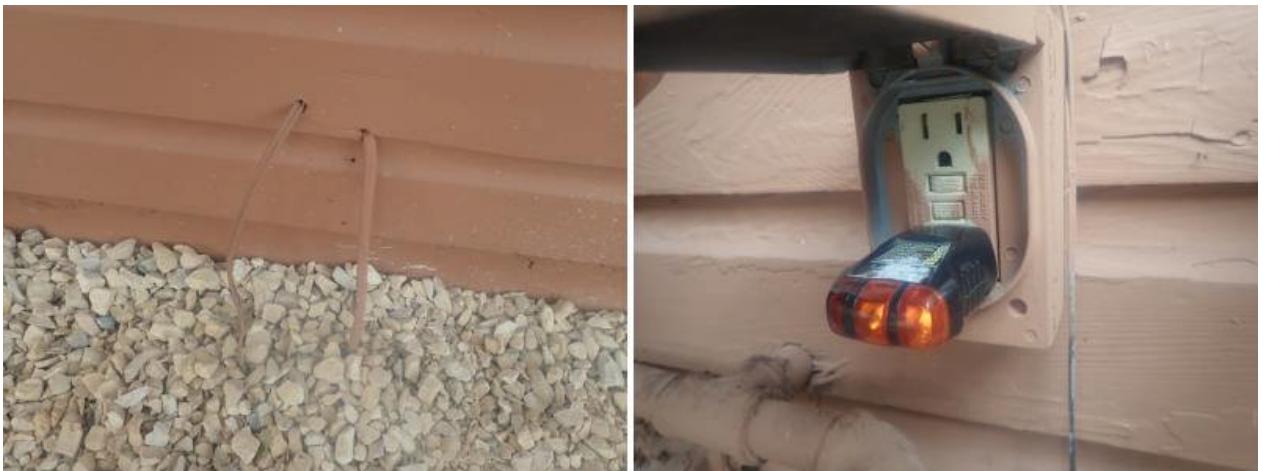
Unprotected nonmetallic sheathed cable (romex) present at the exterior of the cottage/garage. Electrical cable is subject to physical damage and is typically installed in attics and inside wall cavities. In addition, this type of cable is not approved for use in damp locations and does not have the UV protection necessary for exterior installation. Corrections should be made by a licensed electrical contractor.

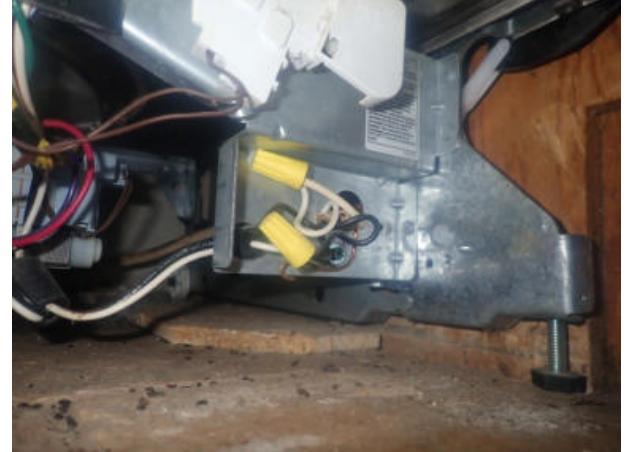
Receptacle outlets that serve the counter surfaces and appliances are not GFCI (ground fault circuit interrupter) protected. Installation of GFCI (ground fault circuit interrupter) devices at all receptacle outlets that serve the counter surfaces, disposal, and dishwasher is advised.

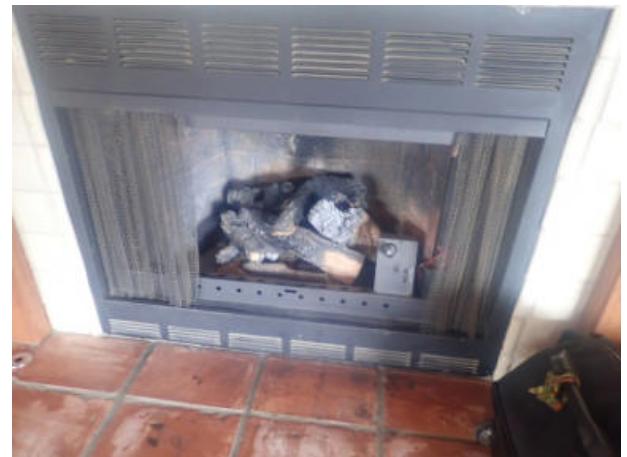
I could not get the fireplace burner to ignite. In addition, something in the fireplace was beeping during this inspection. If battery replacement does not allow this to function, I recommend review by a qualified gas fireplace technician and corrections, as needed.

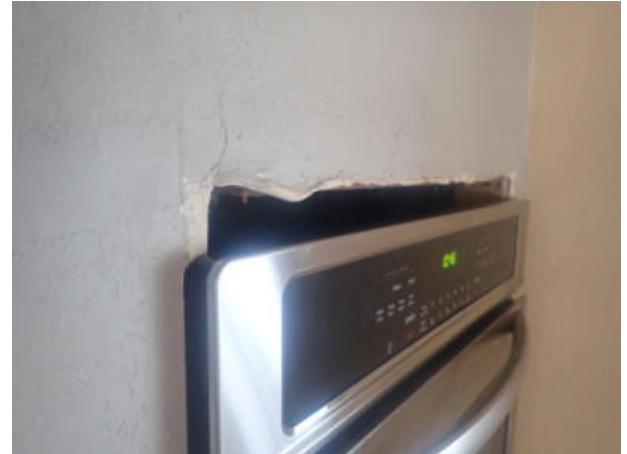
The opening in the wall at the oven is rough and oversized. I recommend corrections.

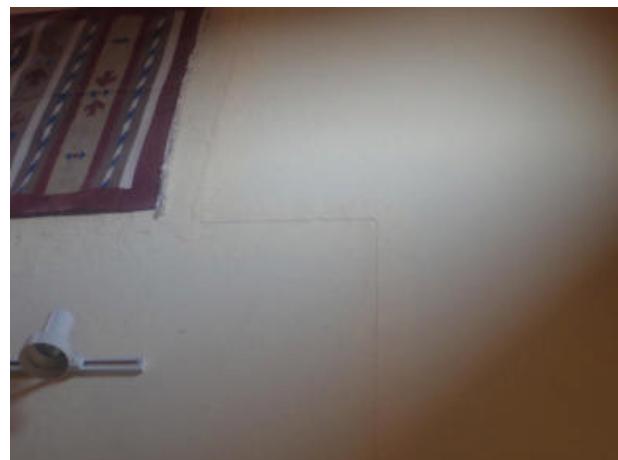
Cracks were observed in the wall surfaces. Cracking in walls and ceilings may be related to the sloped floors described above.

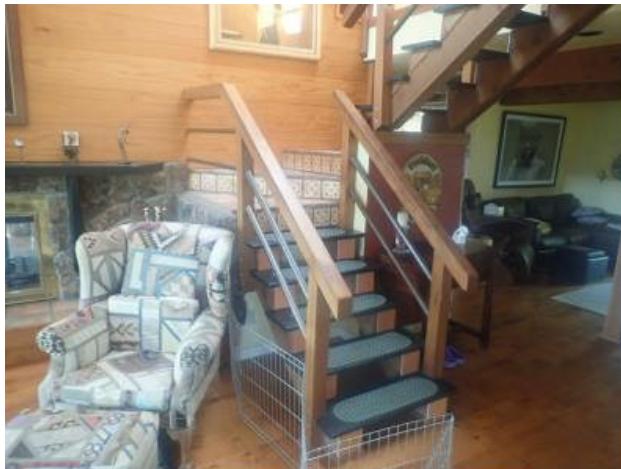
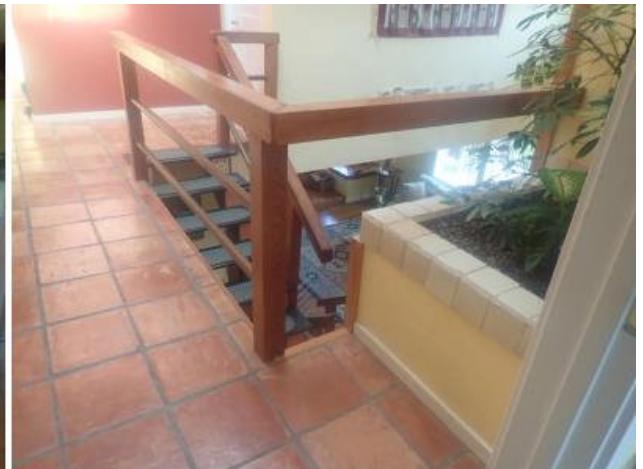
Steps do not have a proper handrail. Typically, when more than three risers are present, a stairway should have a guardrail with a continuous handrail that can be easily gripped; however, I am of the opinion that even a single step should be provided with a handrail as many people need some assistance to negotiate a stairway. Handrails should have a minimum clearance from the wall or guardrail of no less than 1½ inches, should not project into the stairway more than 4½ inches, should be between 34 and 38 inches above the nosing and the ends of the handrail should "return" back to the wall or newel post to help prevent catching/hooking loose clothing or belongings on the projecting end. The diameter of a circular handrail should be between 1¼ and 2 inches. Handrails are intended to help prevent an individual from falling when ascending or descending a stairway.

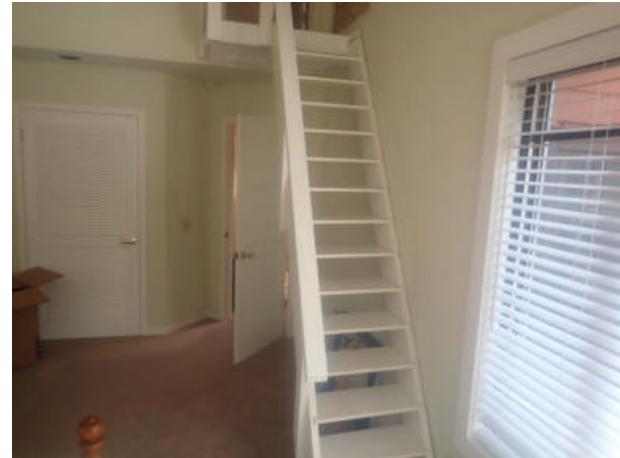
The ladder to the loft is steep and does not have a guardrail. This ladder is difficult and potentially hazardous to ascend/decsend. Caution is advised.

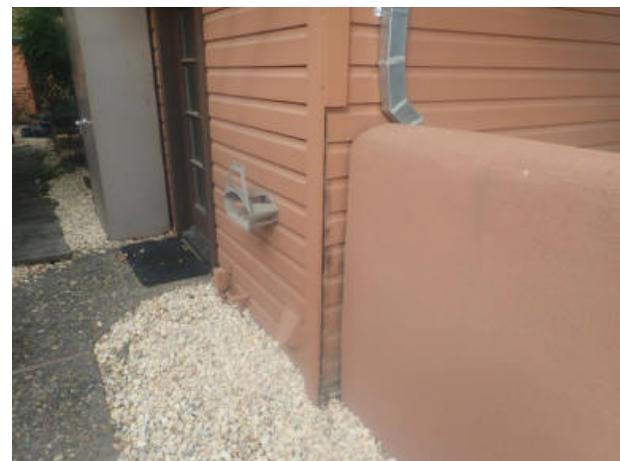
Trim is missing at the left/rear. Trim should be installed to help prevent water from gaining entry to areas behind the siding.

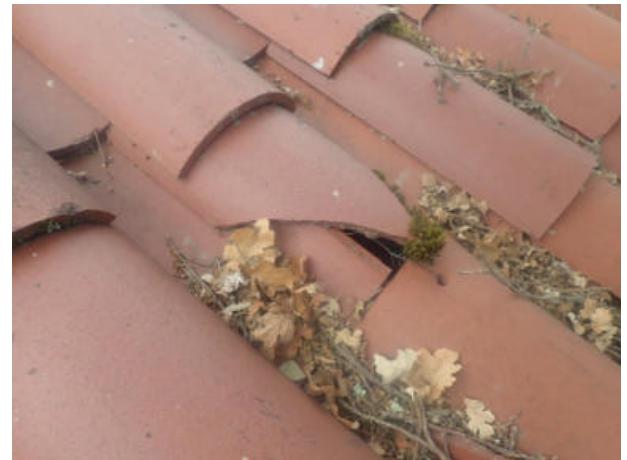
Damaged/displaced tiles were observed at the left side of the roof. Damaged tiles should be replaced by a licensed roofing contractor to prevent leaks and subsequent moisture damage.

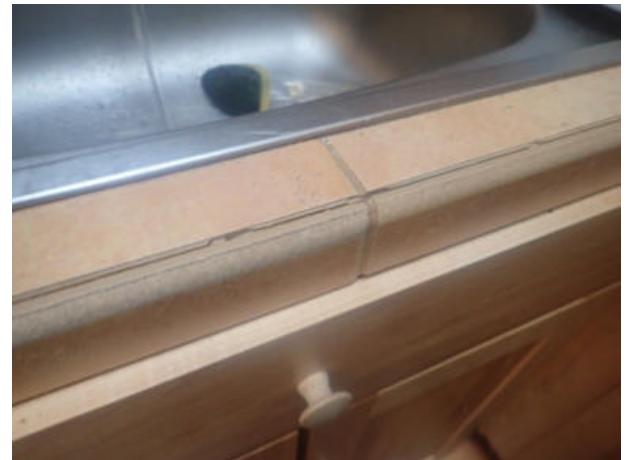
Cracks/voids present in grout. Regrouting is suggested to prevent water from penetrating below the tile.

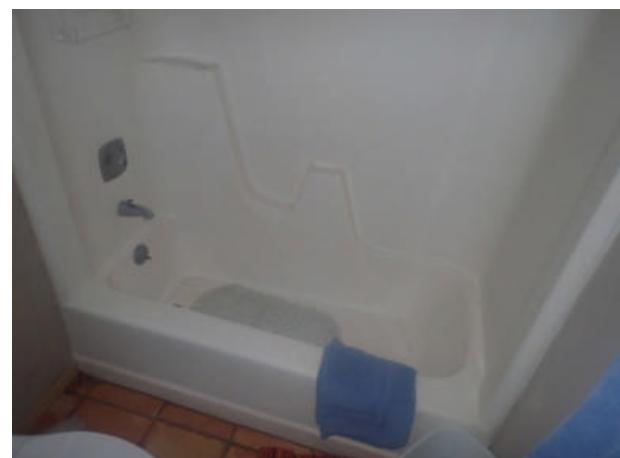
The faucet does not operate. This is often caused by an aged cartridge or valve stem assembly and can usually be corrected by replacement. While replacement is generally straightforward, I recommend corrections be made by a licensed plumbing contractor.
