Inspected for:  
Linda or Bret Anderson  
3510 Alta Vista Avenue  
Santa Rosa, CA

## Full Circle Inspections, Inc.

11/30/2020

Re: 3510 Alta Vista Avenue  
Santa Rosa, CA

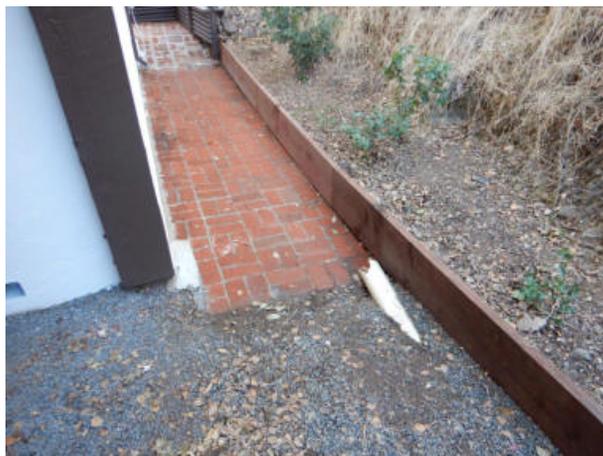
Walkway at the left side has pipes that terminate onto the walkway and the surface appears lower than the surrounding areas. I am concerned that water will collect and stand in this area. This will contribute to water accumulation under the house as well. I recommend diverting water away from this area.

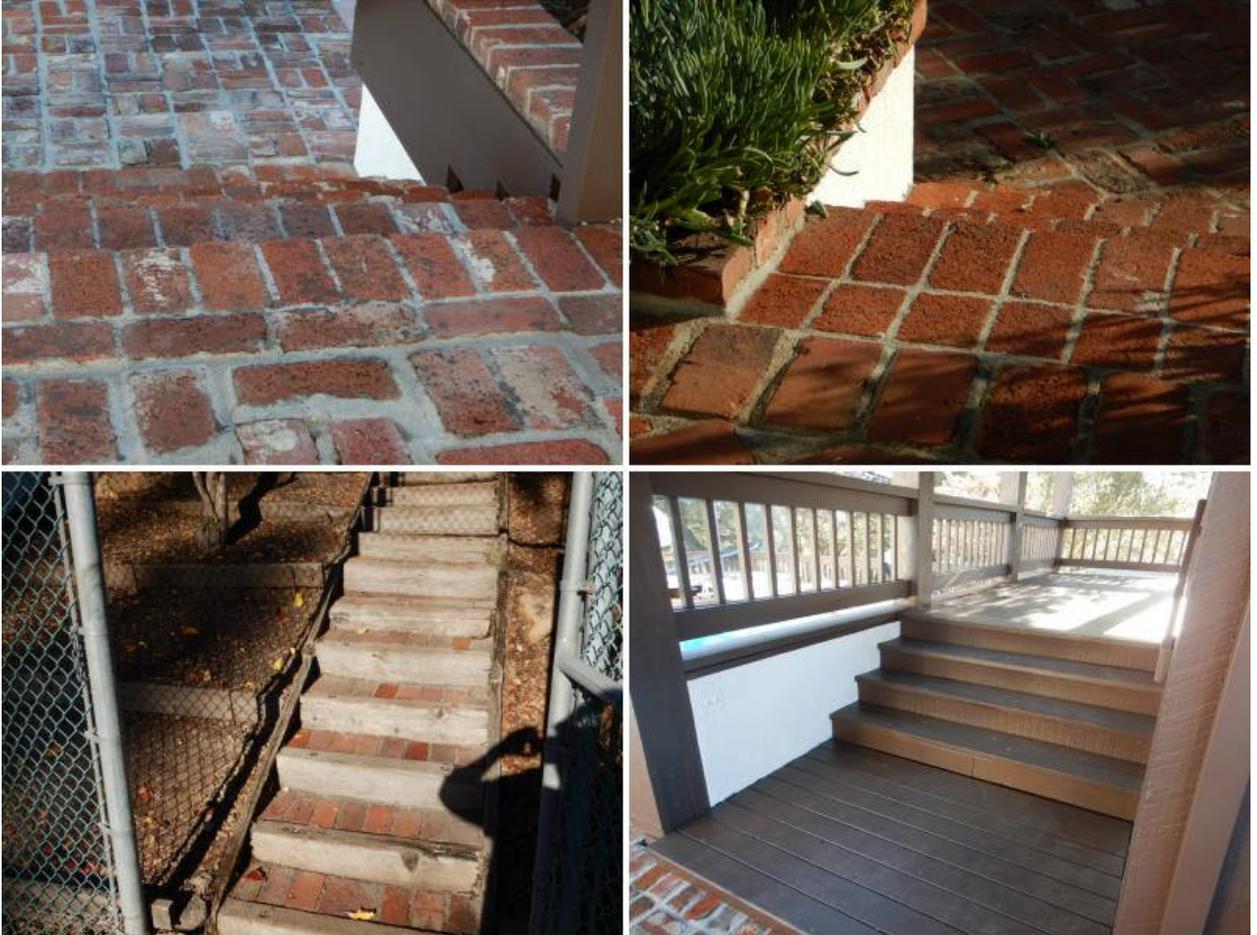
## Steps:

Step treads/risers are inconsistent. Typically, the maximum difference in riser height or tread depth for any stairway is 3/8". Current construction standards require that risers not exceed 7 3/4 inches in height and that tread depth be no less than 10 inches. As the current configuration could cause an individual to trip/fall, this should be corrected.

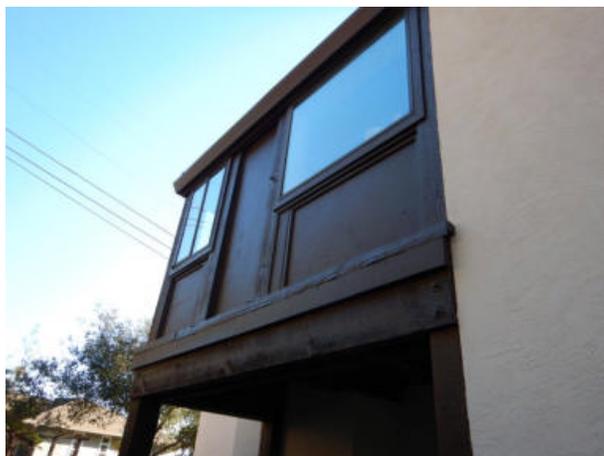
The siding on the exterior of the master bedroom extension appears to be regular plywood rather than a siding material. I do not know if this material is designed for exterior/siding use. Evidence of weathering was observed to the exterior. This should be periodically inspected and repainted, as needed.

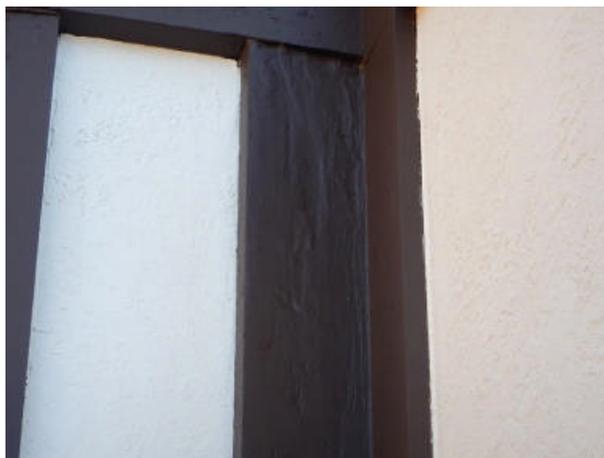
Trim is decayed/damaged at various areas. Damage may extend into siding and inaccessible areas. As this is not an inspection for wood destroying organisms (WDO) and other areas of damage may be present, I recommend review of this home by a California Structural Pest Control Board licensed "branch 3" inspector and corrections, treatment, or repairs made, as needed.

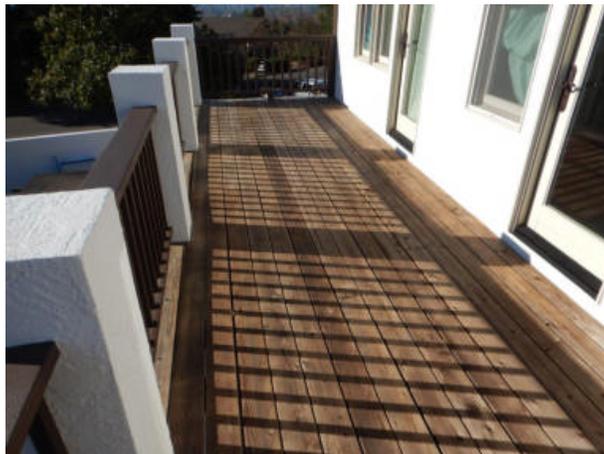
Weathered deck boards were found. Exterior decks are subject to the weather and therefore have a limited life. This should be inspected by a licensed branch 3 inspector and any damaged lumber replaced with new material or treatment made, as needed.

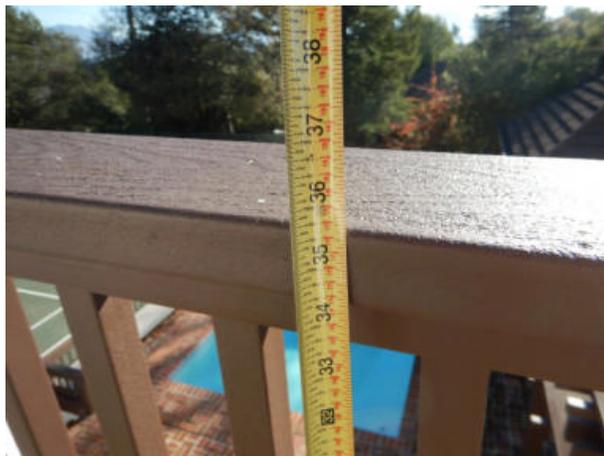
#### Railing:

Railing is lower than allowed by current construction standards. Current construction standards require a minimum height of 42 inches from the deck surface to the top of the guardrail. My primary recommendation is to upgrade or replace this guardrail to help increase safety.

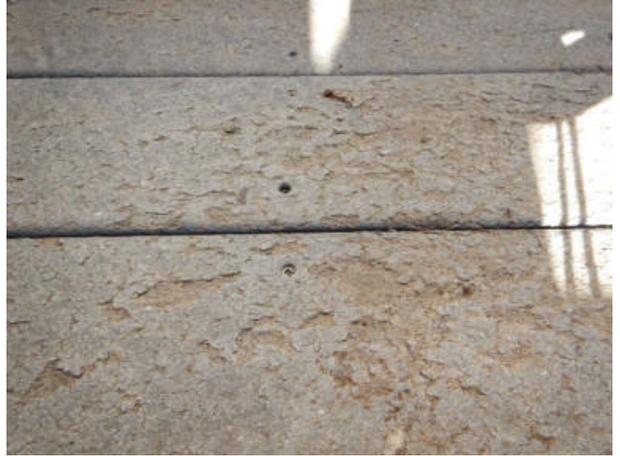
The composite deck boards are deteriorated/damaged. This could be a result of a defective material. I was unable to determine the remaining useful life and I recommend replacement.

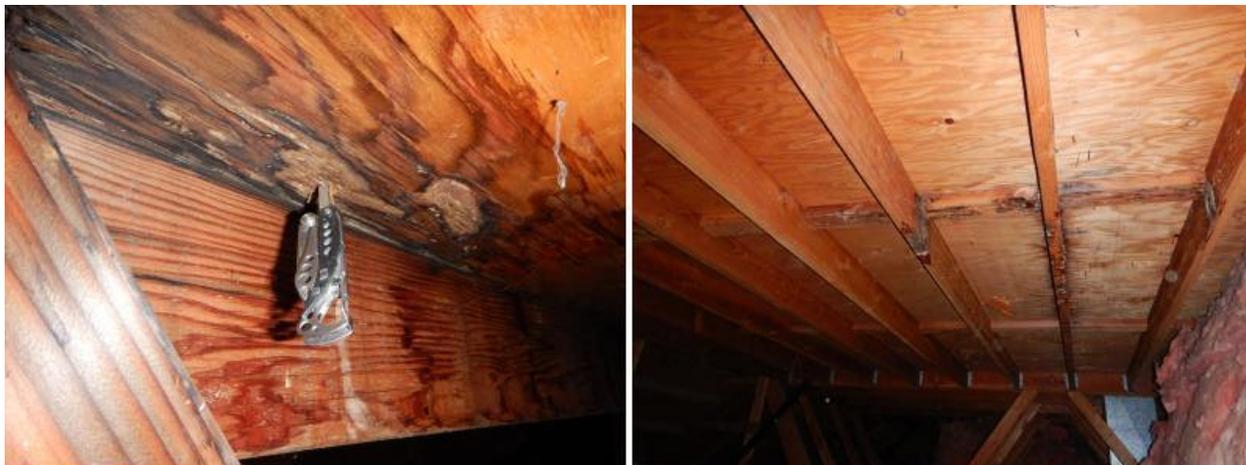
### Leaks:

Moisture staining was found on the roof sheathing at various areas throughout the attic and some decay was found above the master bedroom. Stains were observed in the living room as well. As I was unable to inspect the condition of the upper roof, I cannot provide any information as to whether I believe any of this is due to current or past leaking. I recommend review of the roof by a licensed roofing contractor for more information.

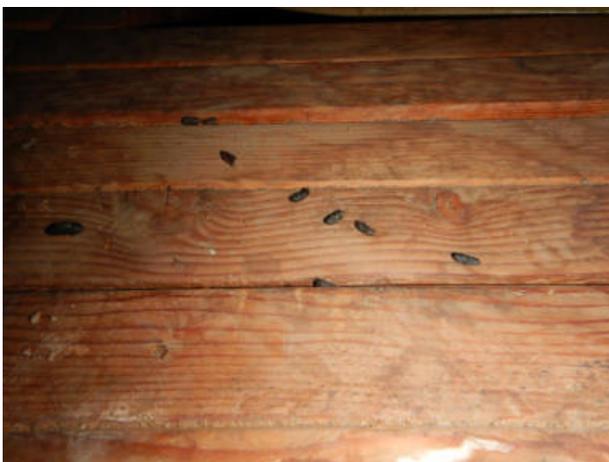
Animal feces/droppings and trails were found. While no accompanying odor was noticed at this time, I was unable to verify if this represents an infestation that has been corrected or is temporarily dormant. Vermin/animals will damage wiring, ducting and piping by gnawing on the materials, gain access to wall cavities, foul these areas with feces and may pose a health risk. I recommend consulting the current owner for information regarding any past infestations and corrections. As inspections for wood-destroying organisms (WDO) are covered by a "branch 3" license through the Structural Pest Control Board, "termite" inspectors generally do not comment on the presence of general pests (ants, spiders, rodents, etc.). If no documentation of correction can be provided by the current owner, I suggest

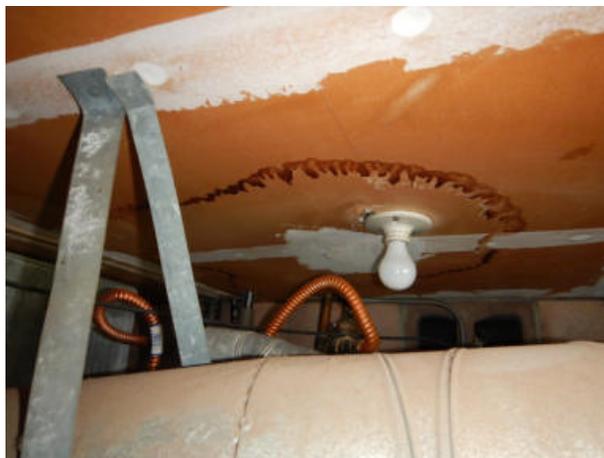
Stains were observed on the basement ceiling. This is located under the approximate area of the downstairs bathroom and was dry.

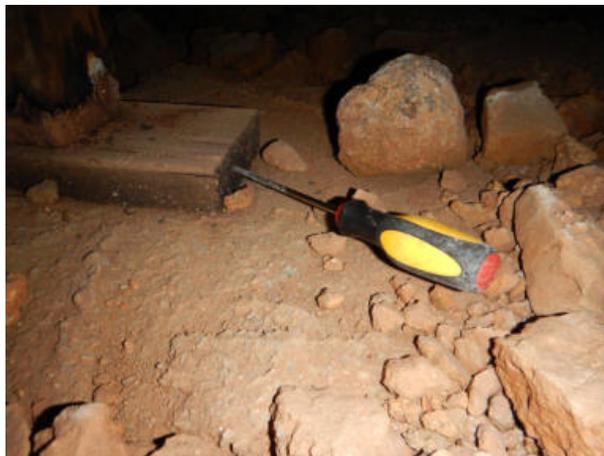
Decayed/damaged wood post found under the living room or dining room. As this is not an inspection for wood destroying organisms (WDO) and other areas of damage may be present, I recommend review of this home by a California Structural Pest Control Board licensed "branch 3" inspector and corrections, treatment, or repairs made, as needed.

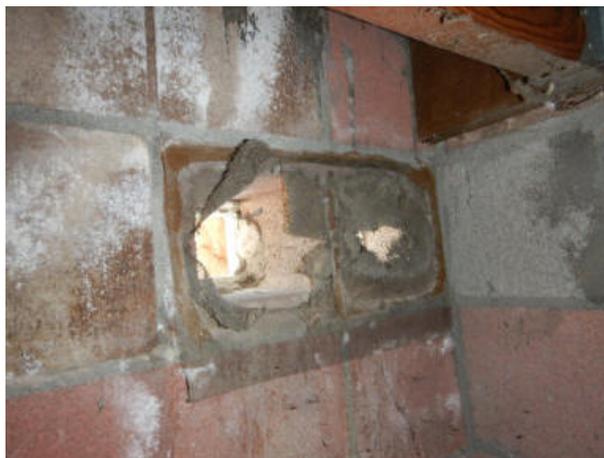
Ventilation of the foundation crawlspace area is limited. While no evidence of moisture damage could be found at time of inspection, increasing ventilation should be considered. Increasing ventilation can be achieved with a few different methods. Adding perimeter vents will often provide increased air flow. Where vents are not practical, installation of a vapor/moisture barrier or retarder on the soil can help to contain much of the moisture in the soil, thereby permitting the existing vents to function more effectively. As an alternative, a ducted vent/fan system can be used to introduce air from the exterior and provide increased air flow to specific areas. At a minimum, this area should be regularly inspected by a licensed "branch 3" wood destroying pest inspection company for any signs of damage or infestation that would require correction or treatment.

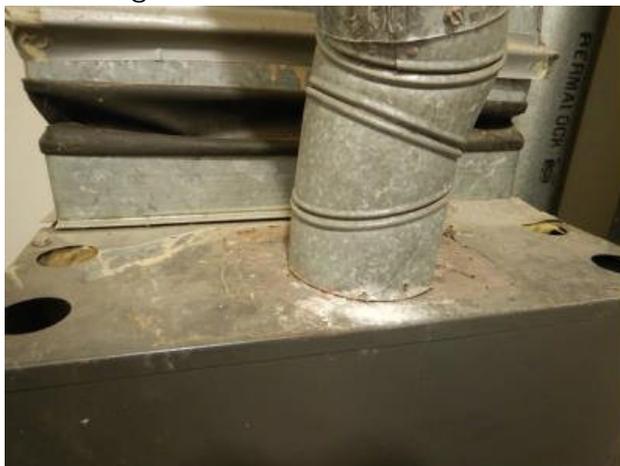
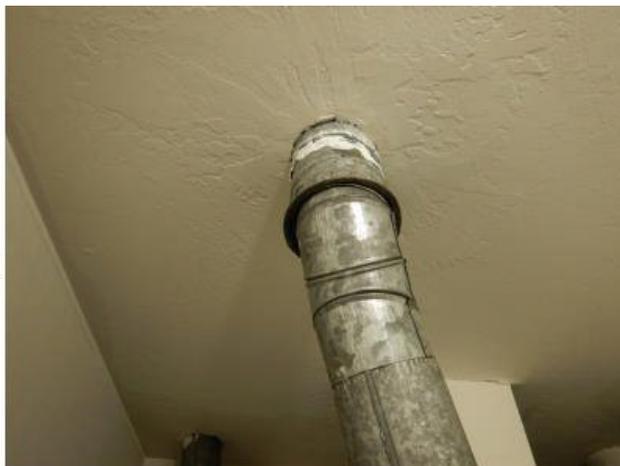
**Gas Venting:**

Mineral staining was found at the base of the gas vent pipe. This indicates moisture has condensed on the interior of the gas vent pipe and may be due to the single-walled gas vent pipe or possibly improper venting of combustion gases. As this can result in corrosion/damage of the gas vent pipe and unsafe operation of the furnace, the heating system should be reviewed and corrections made by a licensed heating contractor.

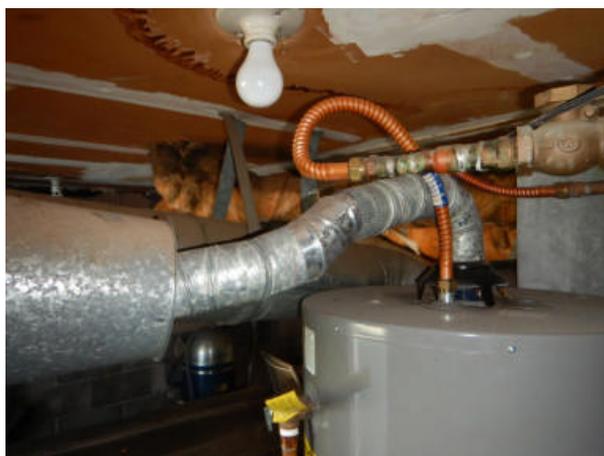
The gas vent pipe immediately above the tank is improperly sloped. This will not allow the water heater to draft or exhaust the combustion gases properly and may allow the exhaust gases, potentially including carbon monoxide, to accumulate in this area. The minimum allowable slope is typically  $\frac{1}{4}$  inch of vertical rise per foot of horizontal run. The gas vent pipe should be repaired or replaced by a licensed heating or plumbing contractor.

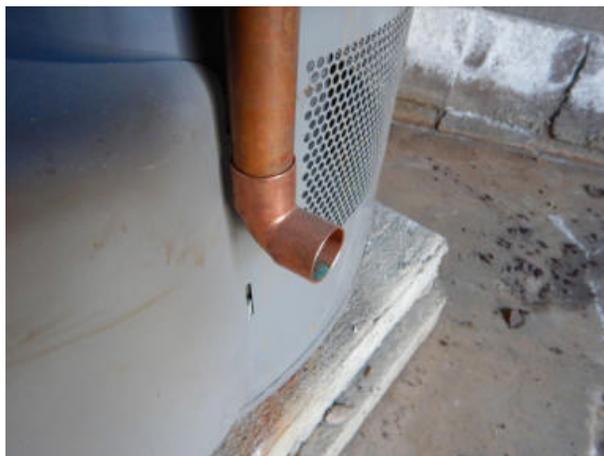
The temperature/pressure relief valve installation is improper. A T/P valve is designed to discharge water from the tank should the water in the tank become too hot or the pressure too high. In this particular case, the end of the discharge line points outward. The pipe should extend to the exterior, turn downward and terminate between 6 and 24 inches from the exterior grade to prevent scalding water from shooting out horizontally should the valve discharge. The temperature/pressure (T/P) relief valve was not tested at time of inspection as it is designed as a safety valve only and may leak after testing. Corrections should be made by a licensed plumbing contractor.

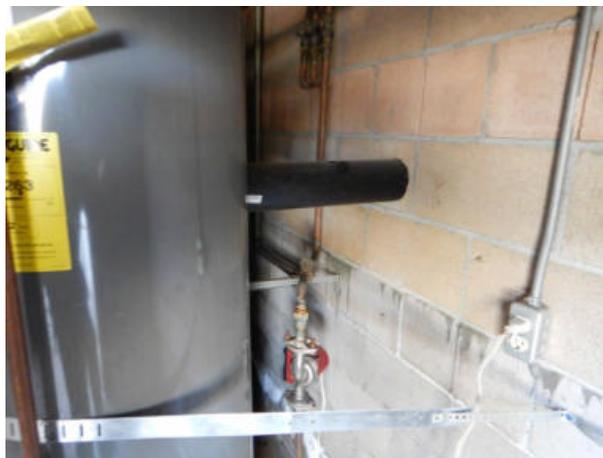
Seismic/earthquake bracing for the water heater is inadequate. While two straps are present, they do not appear to have been installed as specified and may not perform as intended. The intent of seismic bracing is to restrict the water heater from falling over in the event of an earthquake. The distance from the tank to the wall is greater than 1 inch. A length of ABS pipe was present to fill the distance, but I am concerned that this will not be adequate and could allow the tank to move laterally during an earthquake. Most manufacturers' instructions require this space be filled with a bracket or a framework installed to limit movement. Complete instructions can be obtained from the manufacturer of the kit. These should be reviewed and corrections made, as needed. More information can be obtained from the Division of the State Architect or from the pamphlet titled The Homeowners' Guide to Earthquake Safety.

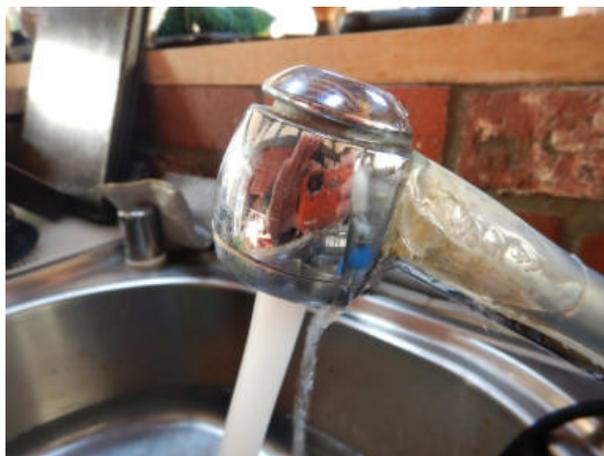
Water leaks at the sprayer handle when the faucet is operated. This is likely contributing to the water found in the cabinet under the sink. I recommend corrections by a licensed plumbing contractor.

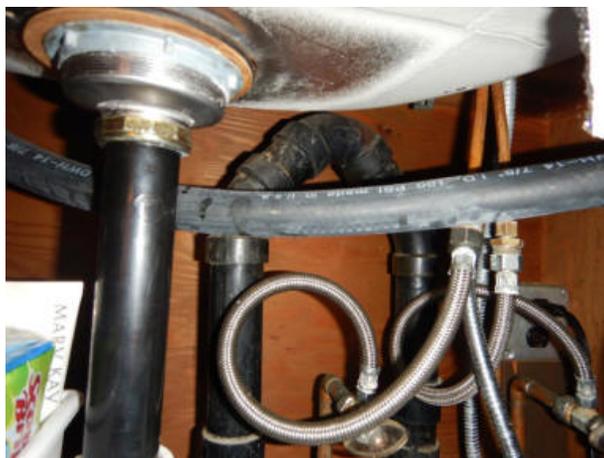
"Gurgling" noted when the sink was drained. This commonly indicates the water "weir" is being siphoned out of the p-trap and typically indicates a blocked or improper vent. I noticed an island loop in the sink cabinet, which should allow the drain to vent properly, but the gurgling is an indication that it isn't functioning. This should be reviewed and corrected by a licensed plumbing contractor.

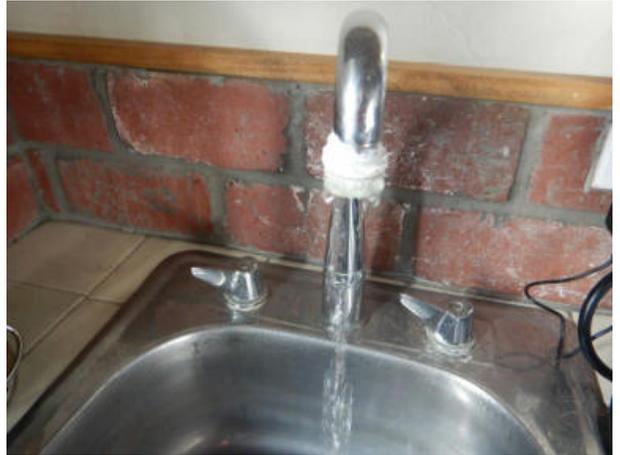
Some of the wet bar sinks do not have even and full flow. I recommend corrections by a licensed plumbing contractor.

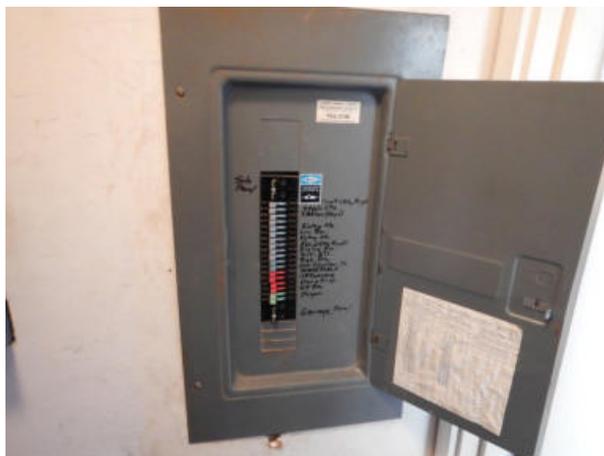
Clearance to access this panel is restricted. Generally, a minimum clear workspace of 30 inches wide by 36 inches deep is required to allow adequate access to the panel. In addition, panels should not be installed in a clothes closet to keep the panel away from combustible items. As this panel is installed in a clothes closet, corrections would require moving the panel. I recommend review and any needed corrections by a licensed electrical contractor.

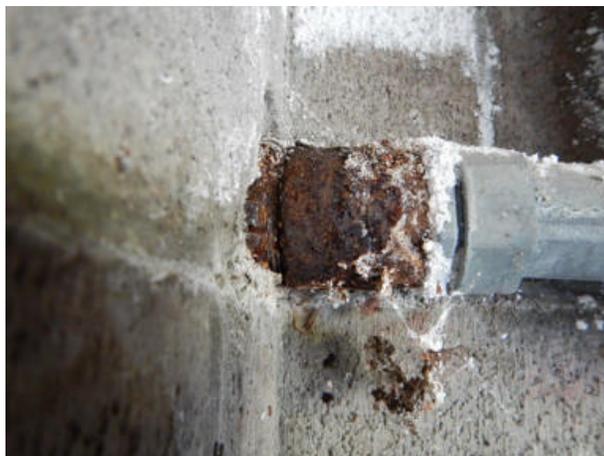
The conduit adjacent to the panel is corroded. I am unable to determine the condition of the buried portions of this conduit; however, I am concerned that it may be corroded/damaged.

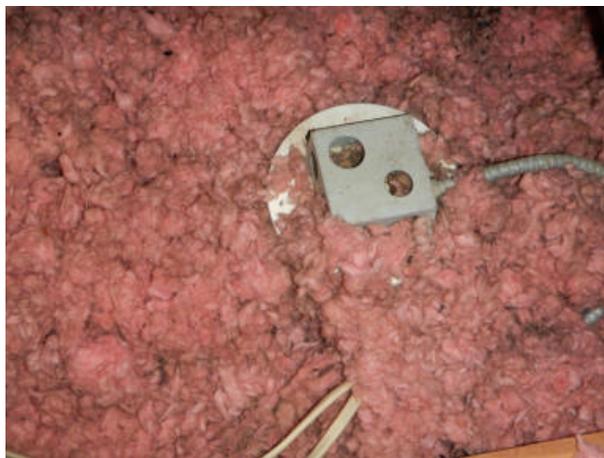
fiberglass insulation is against some of the recessed "can" lights as well as in the electrical junction boxes. These lights do not appear to be designed for direct contact with building insulation. Fixtures installed in direct contact with insulation must be IC rated (insulation contact). Non IC lights are a latent fire hazard. As a general rule, I recommend insulation be kept away from the lights unless IC is verified. I also recommend cleaning insulation out of the junction boxes and closing the openings with knockout seals.

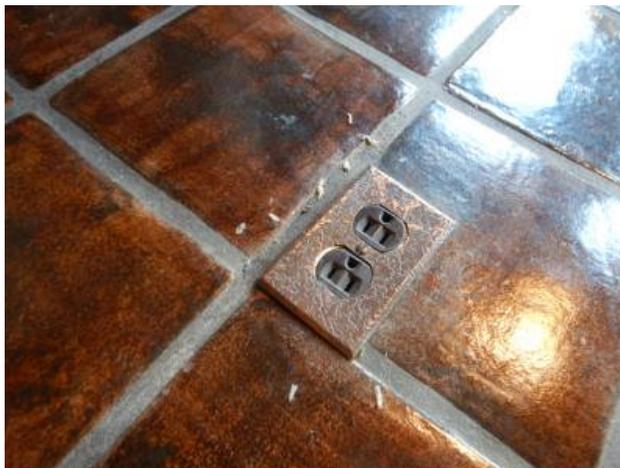
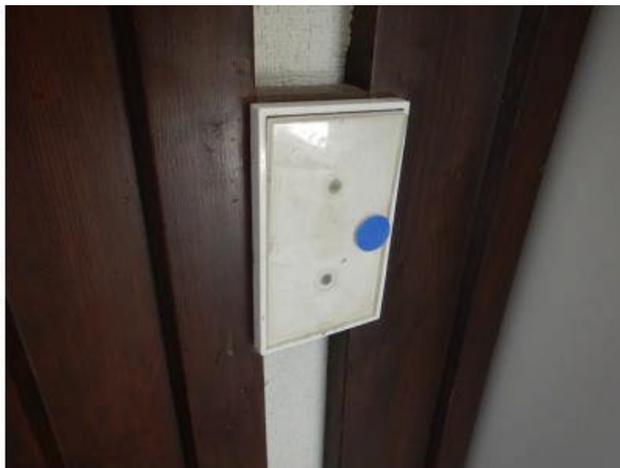
The floor receptacle outlet is improper. A floor outlet is required to be recessed below floor level and a strong metal cover with removable or openable doors should be used to protect the device from damage. Corrections should be made by a licensed electrical contractor.

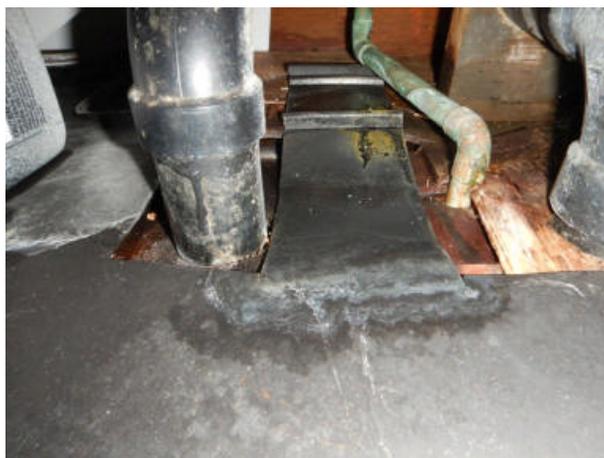
The cabinet under the sink is wet. This is a result of a leak at the sink above.

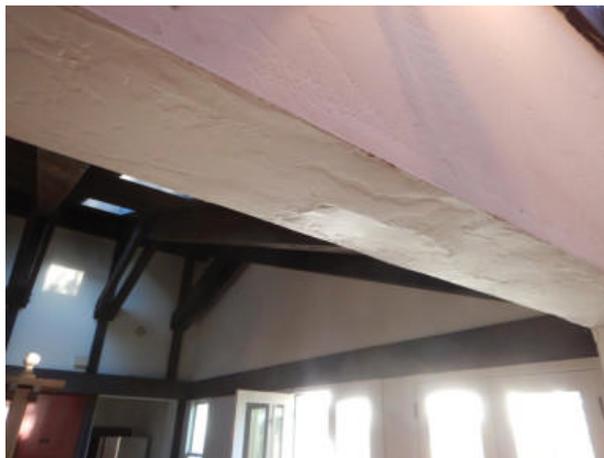
The ceiling adjacent to the fireplace is moisture damaged. Please refer to the skylight notes below for related information.

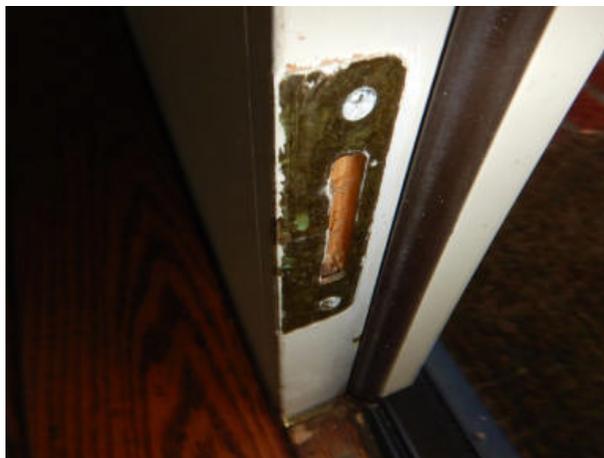
I was unable to open a secondary door at the kitchen area. The threshold and head locks are missing or damaged. I recommend corrections to allow proper operation.

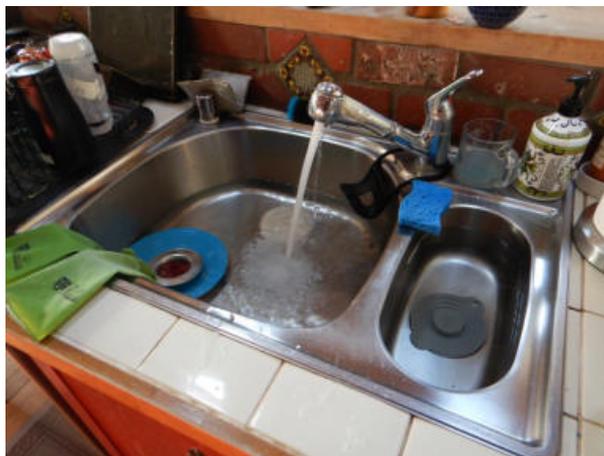
Water leaks from the sprayer handle while the faucet is on. I suspect this is contributing to the water under the sink. Please refer to the plumbing section of this report for related information.

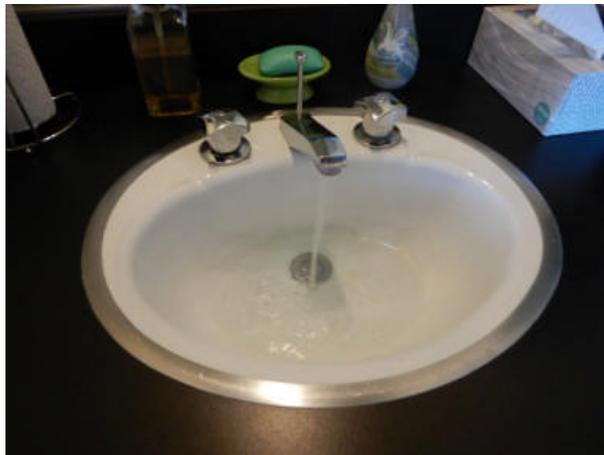
Hot water flow was restricted. This could be due to obstruction with in the valve or the supply. Please refer to the plumbing section of this report for related information.

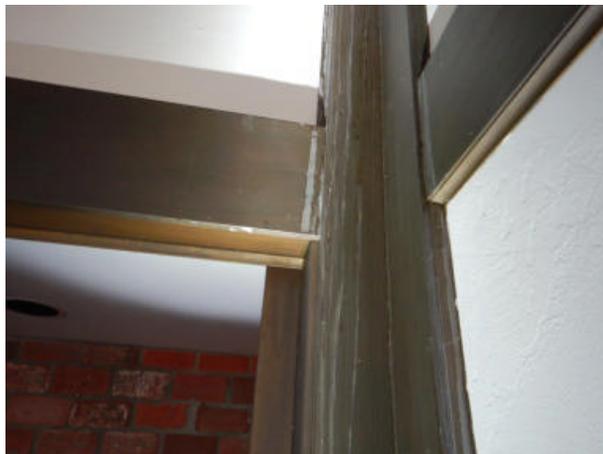
Moisture stains were observed on the wall in the living room. This area was dry at time of inspection, however no determination could be made as to whether this represents an active leak. Client should consult with the seller regarding this staining and any related repairs. If no documentation can be provided, this should be reviewed by a licensed roofing contractor.

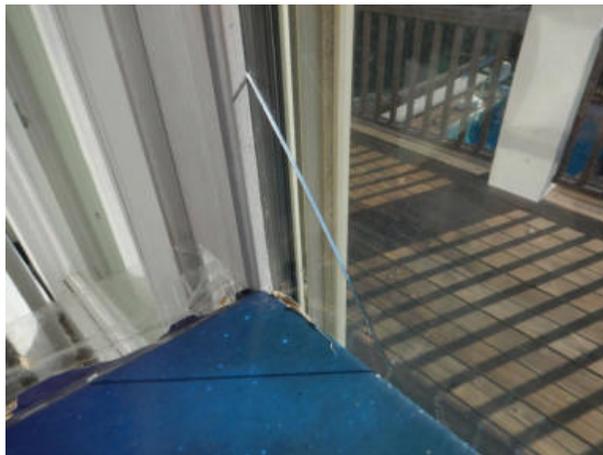
Glass is cracked/broken at the right/front bedroom window. Broken glass can cause lacerations and cracked or broken windows should be replaced by a licensed glazing contractor.

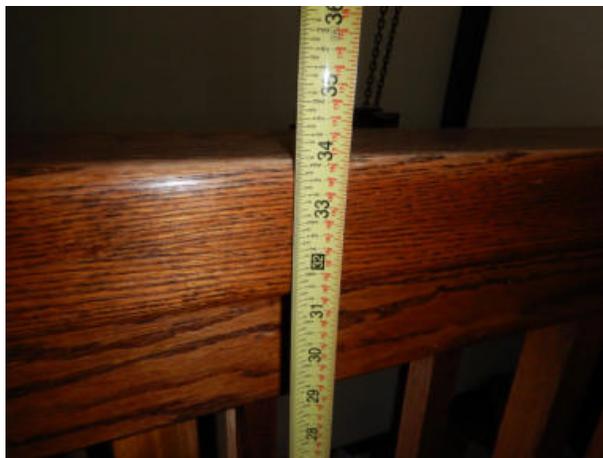
The guardrail is lower than allowed by current construction standards. When this home was built, guardrails were required to be between a minimum of 36 inches high, but current requirements are 42 inches high. I recommend corrections.

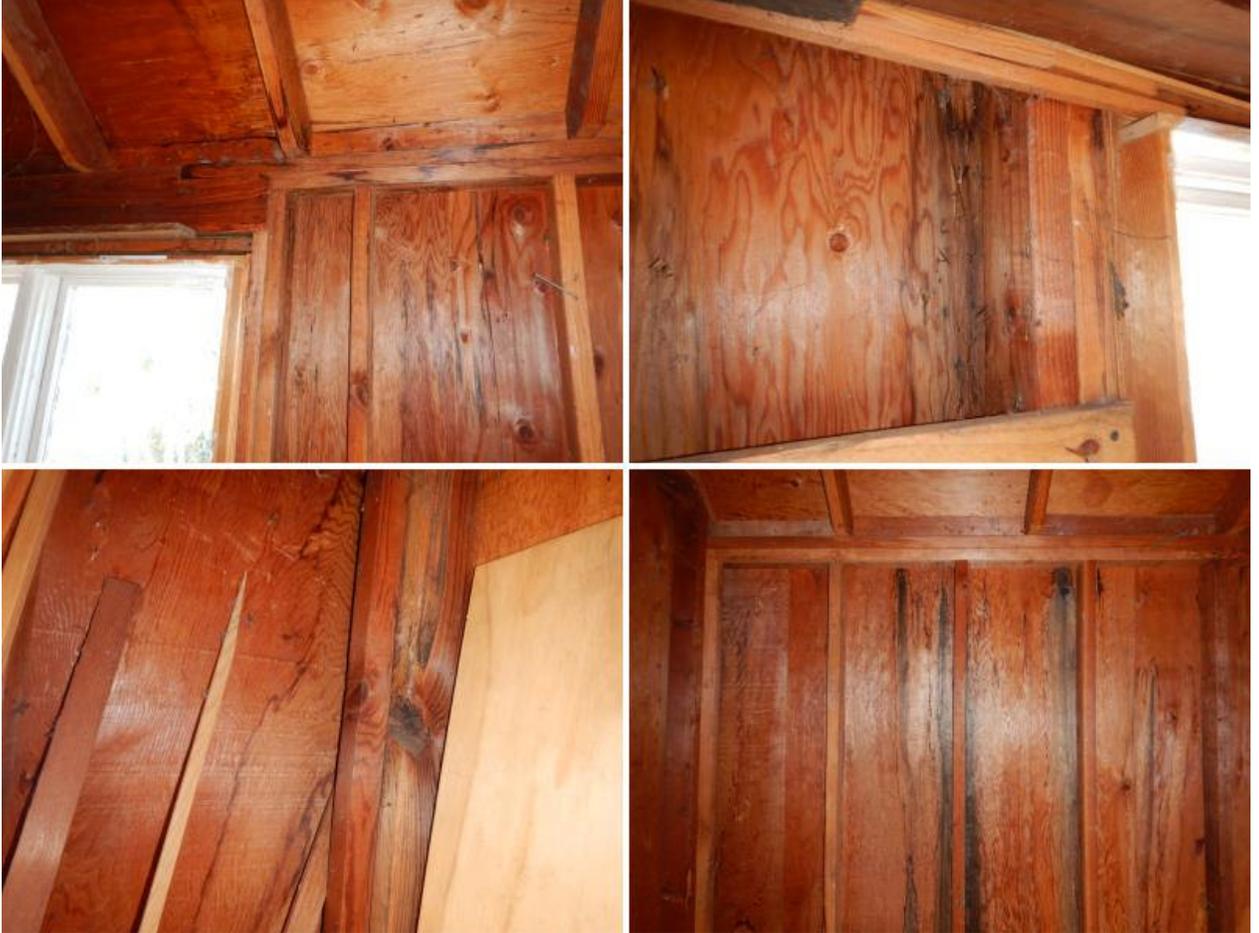
Walls:

Moisture stains were observed on the interior surfaces of the exterior walls. These areas were dry at time of inspection, however no determination could be made as to whether these represent active leaks. Further review would require "leak-testing" the exterior of the home to determine if these represent active leaks.

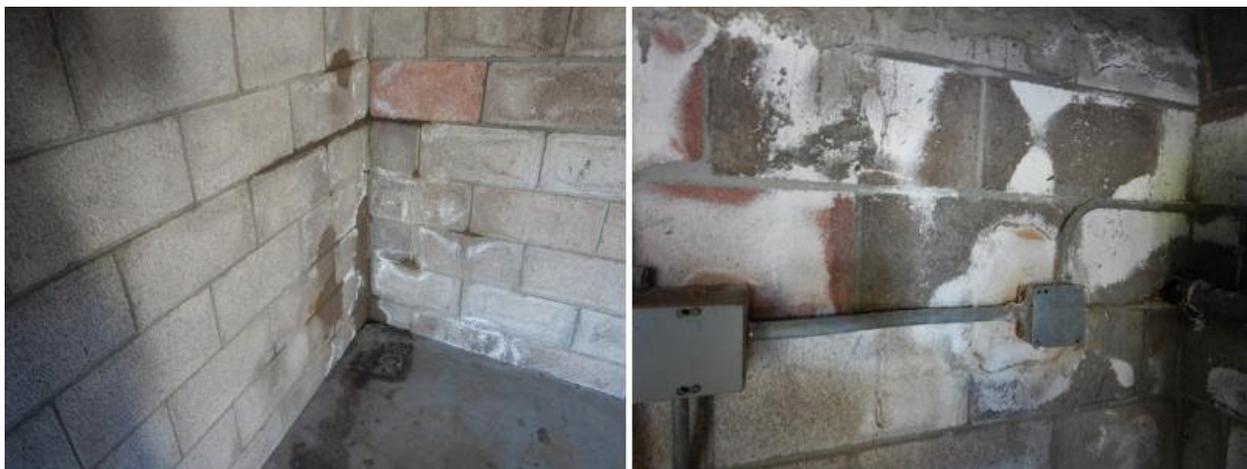
### Walls:

The block wall at the left/rear was damp and other walls show signs of efflorescence. Efflorescence is a white powdery build-up that occurs when water penetrates through concrete or masonry to the interior. As described earlier in this report, I recommend diverting exterior drainage away from the foundation.

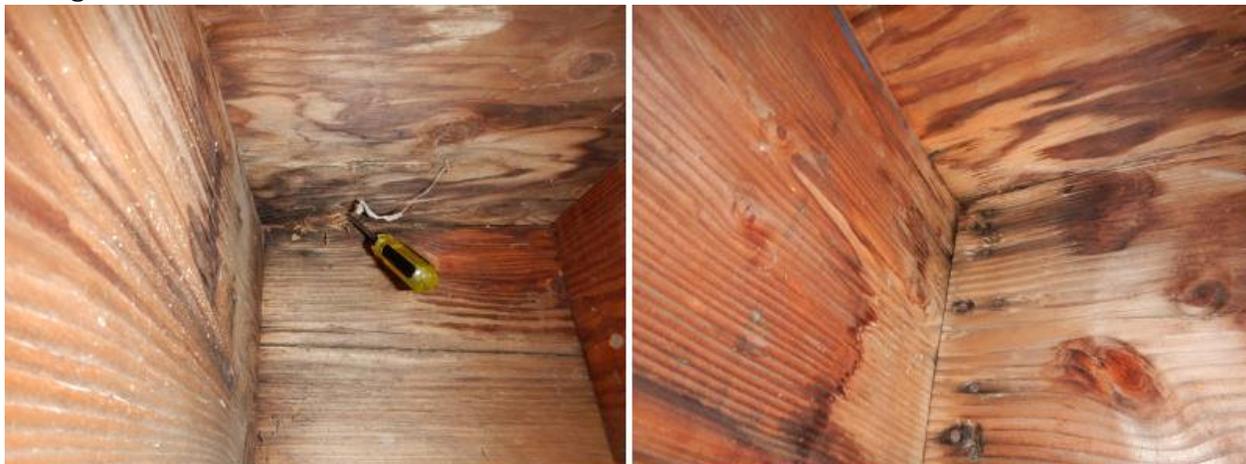
Floor Above  
Framing:

Wood is decayed/damaged at the deck framing above. Damage may extend into inaccessible areas. As this is not a pest inspection and other areas of damage may be present, a licensed pest inspection company should inspect this building and repairs should be made, as needed.
