# WOOD DESTROYING PESTS AND ORGANISMS INSPECTION REPORT

Building No. 3510	Street Alta Vista Avenue	City Santa Rosa	Zip 95409	Date of Inspection 11/30/2020	Number of Pages 10
----------------------	-----------------------------	--------------------	--------------	----------------------------------	-----------------------

<h2 style="margin: 0;">North Coast Termite Control</h2> <p style="margin: 0;"><b>2777 Yulupa Avenue #608</b> <b>Santa Rosa CA 95405</b></p> <p style="margin: 0;">Tel (707) 328-4008 <a href="mailto:northcoasttermite@comcast.net">northcoasttermite@comcast.net</a></p>	Report # : 8155 Registration # : PR4280 Escrow # : <input type="checkbox"/> CORRECTED REPORT
--	---	---

GENERAL DESCRIPTION: Multi-level single family residence and detached garage.	Inspection Tag Posted: SUBAREA
	Other Tags Posted: NONE CURRENT

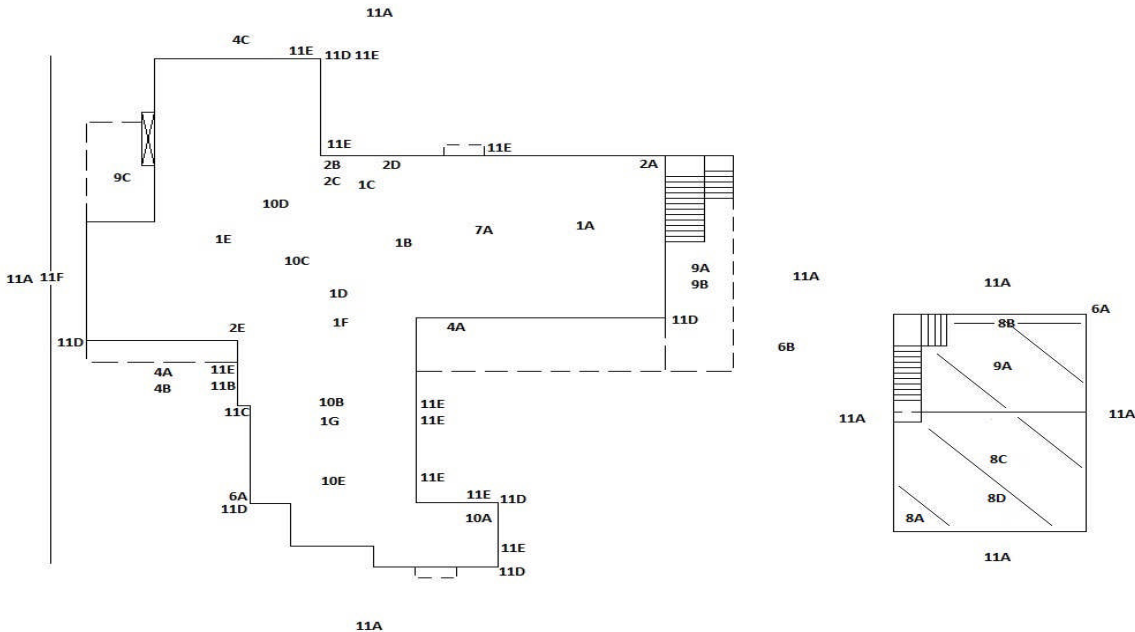
**Diagram Not To Scale**

#11E FINDING: Fungus and excessive moisture has caused damage to sections of the band boards in the approximate areas indicated on the diagram.

RECOMMENDATION: Owner/agent should engage the services of a licensed contractor to remove fungus damaged wood member(s) and replace with new material.  
(SECTION I)
