Gage Inspection Services

Property Inspection Report

811 Sentinel Ct, Santa Rosa, CA 95409
Inspection prepared for: Debrah Orlando
Real Estate Agent: Doug Swanson -

Date of Inspection: 6/2/2023 Time: 9:00 AM
Order ID: 1320

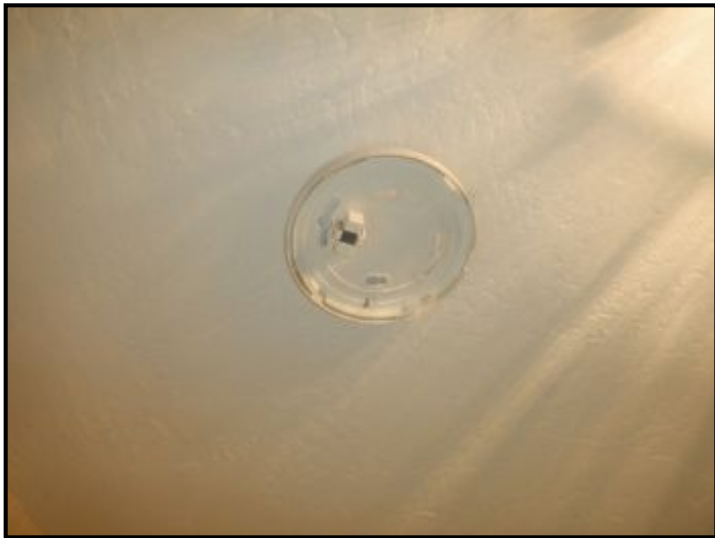
Inspection Details		
Page 19 Item: 10	Smoke Detectors	<p>Maintenance There is a missing smoke detector in the hallway. It is recommended to install newer 10 yr smoke detectors in the hallway as well as in each individual bedroom. Recommend testing the system prior to occupying the home and every month to identify functional operation of the detectors. If applicable, tall ceiling height installation may not be accessible for testing. California law requires that working smoke detectors be present upon the transfer of sale.</p>

<p>Missing smoke detector.</p>

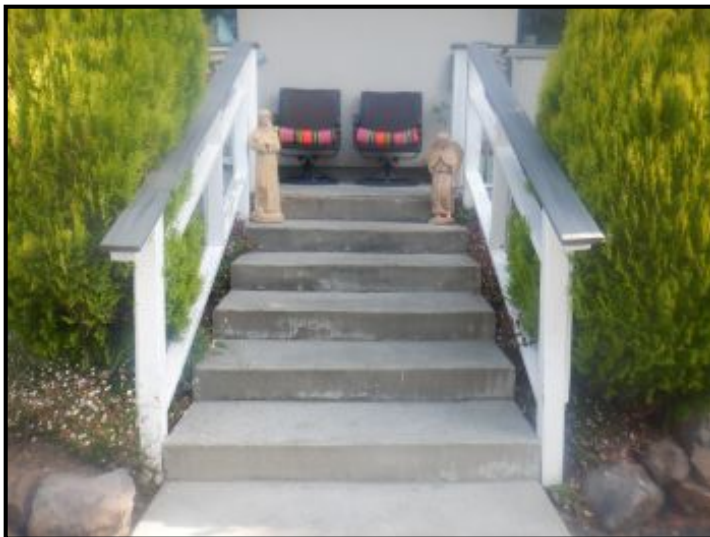
Page 21 Item: 3	Steps	<ul style="list-style-type: none"> • Attention • The railing system for the concrete stairway at the left side of the home does not have what is considered a gripable hand rail system. Installing a hand rail system up to current standards is recommended as a health and safety consideration. • Any stairway with 4 or more risers should have a handrail system installed. As a health and safety consideration it is recommended to install a railing/handrail system at the exterior concrete steps.
-----------------	-------	--

Railing not considered a gripable hand rail.

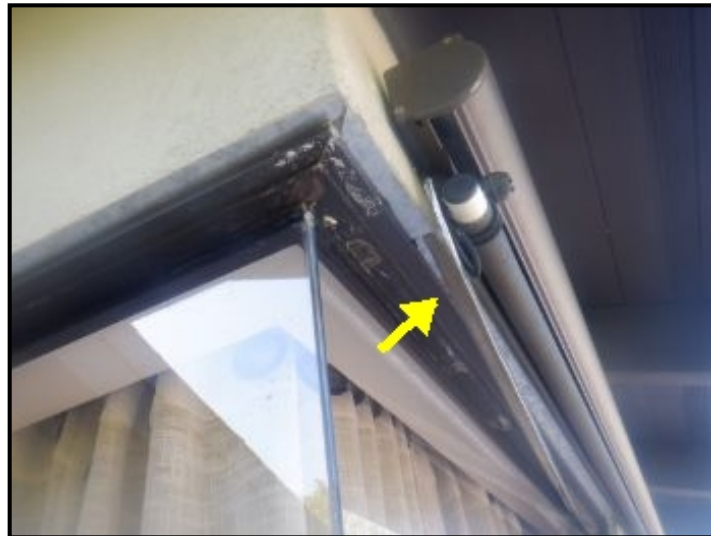
Page 24 Item: 4	Window Glass	<p>Attention There is missing and loose exterior weather stripping for the corner window in the dining area. The weather stripping helps to prevent potential moisture intrusion and should be replaced.</p>
-----------------	--------------	--

Loose weather stripping around window.

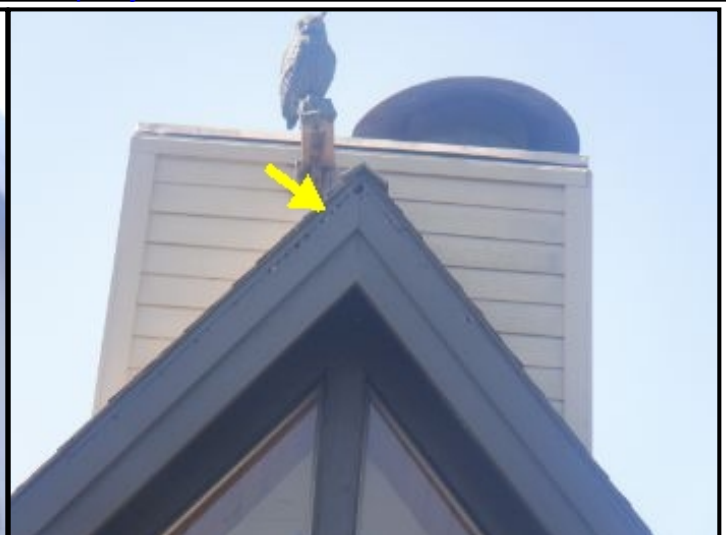
Page 25 Item: 7	Fascia Boards/Trim	<ul style="list-style-type: none"> • Maintenance • Fascia damage has been noted at the north exterior of the home. We recommend referring to the pictures and contacting a qualified contractor to review the current pest report and make needed repairs. • Bird damage was noted to the fascia boards at the north side peak of the roof. We recommend contacting a qualified pest control company for evaluation/recommendations.
-----------------	--------------------	--

Bird damage at peak of roof.

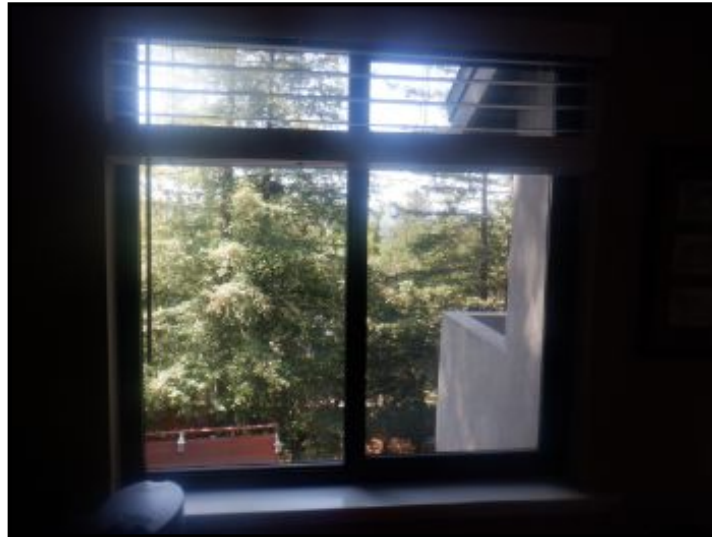
Page 25 Item: 9	Double Pane Seals/Insulating Windows	<p>Maintenance There is a double pane insulating window that has lost the vacuum seal between the panes of glass. The location is the bedroom at the end of the hallway. The conditions is identified by signs of fogging, a halo effect or condensation build up between the panes of glass. Recommend contacting a glass company for complete window evaluation and estimates for replacement. The deficiency on any other windows is sometimes only visible under certain climatic conditions.</p>
-----------------	--------------------------------------	---

Lost seal at bedroom window.

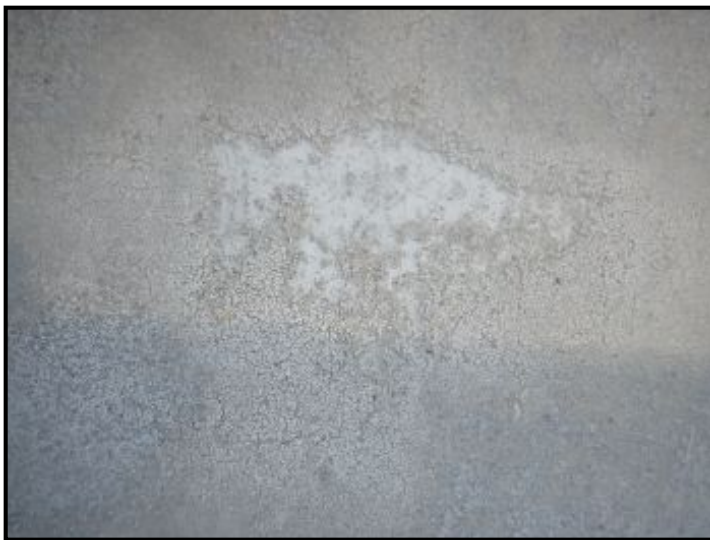
Page 29 Item: 1	Surface	<ul style="list-style-type: none"> • Attention • The south side balcony is a wood framed deck with a weather proof membrane installed. The surface coat is showing wear and is recommended to be resealed to prevent deterioration and potential moisture intrusion. • There is a lifted deck board off the bedrooms that may cause a potential tripping hazard. Its recommended to refasten the board to the deck framing as a preventative measure.
-----------------	---------	---

Worn surface at master bedroom deck.

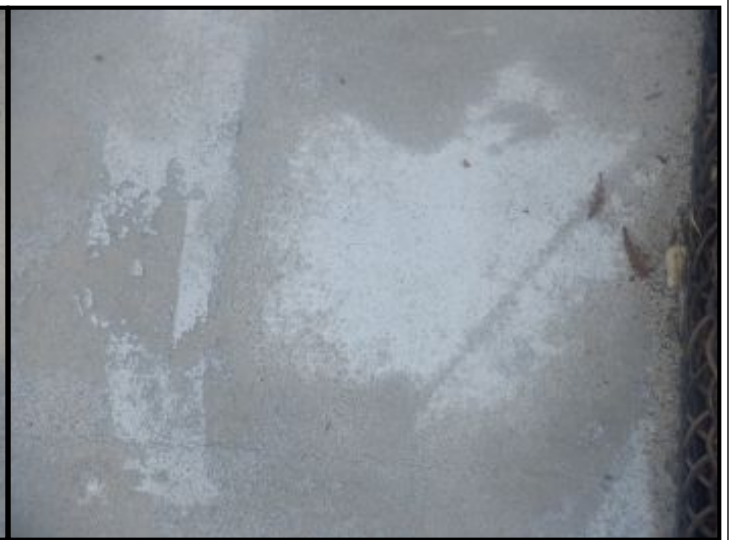
Worn surface at master bedroom deck.

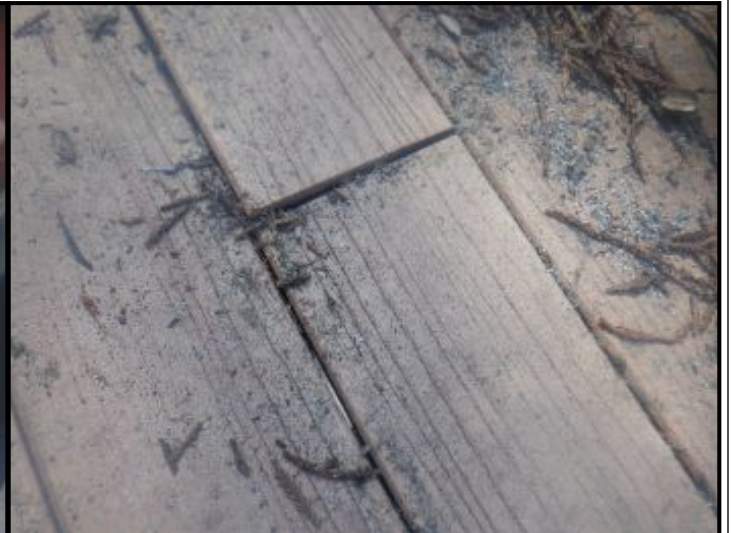
Lifted deck board.

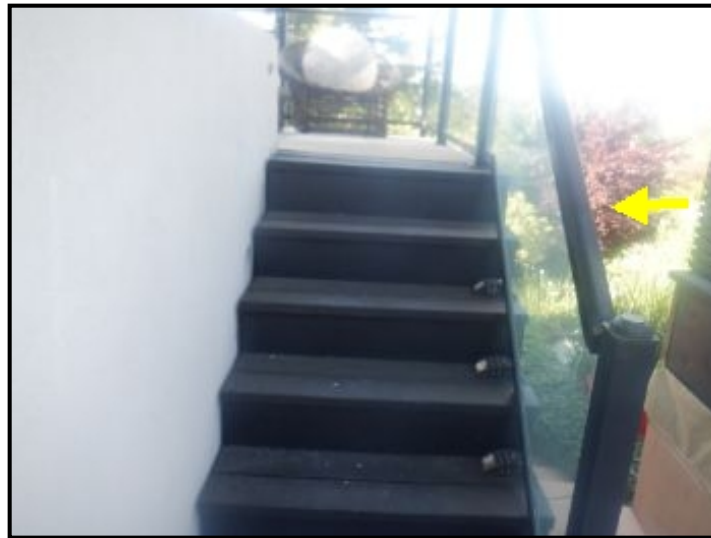
Page 29 Item: 3	Steps/Handrails	Attention The hand rail at the stairway up to the south side balcony is wobbly. It is recommended to tighten the supplied hardware as needed.
-----------------	-----------------	---

Wobbly stairway railing.

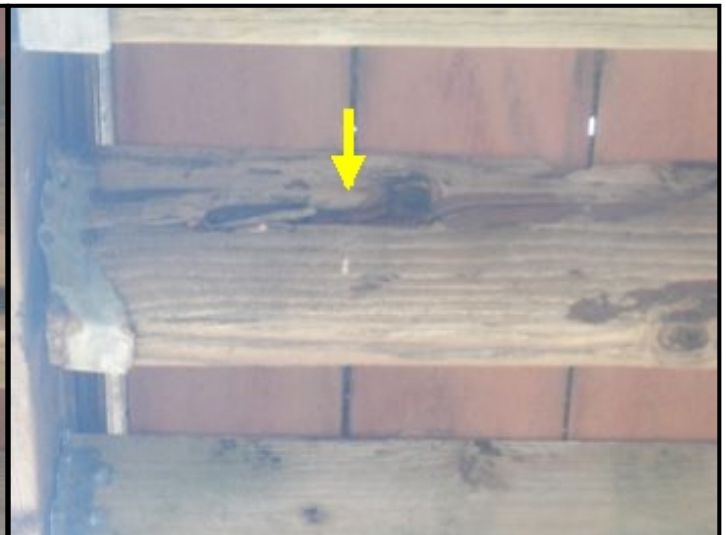
<p>Page 30 Item: 4</p>	<p>Foundation/Framing</p>	<ul style="list-style-type: none"> • Maintenance • There are joist hangers that are pulling away from the deck fascia board and fasteners that are not properly set. Though currently serviceable we recommend contacting the appropriate specialist for evaluation/repairs. • There was deterioration noted one of the deck joists at the left side of the home. Damaged wood should be removed and supported with new lumber and corrective measures to prevent this from recurring. We recommend referring to the current pest report.
------------------------	---------------------------	---

Damage to deck joist.

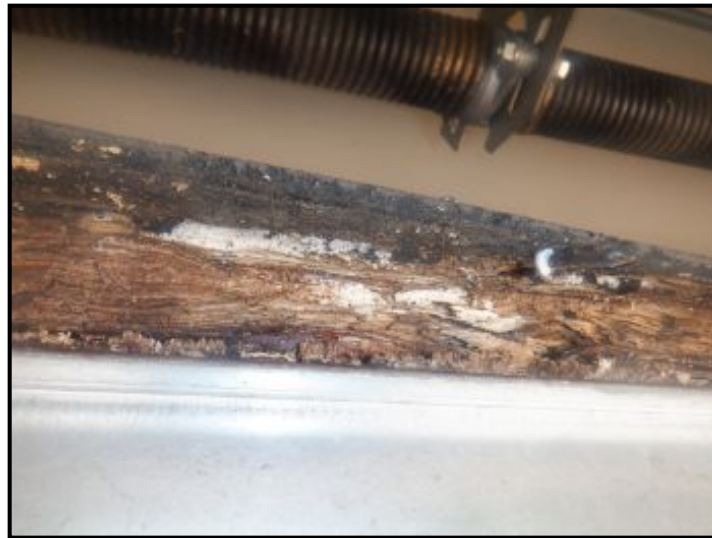
<p>Garage</p>		
<p>Page 32 Item: 2</p>	<p>Garage Door</p>	<p>Maintenance There is wood damage noted to the base of the garage door. Repair/replacement of the damaged wood is recommended. Contact a qualified garage door specialist for evaluation/recommendations.</p>

Wood damage to bottom panel of garage door.

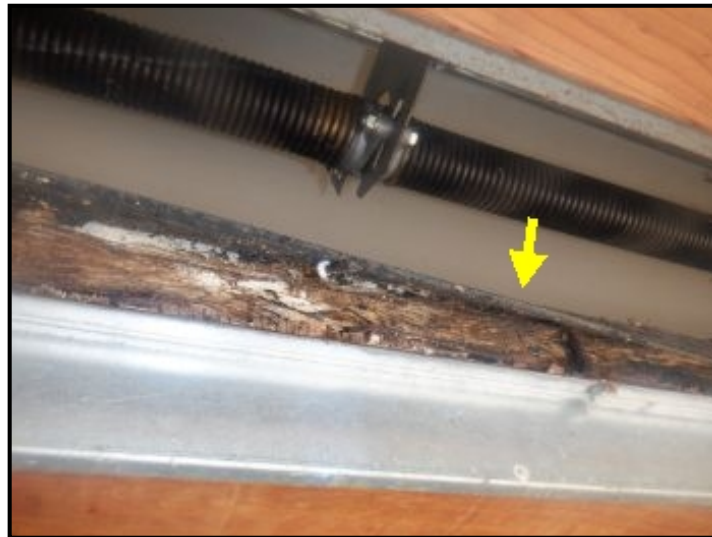
The garage door seal is in a deteriorated condition. Recommend replacing to help prevent moisture penetration and further damage to the garage door.

Deteriorated garage door seal.

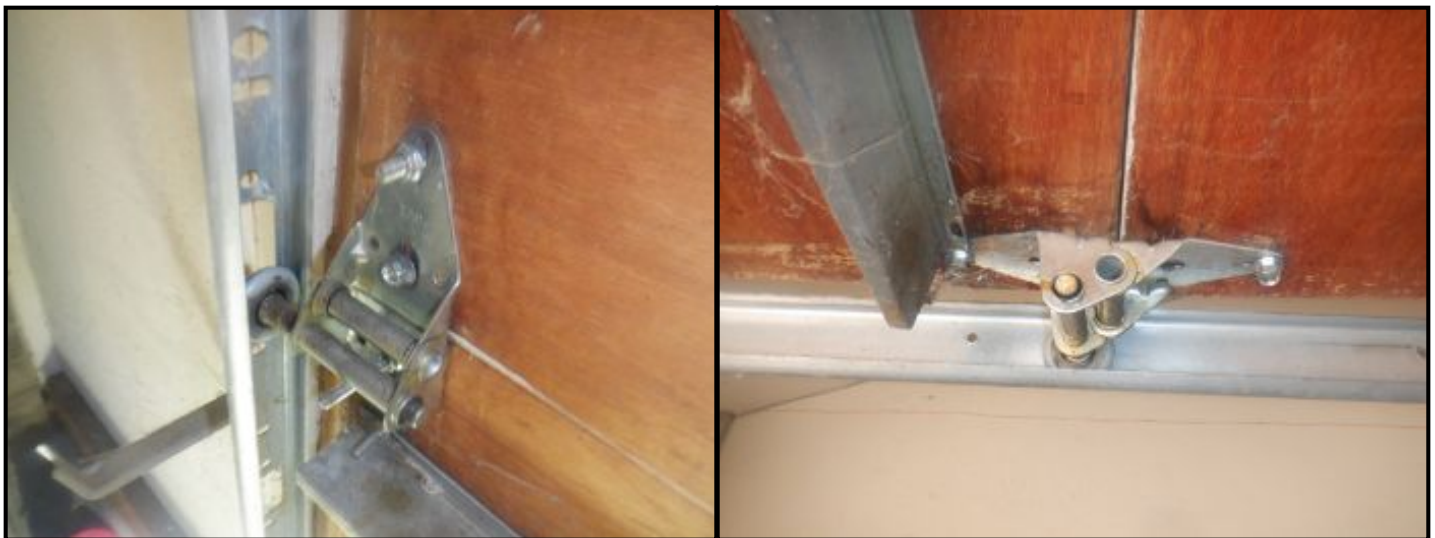
There are a few of the roller brackets that are loose causing the garage door to be rough when opening and closing. It is recommended to tighten any loose hardware as needed.

Loose roller brackets.

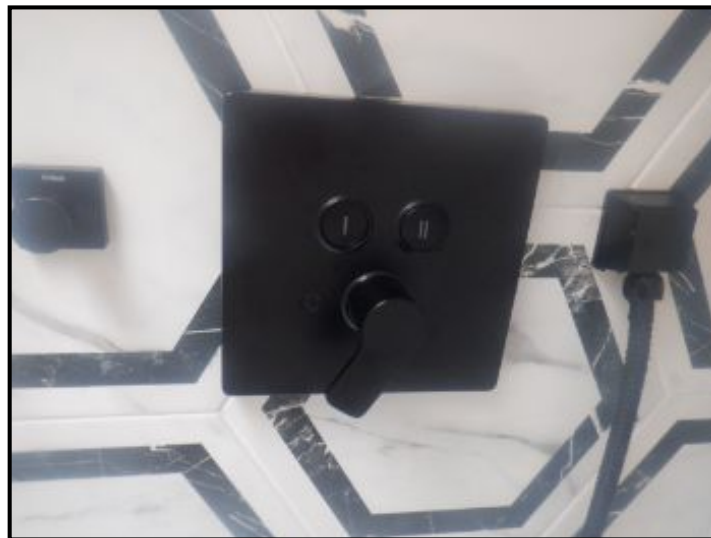
Page 40 Item: 5	Shower Fixtures	<p>Maintenance The shower fixture in the hallway bathroom was loose and the buttons for the wand and shower head were sticking. Recommend contacting a qualified plumbing contractor for evaluation.</p>
-----------------	-----------------	--

Loose shower fixture cover.

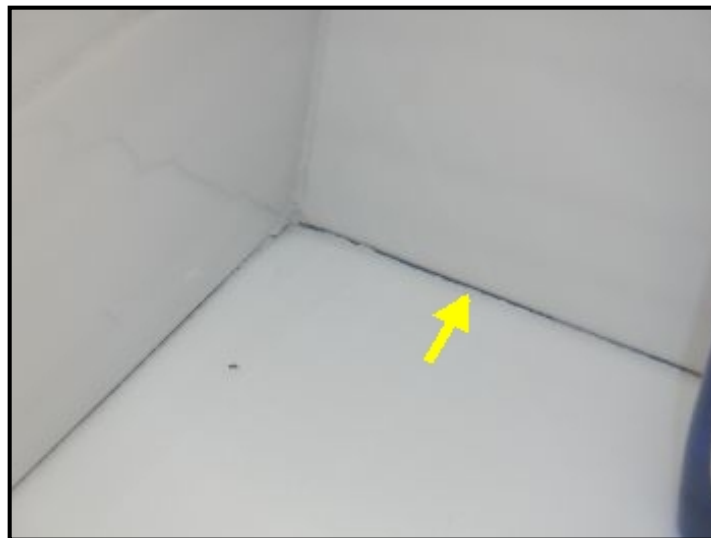
Page 41 Item: 8	Water Resistant Wall Cover	<p>Attention Minor grout voids were noted around the master bathroom tub surround tile wall. This is a condition that can lead to moisture intrusion and deterioration. Regrouting is recommended. These areas should be inspected and touched up on a regular basis as part of preventative home maintenance</p>
-----------------	----------------------------	---

Grout voids around tub.

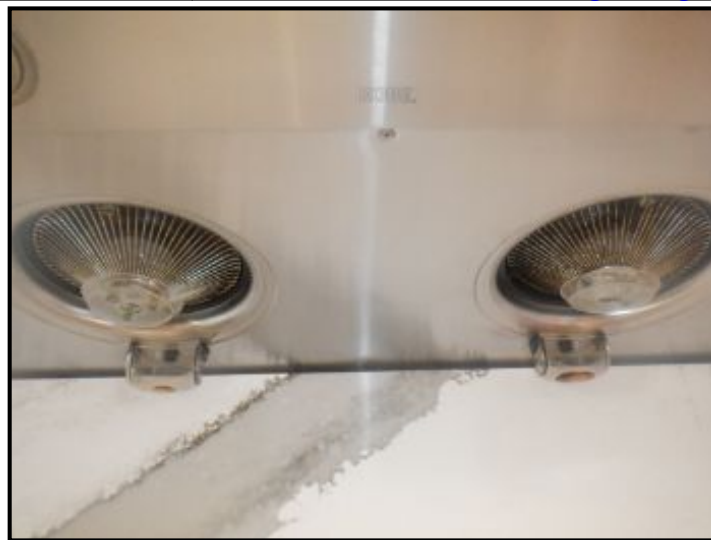
There is grease build up at the stove top exhaust fan and hood. Recommend cleaning and grease laden areas.

Grease build up at stove top exhaust.

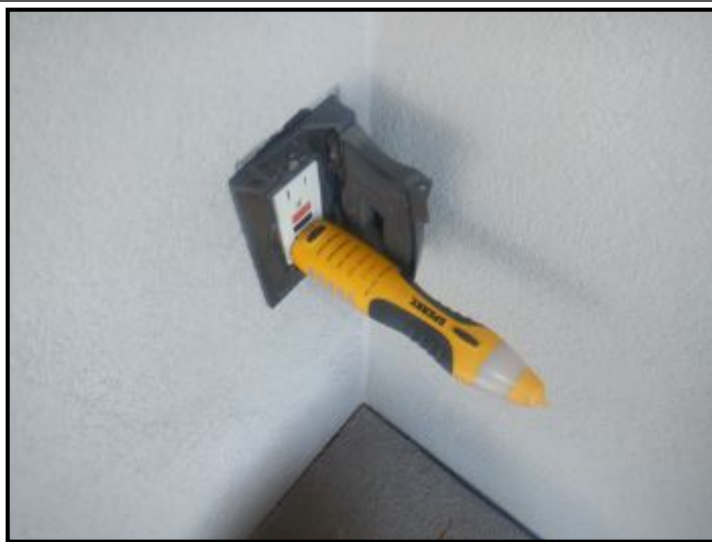
- Maintenance
- The exterior outlet at the deck off the master bedroom was tripped before the inspection started and the inspector was unable to reset indicating repairs/replacement is needed. Contact a qualified electrician for repairs.
- Current electrical standards require that ground fault interrupters (**GFCI**) be located in areas where there is a potential danger of electrical shock. Areas such as kitchens, bathrooms, garages and exterior outlets. The inspector recommend installing GFCI outlets at the outlet next to the studio shower and sink area as a preventative health and safety consideration.

Deck GFCI not resetting.

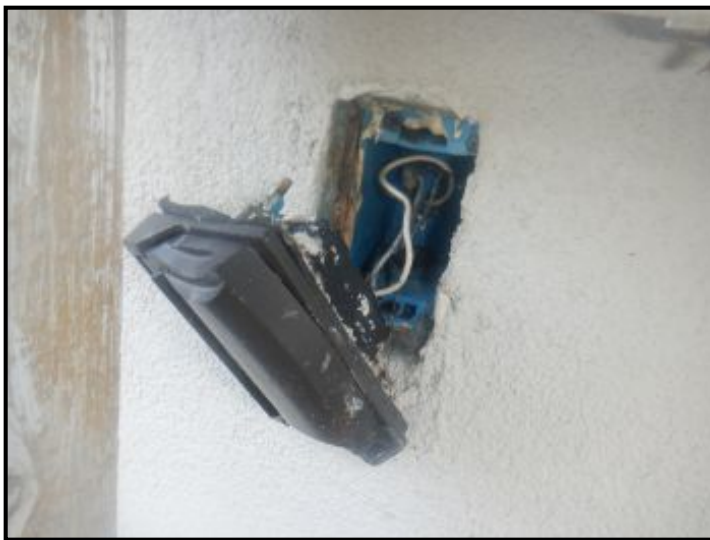
- **Maintenance**
- There is a loose electrical outlet with exposed wiring at the entry of the downstairs studio. Repairs are needed to properly secure the outlet to the structure and protect the wiring system.
- There is a missing junction box cover next to the entry of the downstairs studio. Installing the proper cover is recommended to protect the wiring system.
- All damaged or missing cover plates should be replaced with new cover plates to restore proper function and reduce the risk of electrical shorts and hazardous shocks. There is a missing cover plate in the cabinet above the stove top and missing covers in the sub area.
- There is unused and unprotected wiring in the sub area of the home. If the wiring is not desired removal is recommended.

Loose electrical outlet in front of studio.

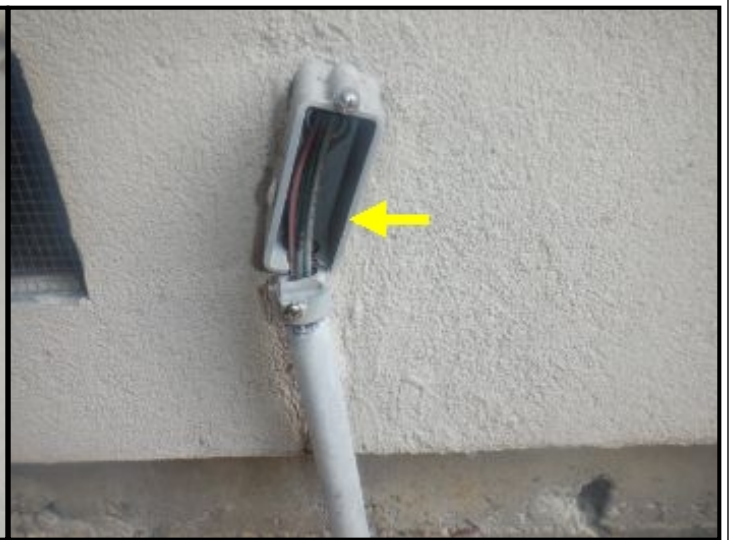
Missing cover

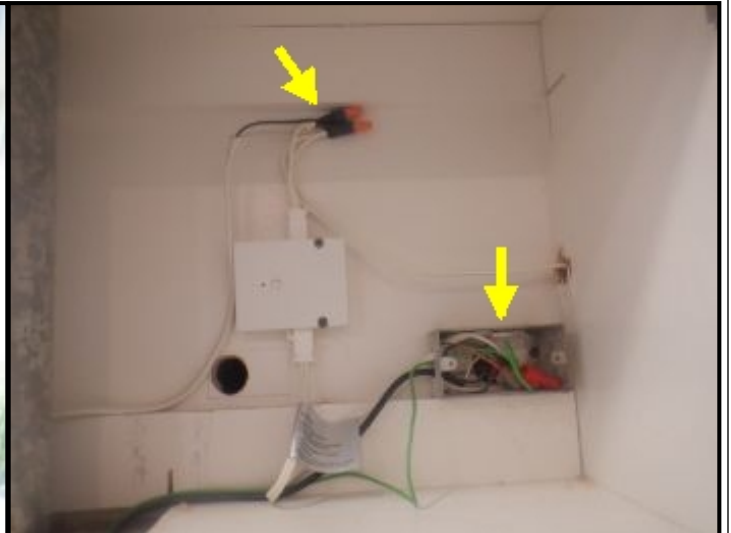
Missing junction box and covers above stove top.

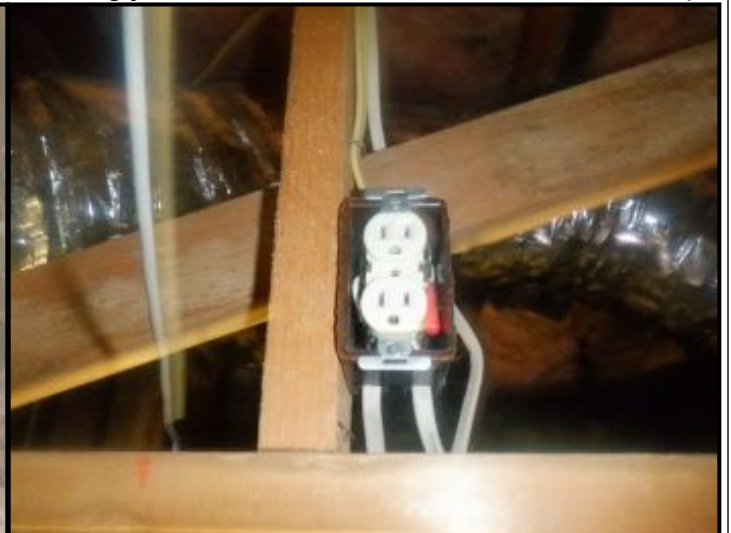
Missing cover plate in sub area.

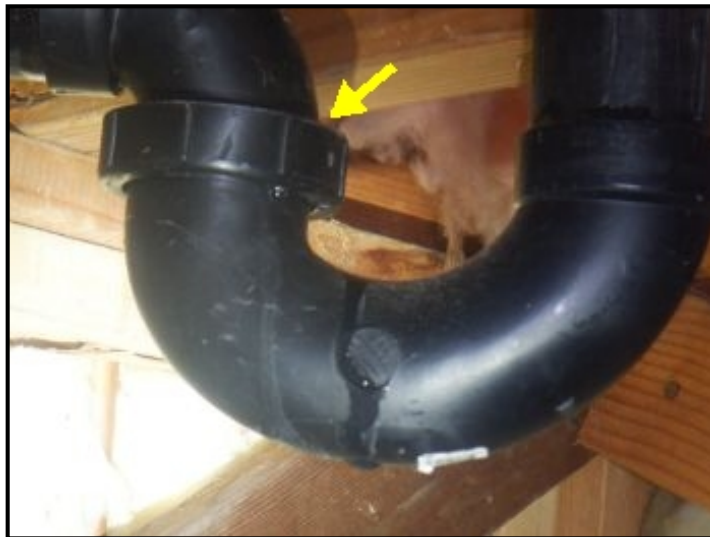
Page 54 Item: 8	Evidence Of Leaks	<p>Maintenance The inspector has found evidence of a plumbing leak. We advise the use of a qualified plumbing contractor to make final determination of the cause and to provide estimates for repairs. Location of the leak is the shower drain line visible from the sub area.</p>
-----------------	-------------------	--

Leaking from shower drain line.

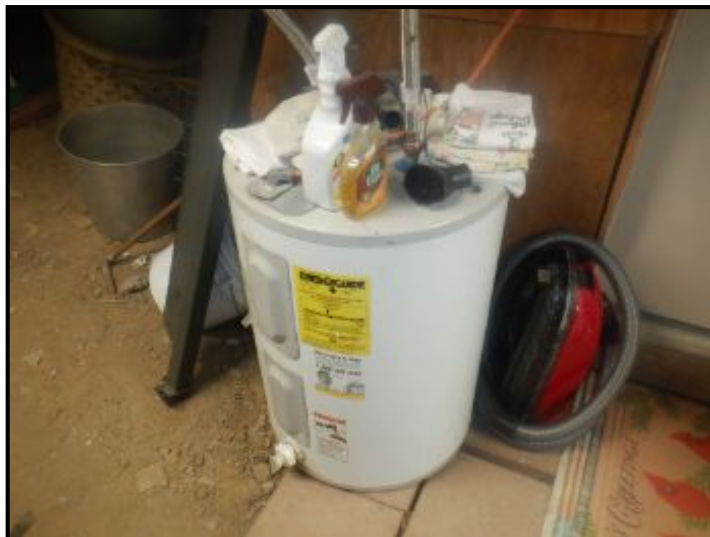
Page 56 Item: 8	Safety Tie Down	<p>Maintenance The water heater is not equipped with a tie down system in the sub area. Installation is required as per The California Office of the State Architect when solder or transferred. Contact a qualified plumbing contractor for repairs.</p>
-----------------	-----------------	---

Water heater not properly strapped.

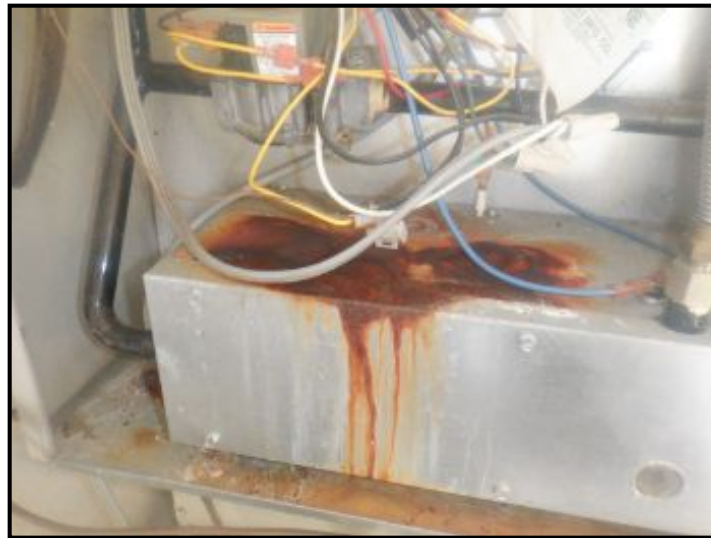
Page 58 Item: 2	Location	<p>Attention There is moisture staining at the interior of the furnace indicating a past moisture issue. At the time of the inspection no current active leaking was noted. We recommend contacting a qualified HVAC contractor for evaluation.</p>
-----------------	----------	---

Staining at interior of furnace

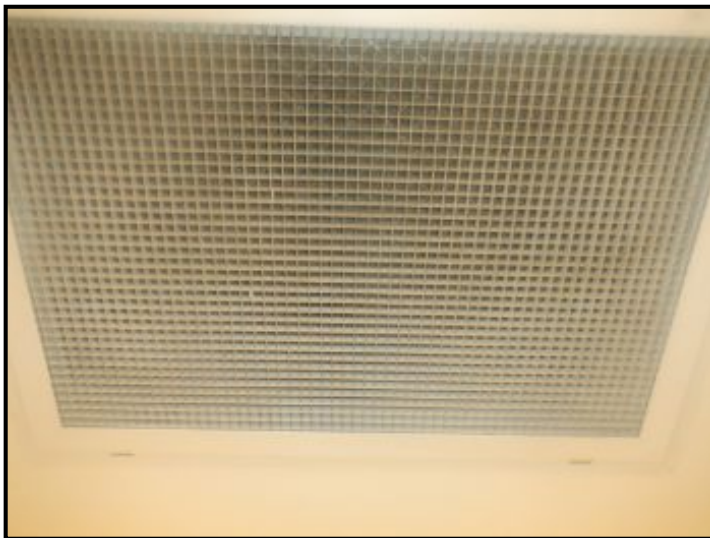
Page 59 Item: 7	Filter Condition	<p>Attention The furnace filters are in need of changing. This can restrict proper airflow and reduce the efficiency of the system. The inspector recommends changing or cleaning the filter on a regular basis as needed.</p>
-----------------	------------------	--

Replace air return filters.

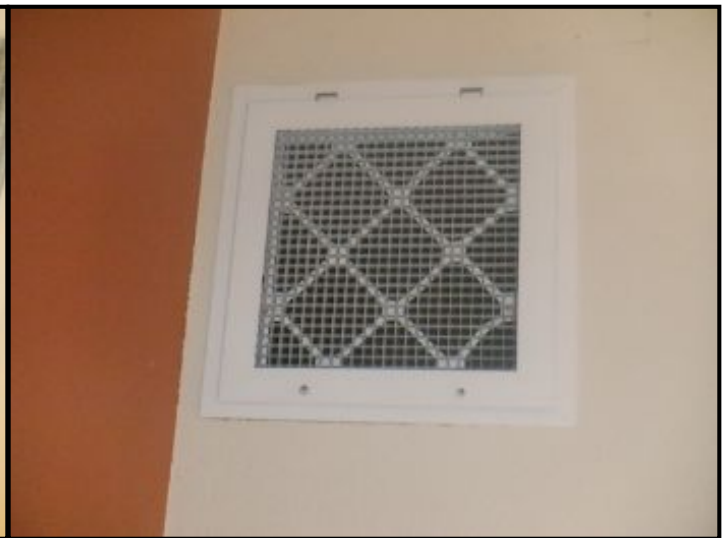
Replace air return filter.

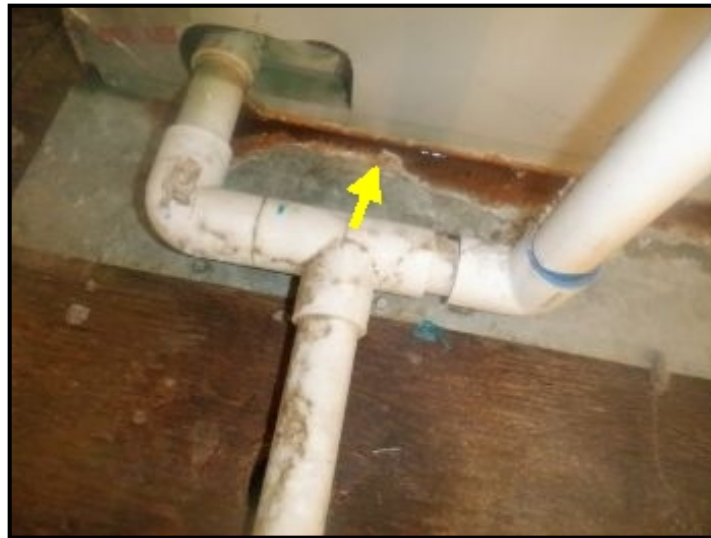
Air Conditioning		
Page 62 Item: 8	Condensate Drain System	<p>Maintenance There is moisture on the platform under the A Coil at the furnace indicating leaking. Contact a qualified HVAC contractor for evalaution/repairs.</p>

Leaking from furnace.

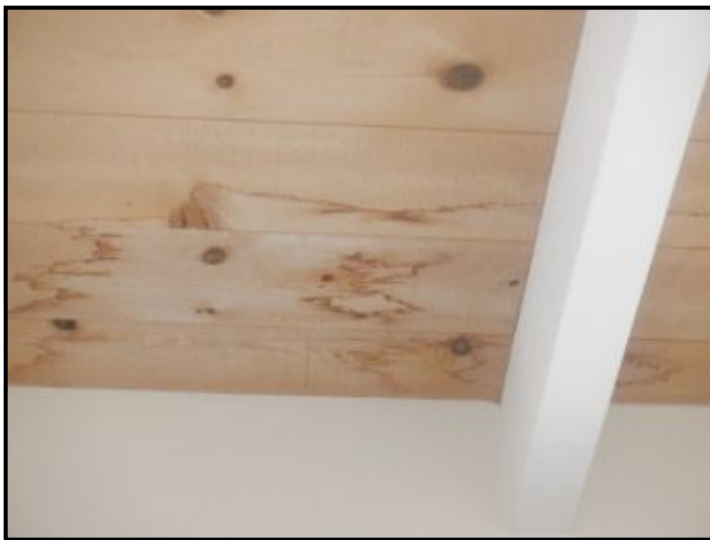
There is moisture staining noted at the ceiling of the family room, kitchen and loft indicating past leaking. The areas were dry at the time of the inspection and no major adverse conditions were noted. We recommend referring to the seller about any past leaking or repairs.

Moisture staining at dining room ceiling.

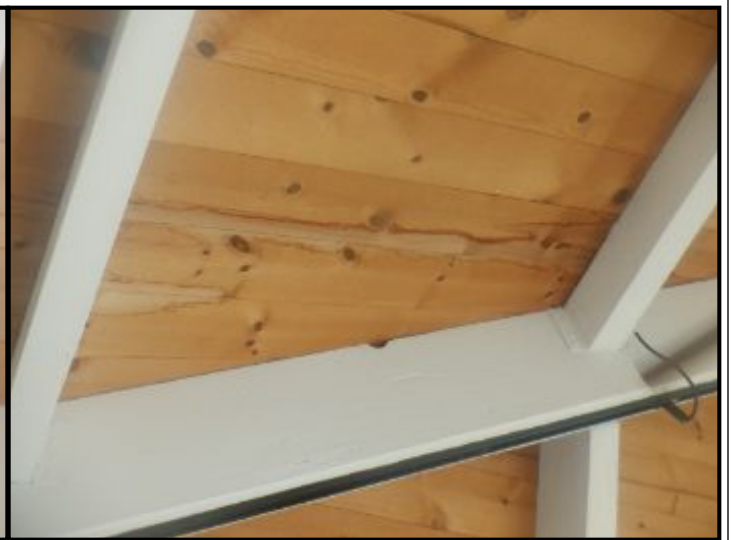
Moisture staining at loft ceiling.

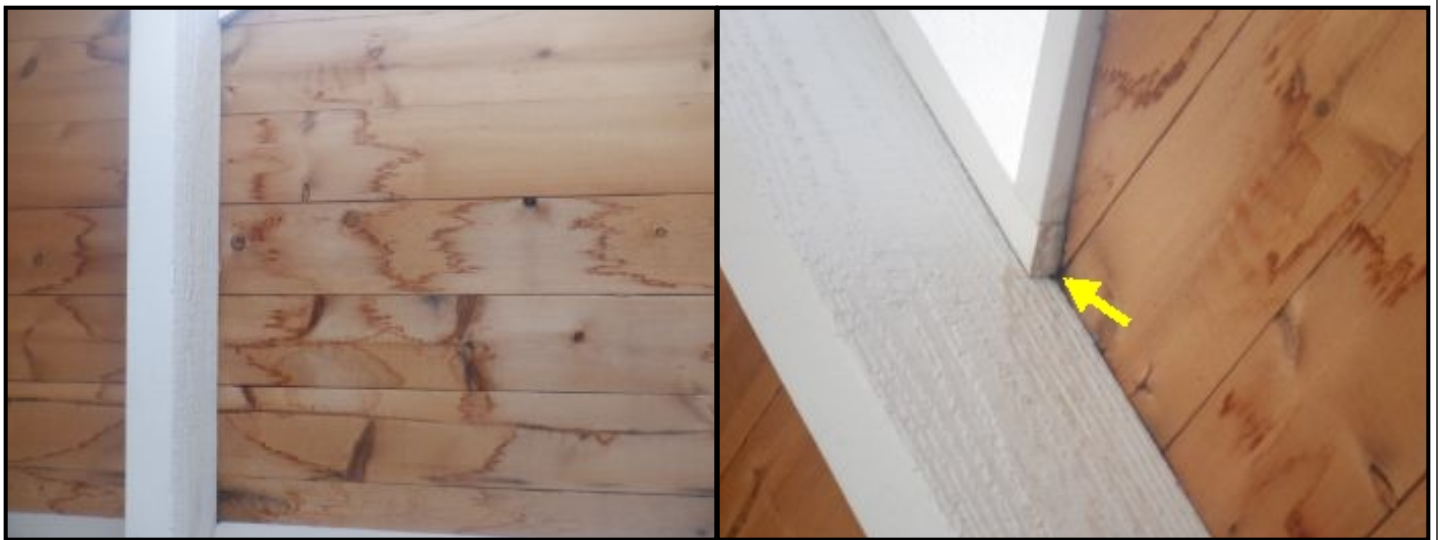
<p>Page 65 Item: 16</p>	<p>Skylights</p>	<p>Attention There is moisture staining around the skylight indicating past leaking. The areas are dry at the time of the inspection and no major adverse conditions were noted. We recommend referring to the seller about any past potential issues or repairs.</p>
-------------------------	------------------	--

Moisture staining below skylight.

Moisture staining at skylight.

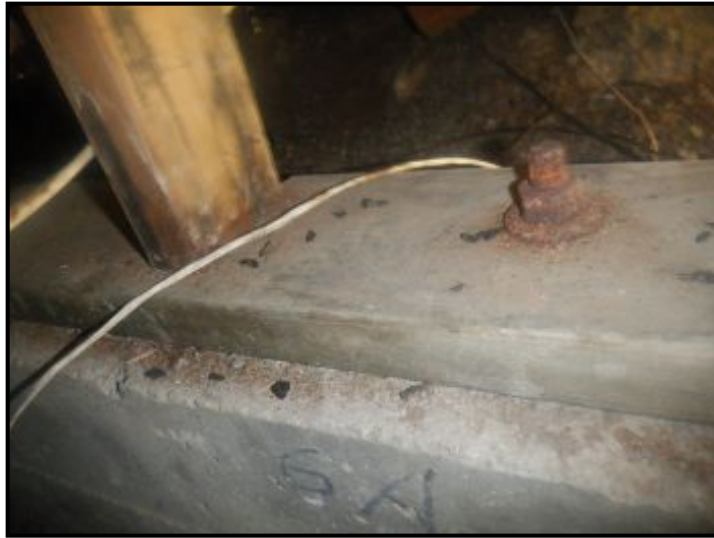
Evidence of rodent activity was noted in the sub area. It could not be determined if this is a current active issue. It is advised to keep the exterior of the home properly sealed to prevent access into the sub area. We recommend contacting the appropriate pest control company for evaluation/recommendations.

Rodent droppings in sub area.

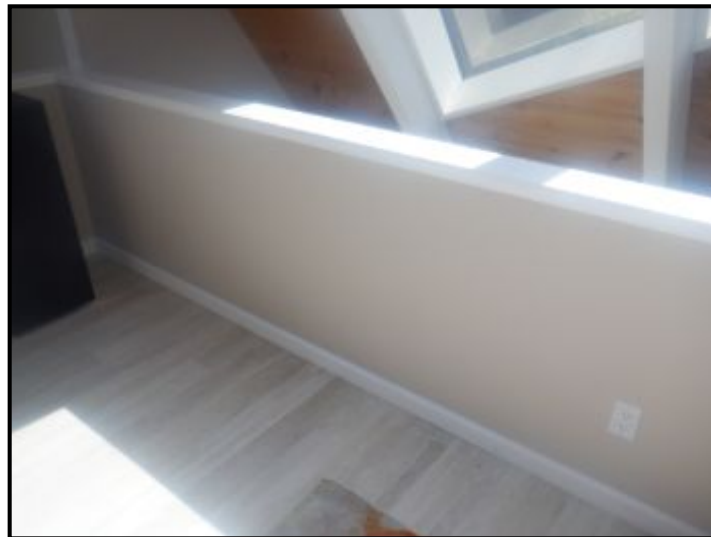
Interior wall lower than current standards.

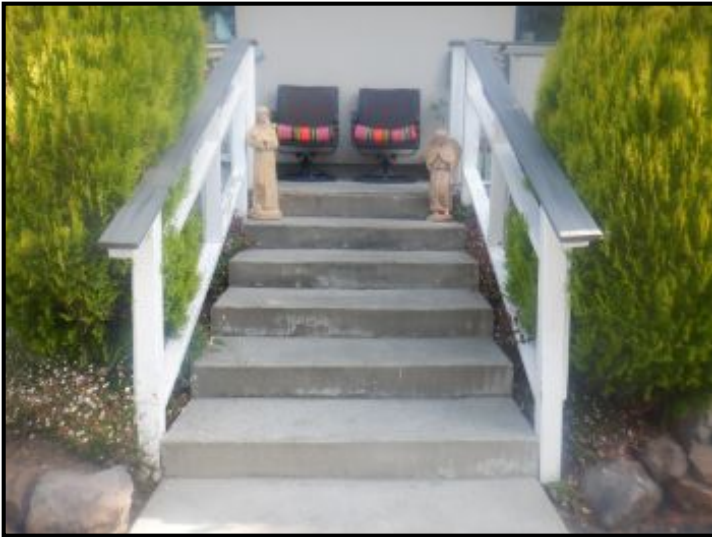
- **Attention**
- The railing system for the concrete stairway at the left side of the home does not have what is considered a gripable hand rail system. Installing a hand rail system up to current standards is recommended as a health and safety consideration.
- Any stairway with 4 or more risers should have a handrail system installed. As a health and safety consideration it is recommended to install a railing/handrail system at the exterior concrete steps.

Railing not considered a gripable hand rail.

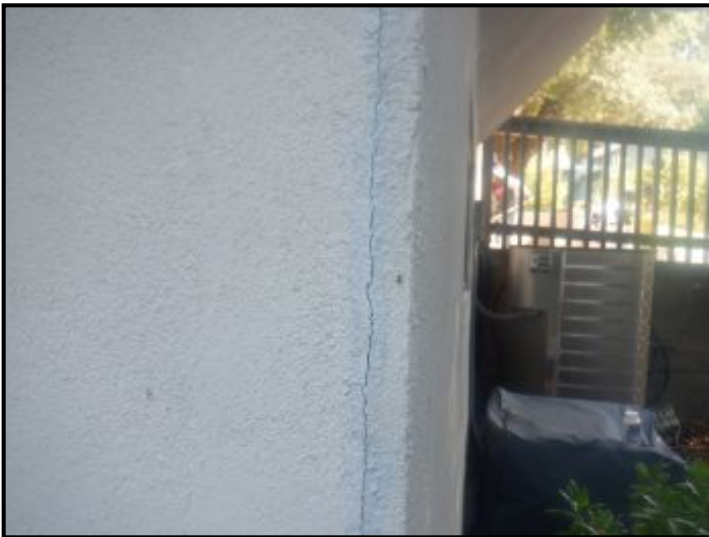
The stucco exterior appears in serviceable condition. Cracking is common to this type of material. Seal any cracking as needed.

Seal stucco cracking as needed.

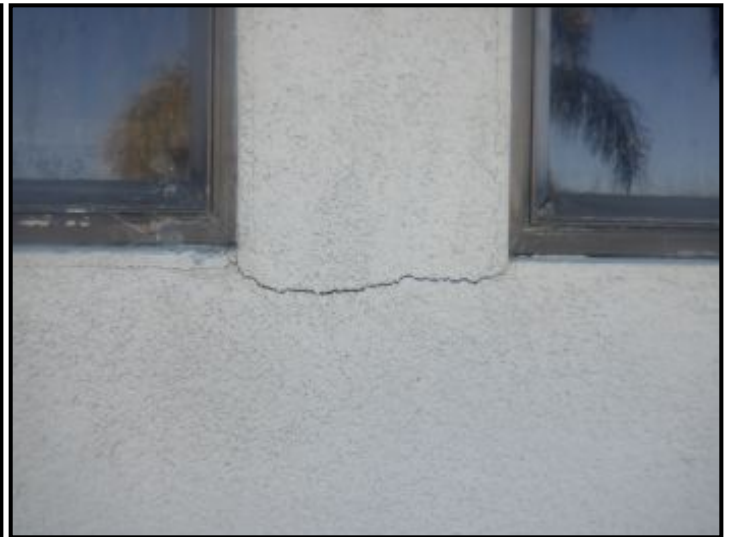
Seal stucco cracking as needed.

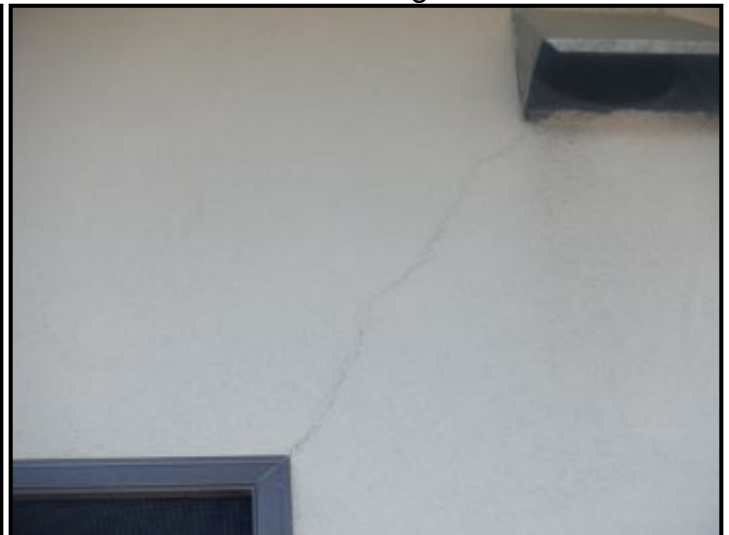
Seal stucco cracking as needed.

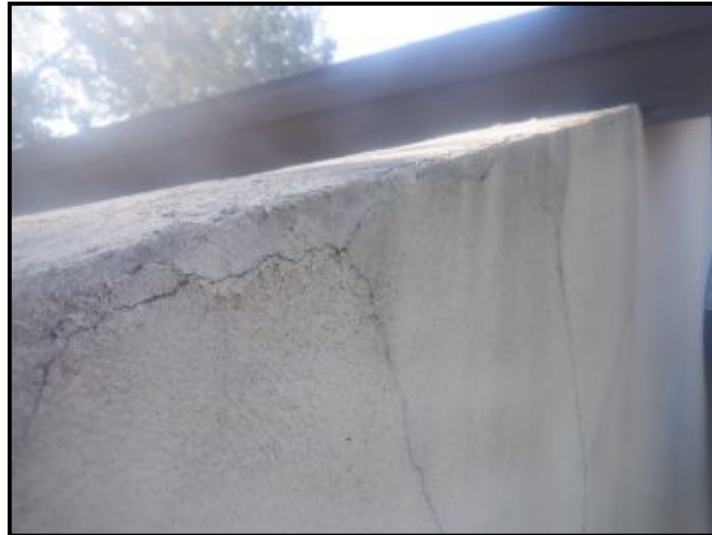
Seal stucco cracking as needed.

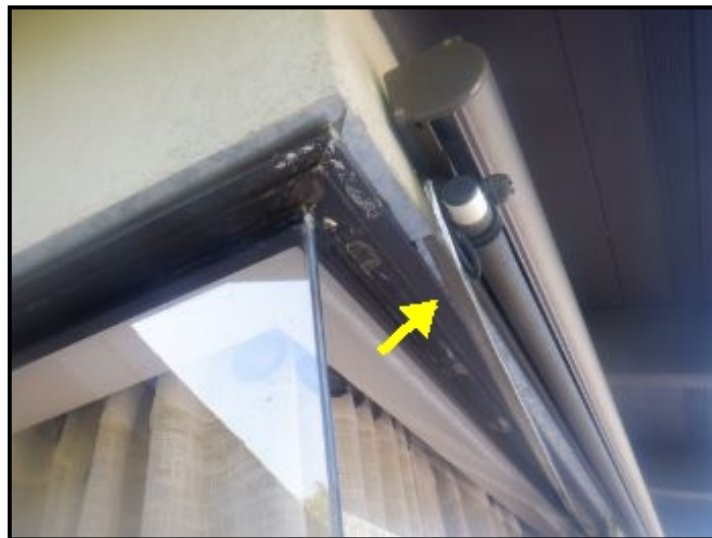
There is missing and loose exterior weather stripping for the corner window in the dining area. The weather stripping helps to prevent potential moisture intrusion and should be replaced.

Loose weather stripping around window.

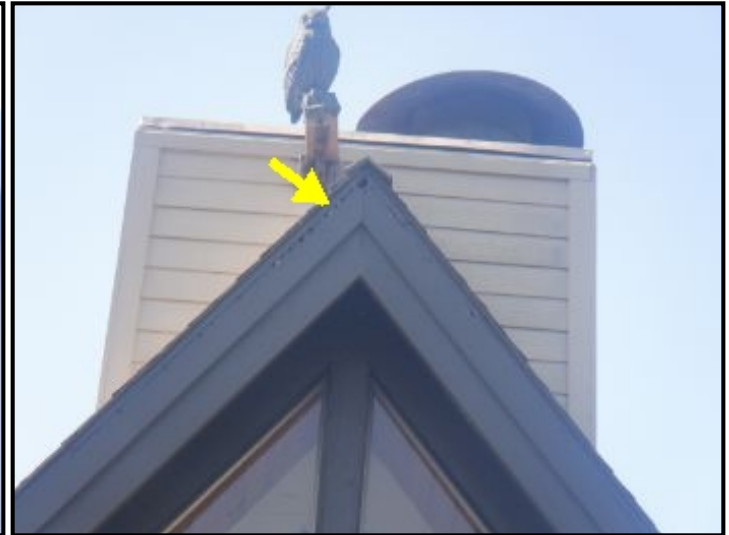
- Maintenance
- Fascia damage has been noted at the north exterior of the home. We recommend referring to the pictures and contacting a qualified contractor to review the current pest report and make needed repairs.
- Bird damage was noted to the fascia boards at the north side peak of the roof. We recommend contacting a qualified pest control company for evaluation/recommendations.

Bird damage at peak of roof.

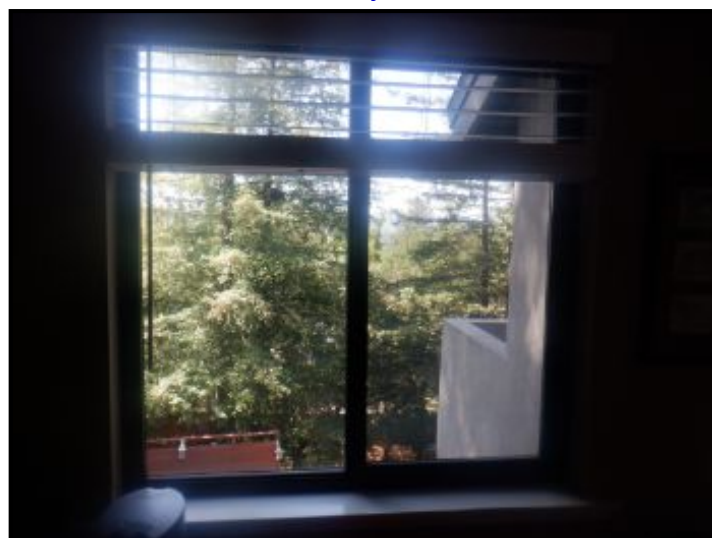
There is a double pane insulating window that has lost the vacuum seal between the panes of glass. The location is the bedroom at the end of the hallway. The condition is identified by signs of fogging, a halo effect or condensation build up between the panes of glass. Recommend contacting a glass company for complete window evaluation and estimates for replacement. The deficiency on any other windows is sometimes only visible under certain climatic conditions.

Lost seal at bedroom window.

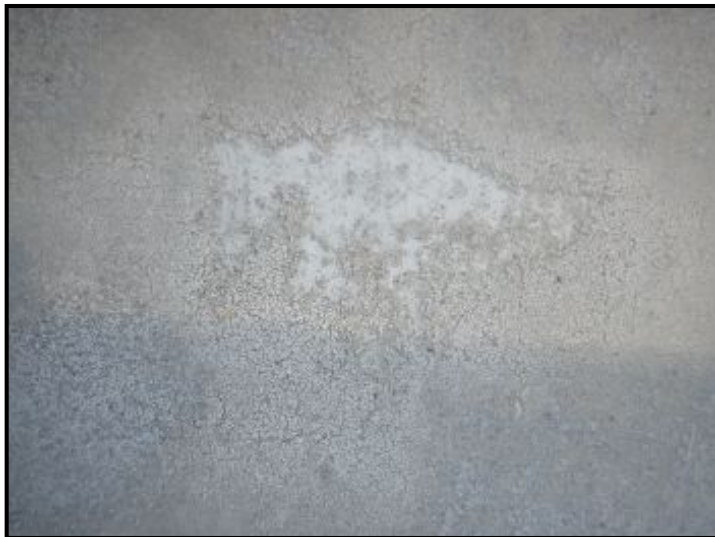
- Attention
- The south side balcony is a wood framed deck with a weather proof membrane installed. The surface coat is showing wear and is recommended to be resealed to prevent deterioration and potential moisture intrusion.
- There is a lifted deck board off the bedrooms that may cause a potential tripping hazard. Its recommended to refasten the board to the deck framing as a preventative measure.

Worn surface at master bedroom deck.

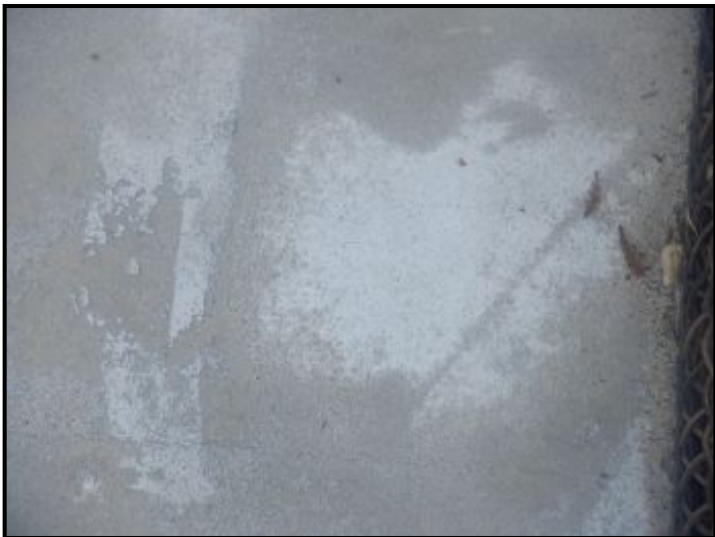
Worn surface at master bedroom deck.

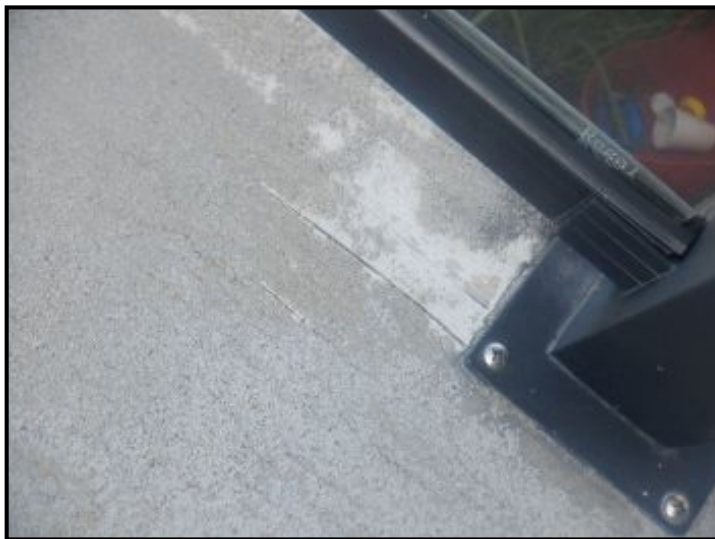
Worn surface at master bedroom deck.

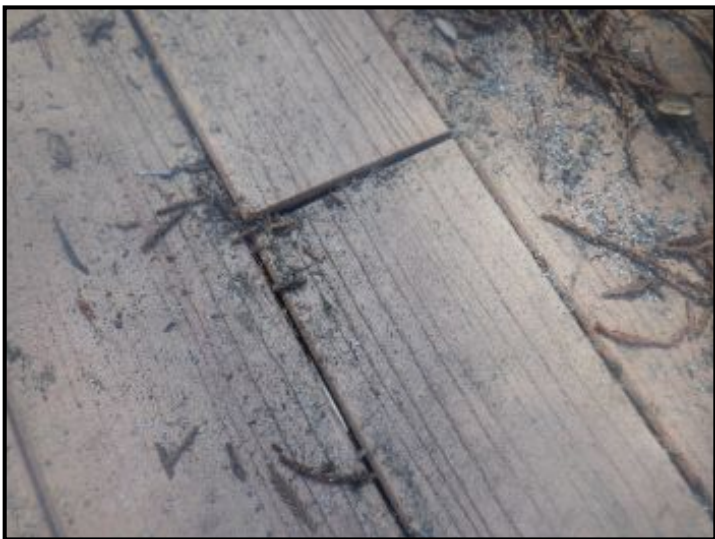
Lifted deck board.

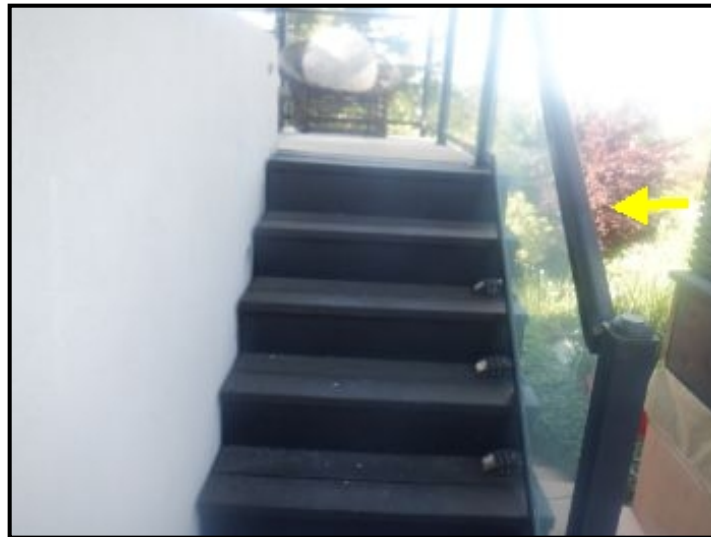
The hand rail at the stairway up to the south side balcony is wobbly. It is recommended to tighten the supplied hardware as needed.

Wobbly stairway railing.

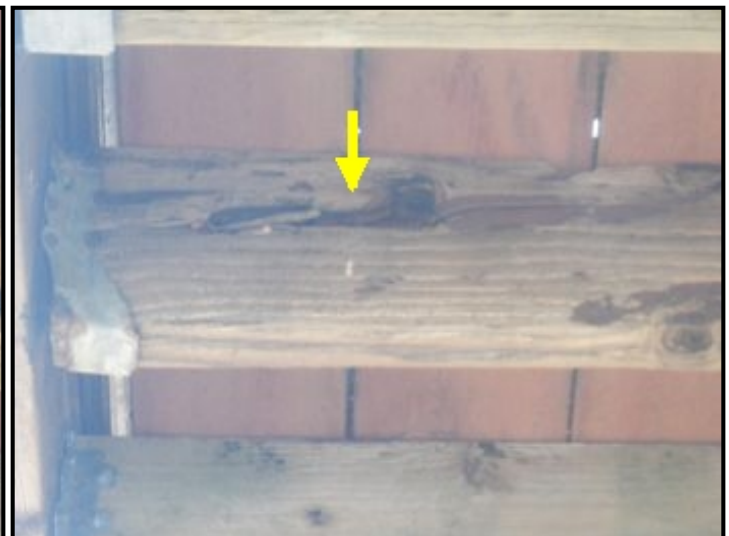
- Maintenance
- There are joist hangers that are pulling away from the deck fascia board and fasteners that are not properly set. Though currently serviceable we recommend contacting the appropriate specialist for evaluation/repairs.
- There was deterioration noted one of the deck joists at the left side of the home. Damaged wood should be removed and supported with new lumber and corrective measures to prevent this from recurring. We recommend referring to the current pest report.

Damage to deck joist.

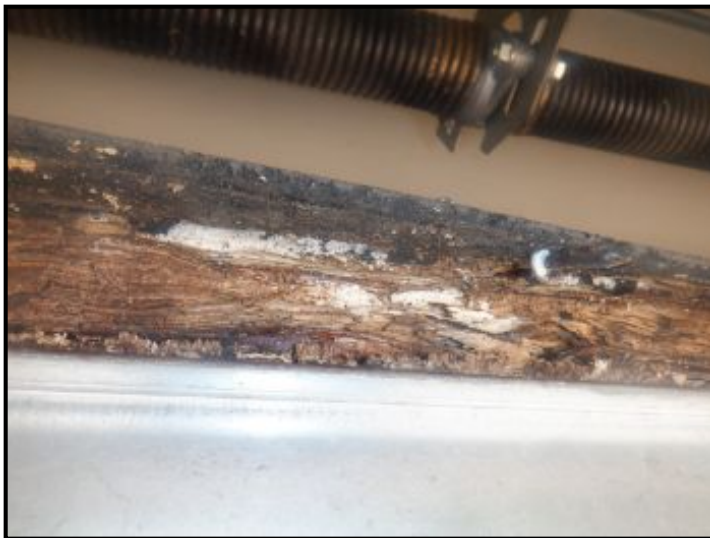
There is wood damage noted to the base of the garage door. Repair/replacement of the damaged wood is recommended. Contact a qualified garage door specialist for evaluation/recommendations.

Wood damage to bottom panel of garage door.
