Gage Inspection Services

Property Inspection Report

811 Sentinel Ct, Santa Rosa, CA 95409
Inspection prepared for: Debrah Orlando
Real Estate Agent: Doug Swanson -

Date of Inspection: 6/2/2023 Time: 9:00 AM
Order ID: 1320

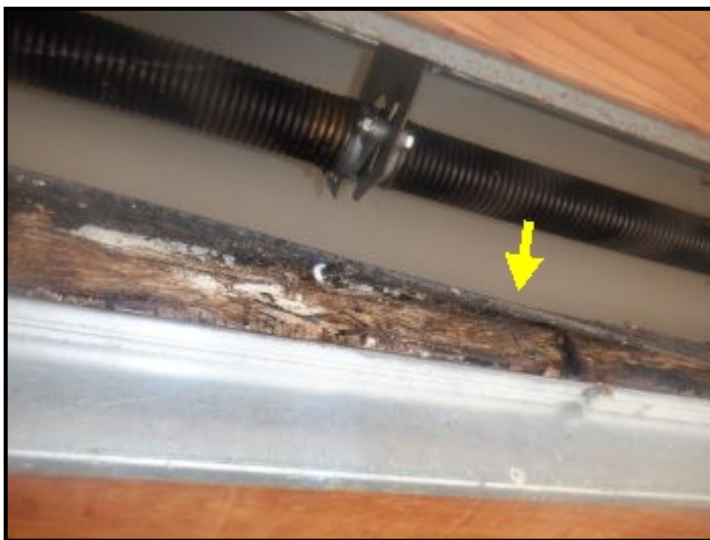
The garage door seal is in a deteriorated condition. Recommend replacing to help prevent moisture penetration and further damage to the garage door.

Deteriorated garage door seal.

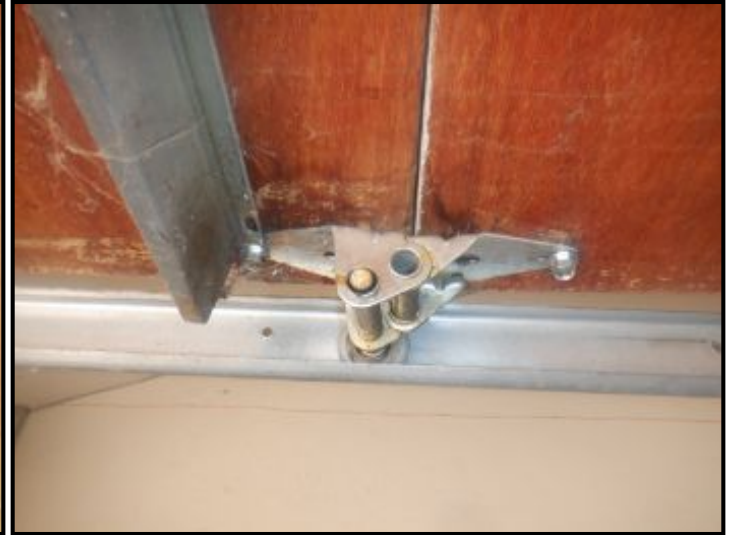
There are a few of the roller brackets that are loose causing the garage door to be rough when opening and closing. It is recommended to tighten any loose hardware as needed.

Loose roller brackets.

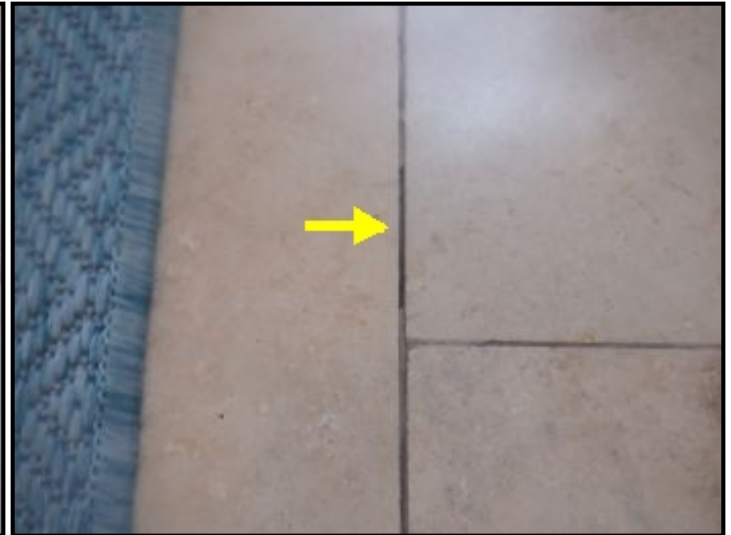
Though serviceable there are a hand full of flooring tiles that are cracked or have grout voids in the dining and entry area.

Grout voids at dining area.

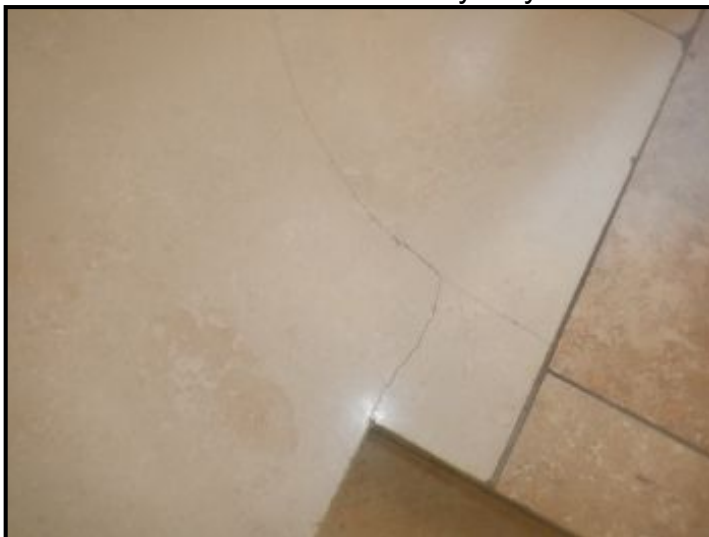
Cracked tiles at entry area.

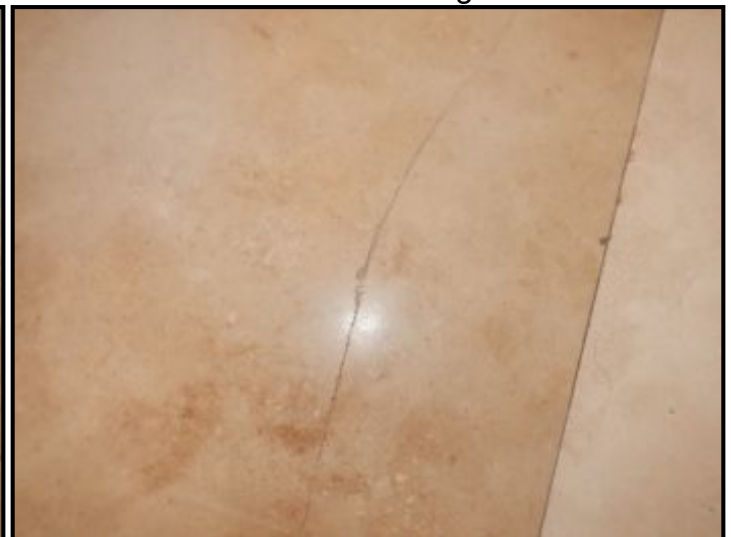
Cracked tiles at entry area.

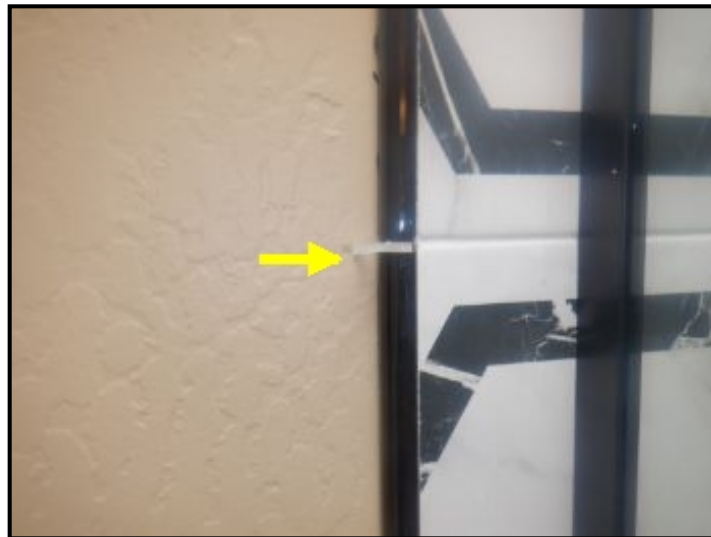
There are grout voids noted to the hallway bathroom wall tiles at the upper quarter round pieces. As in any building, there are cosmetic flaws and blemishes, as well as normal wear and tear. We make no attempt to list all conditions we deem cosmetic in nature.

Grout voids around tiles.

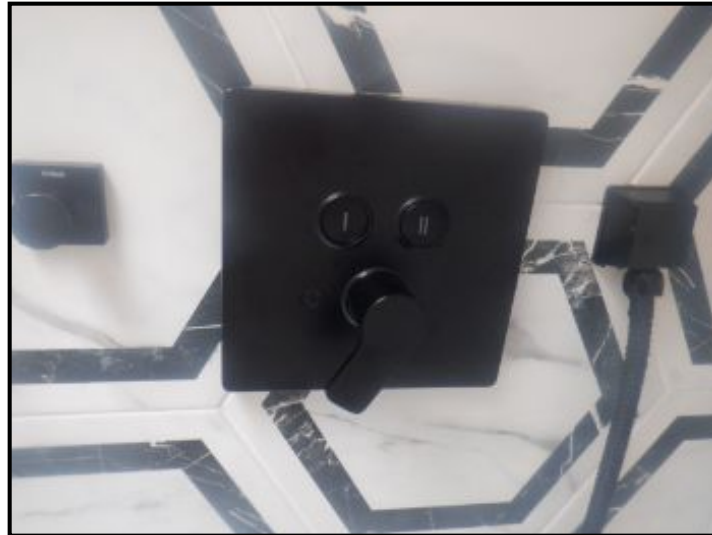
The shower fixture in the hallway bathroom was loose and the buttons for the wand and shower head were sticking. Recommend contacting a qualified plumbing contractor for evaluation.

Loose shower fixture cover.

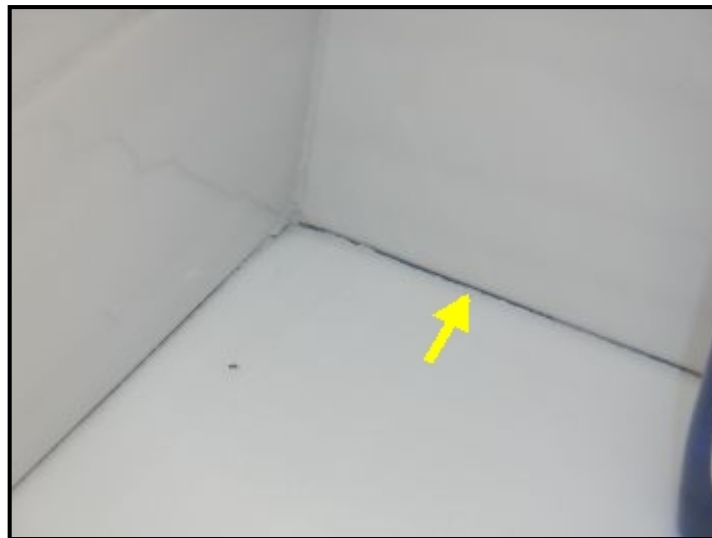
Minor grout voids were noted around the master bathroom tub surround tile wall. This is a condition that can lead to moisture intrusion and deterioration. Regrouting is recommended. These areas should be inspected and touched up on a regular basis as part of preventative home maintenance

Grout voids around tub.

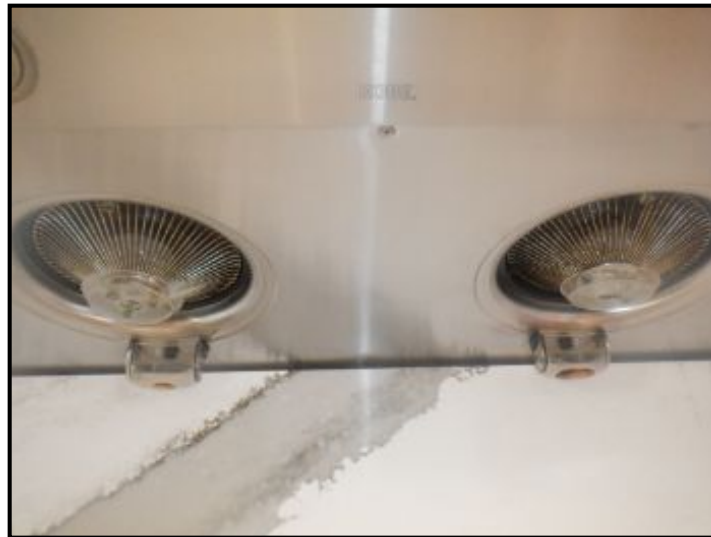
There is grease build up at the stove top exhaust fan and hood. Recommend cleaning and grease laden areas.

Grease build up at stove top exhaust.

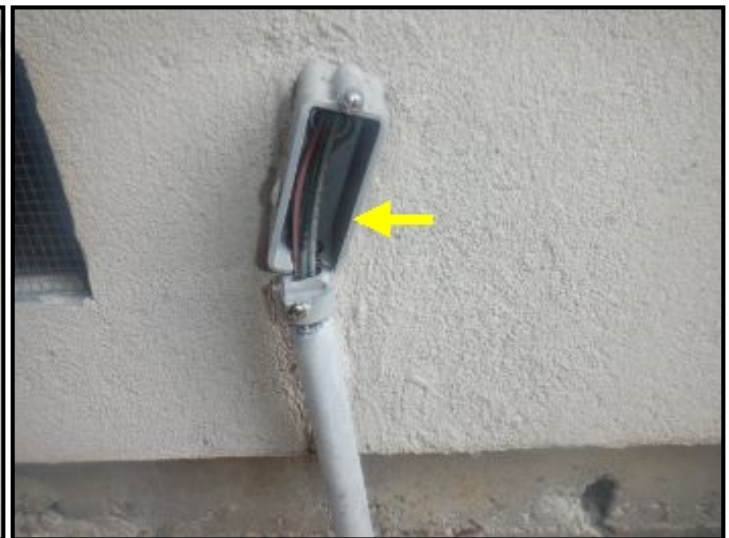
Missing cover

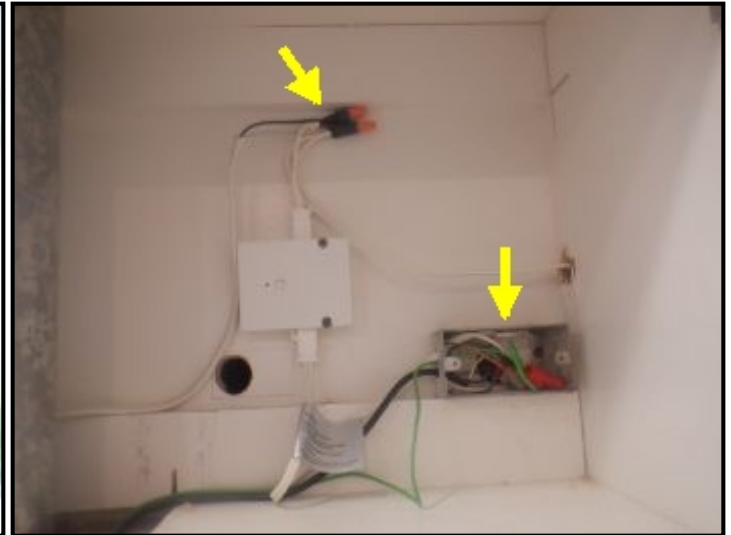
Missing junction box and covers above stove top.

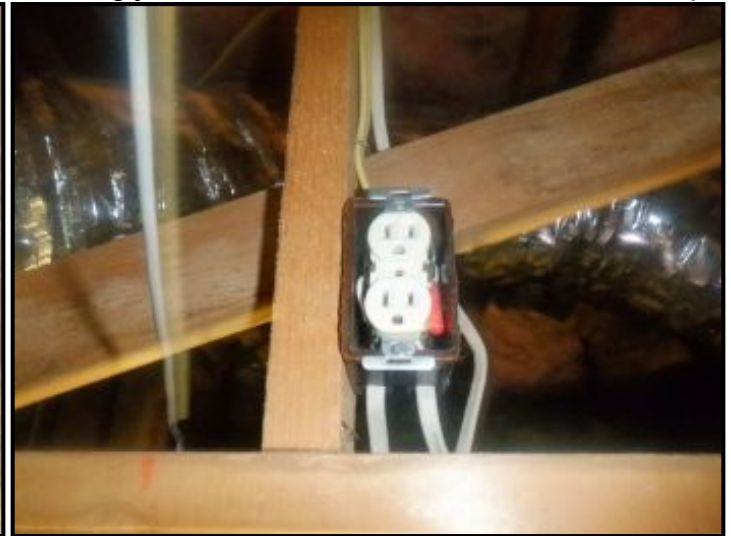
Missing cover plate in sub area.

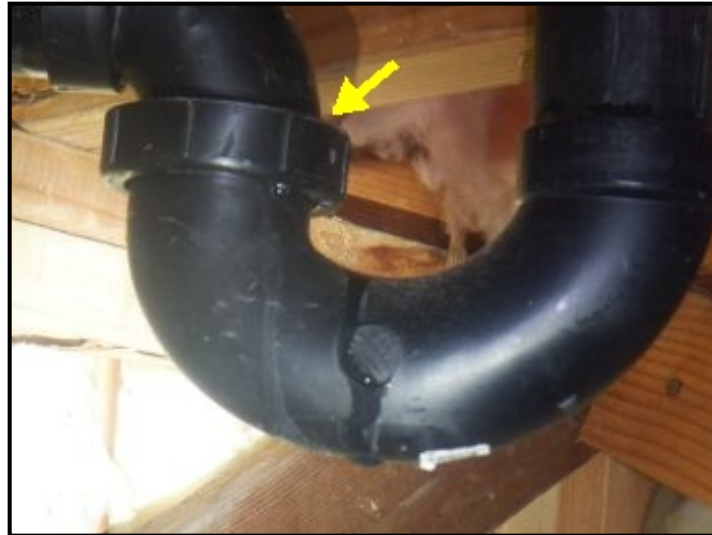
The inspector has found evidence of a plumbing leak. We advise the use of a qualified plumbing contractor to make final determination of the cause and to provide estimates for repairs. Location of the leak is the shower drain line visible from the sub area.

Leaking from shower drain line.

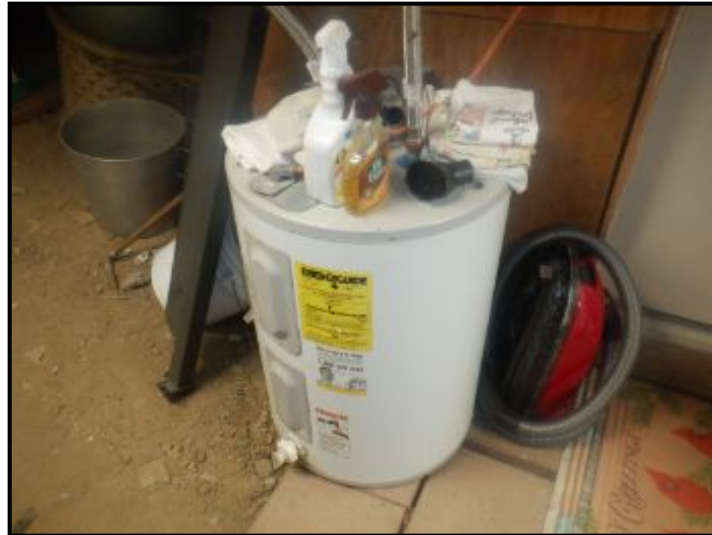
The water heater is not equipped with a tie down system in the sub area. Installation is required as per The California Office of the State Architect when solder or transferred. Contact a qualified plumbing contractor for repairs.

Water heater not properly strapped.

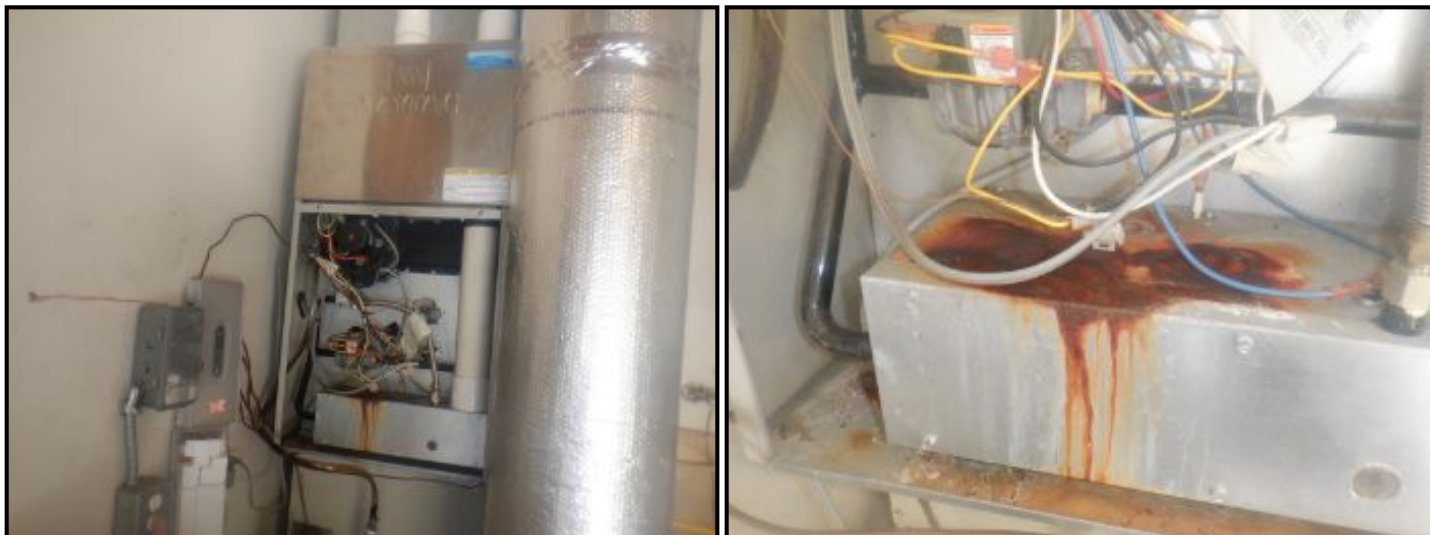
There is moisture staining at the interior of the furnace indicating a past moisture issue. At the time of the inspection no current active leaking was noted. We recommend contacting a qualified HVAC contractor for evaluation.

Staining at interior of furnace

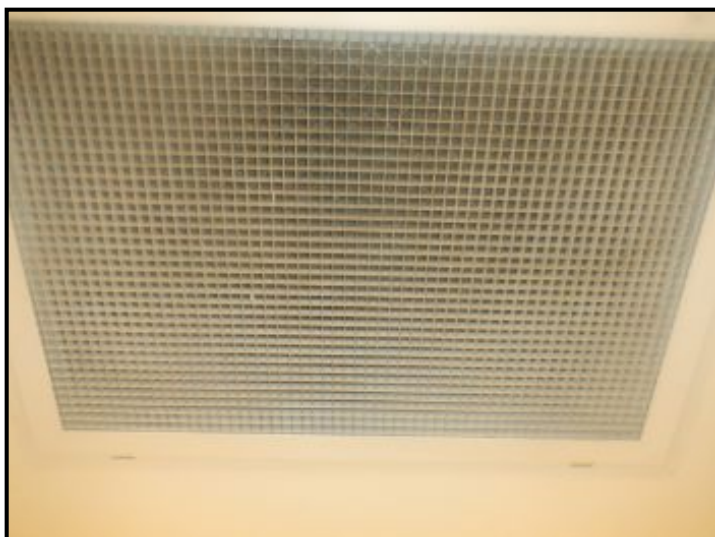
The furnace filters are in need of changing. This can restrict proper airflow and reduce the efficiency of the system. The inspector recommends changing or cleaning the filter on a regular basis as needed.

Replace air return filters.

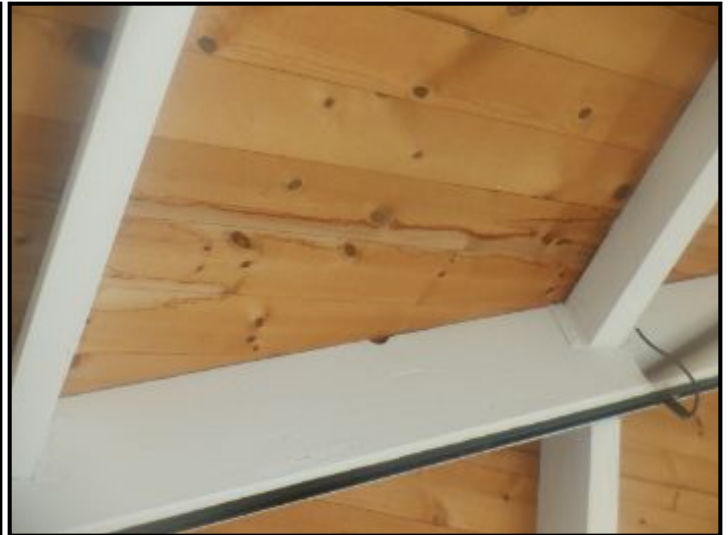
Moisture staining at loft ceiling.

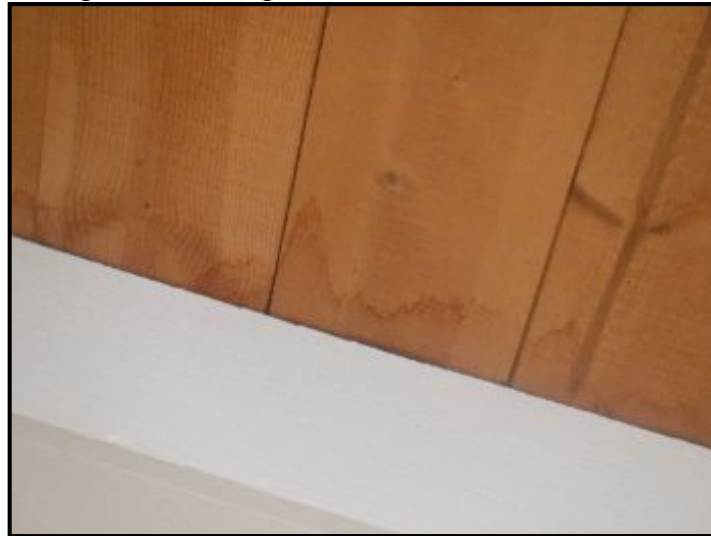
Moisture staining at ceiling.

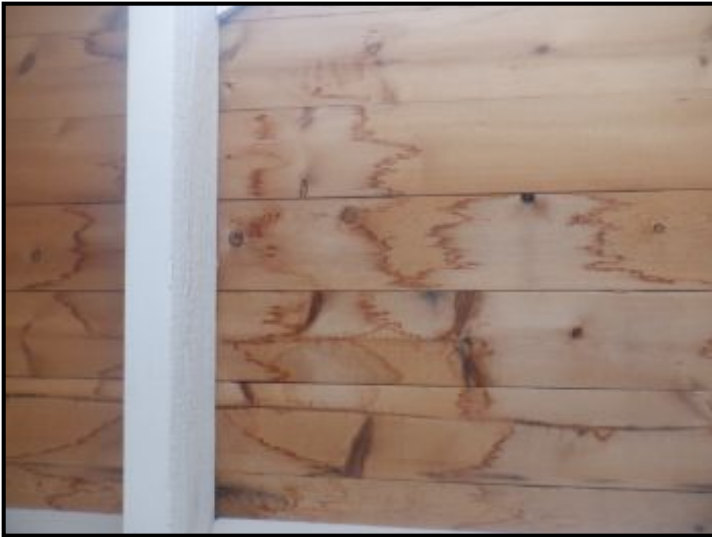
Moisture staining below skylight.

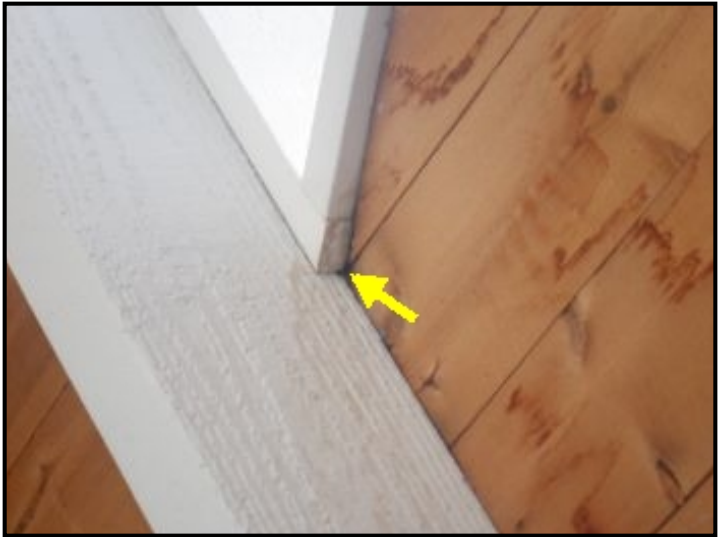
Moisture staining at skylight.

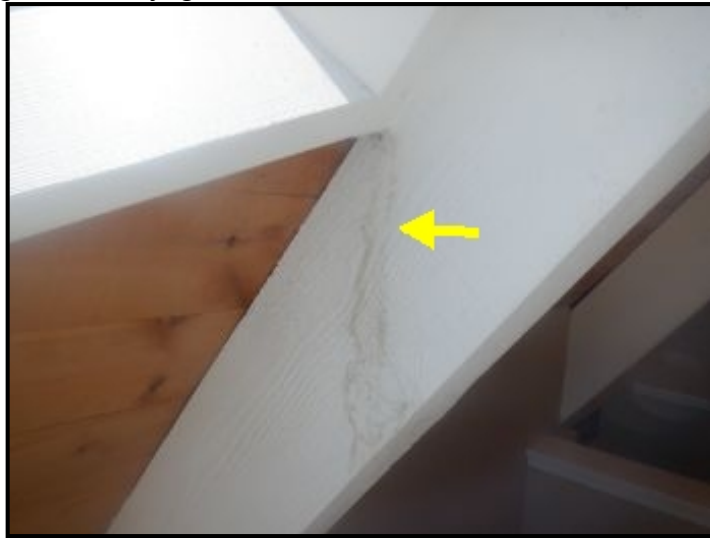
Moisture staining at skylight.

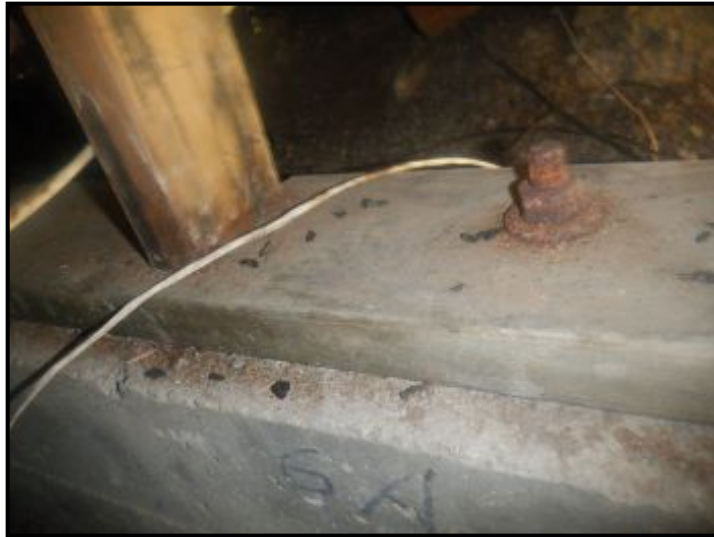
Rodent droppings in sub area.
