Gage Inspection Services

Property Inspection Report

1617 Ronne Dr, Santa Rosa, CA 95404
Inspection prepared for: Bill Cileo
Real Estate Agent: Doug Swanson -

Date of Inspection: 7/13/2023 Time: 9:00 AM
Order ID: 1344

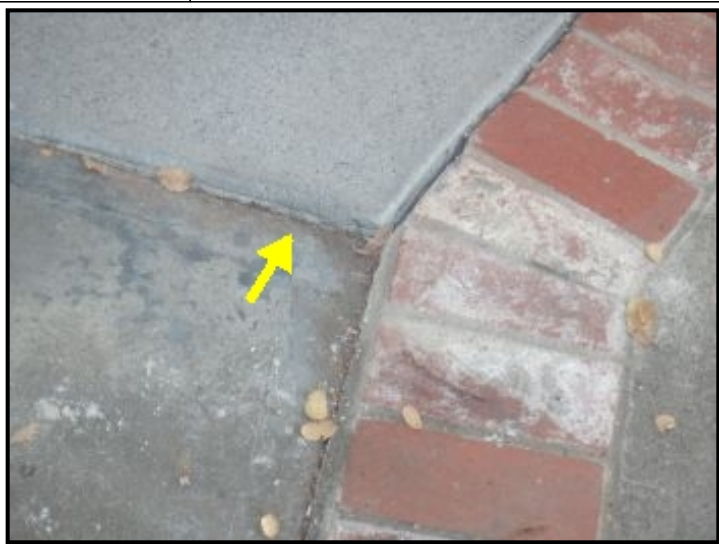
Page 14 Item: 2	Walkways	<p>Attention There are some uneven concrete walkways at the driveway area that may cause potential tripping hazards. Repairs/patching is recommended as a health and safety consideration.</p>
-----------------	----------	--

Uneven concrete walkway at front of home.

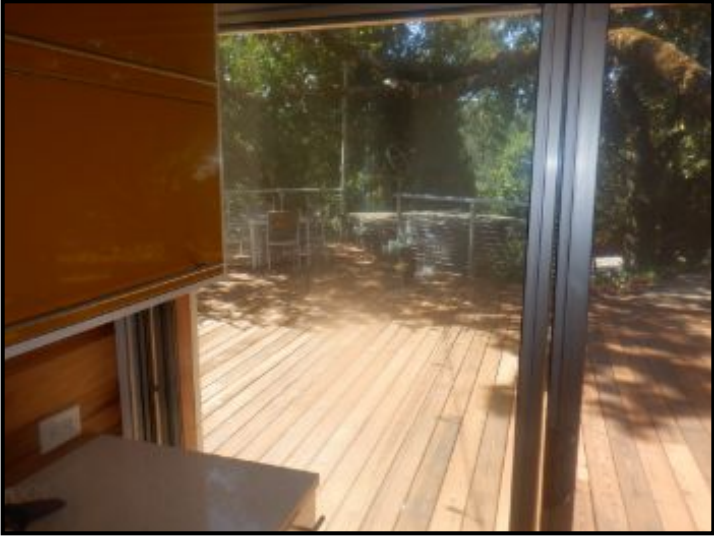
Page 15 Item: 9	Double Pane Seals/Insulating Windows	<p>Maintenance There is a double pane insulating window that has lost the vacuum seal between the panes of glass. The location is the glass slider in the kitchen. The conditions is identified by signs of fogging, a halo effect or condensation build up between the panes of glass. Recommend contacting a glass company for complete window evaluation and estimates for replacement. The deficiency on any other windows is sometimes only visible under certain climatic conditions.</p>

<p>Lost seal at glass slider.</p>		
Page 16 Item: 12	Retaining Walls	<p>Maintenance There is damage to the bottom of the posts at the granny unit brick foundation wall. One of the posts appears to be support at the end of a beam. Future replacement of the support post with pressure treated wood is recommended. Contact a qualified contractor for evaluation.</p> <p>UPON REINPSECTION ON 7/17/23 THE DAMAGED SECTIONS OF POSTS AT THE BRICK FOUNDATION WALL HAVE BEEN REMOVED WITH NEWER PRESSURE TREATED WOOD MEMBERS INSTALLED.</p>

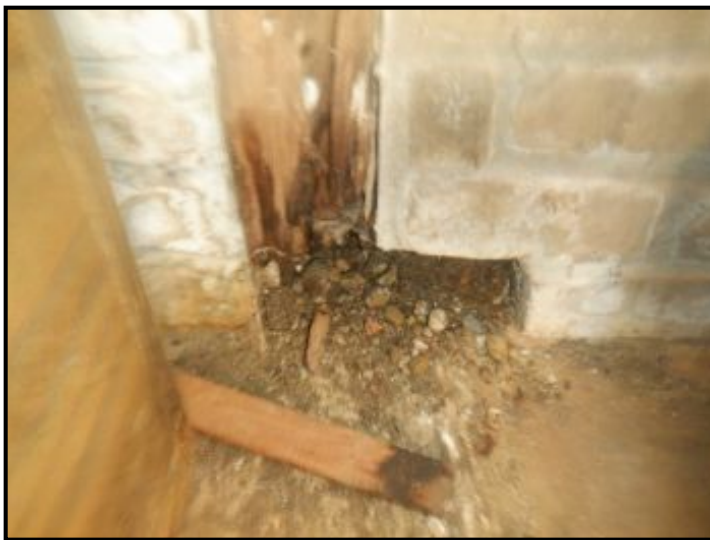
Post damage at brick foundation.

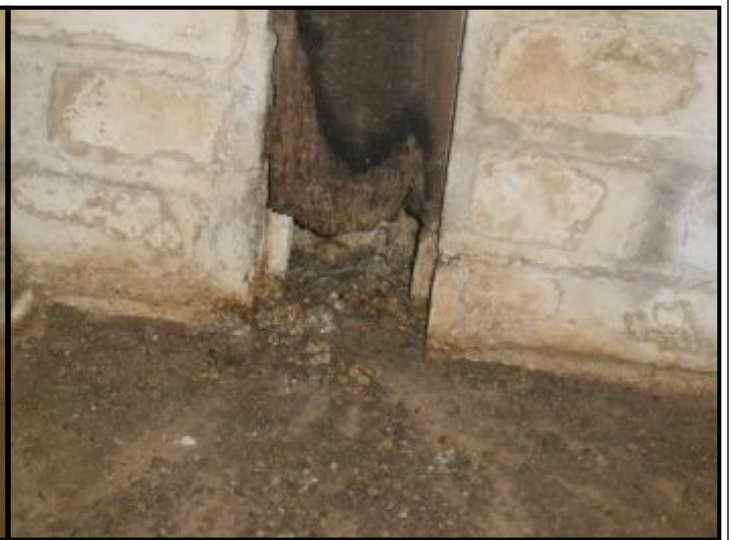
Post damage at brick walls.

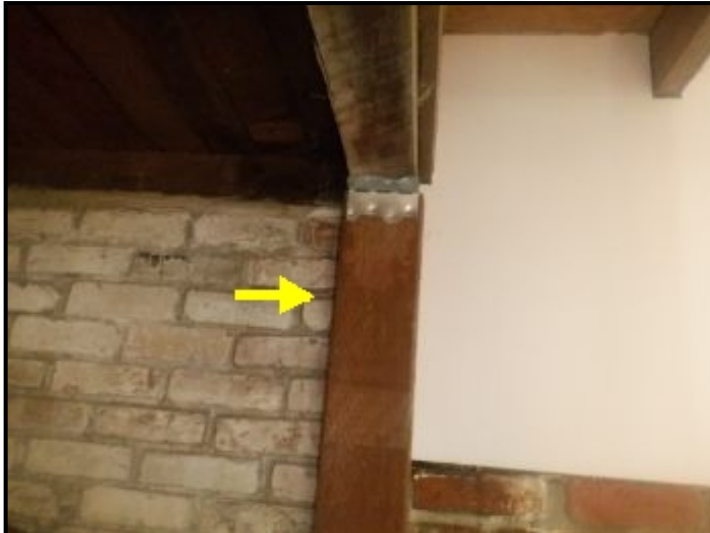
Damaged posts replaced under granny unit.

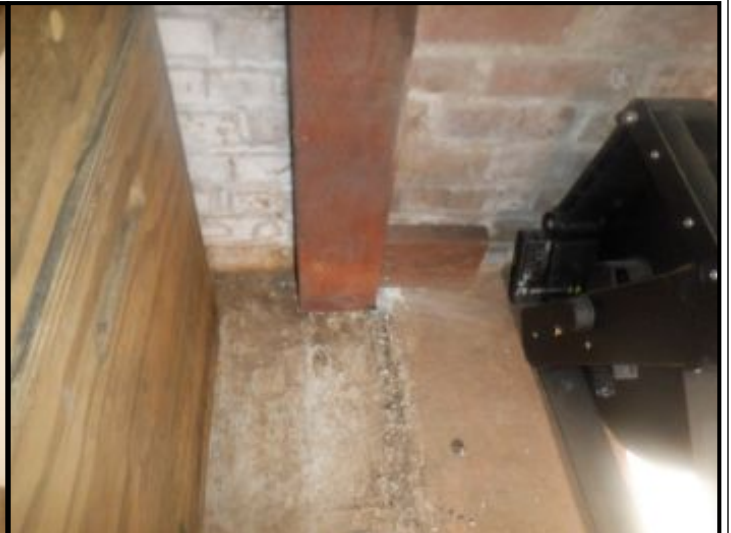
Damaged wood members replaced under granny unit.

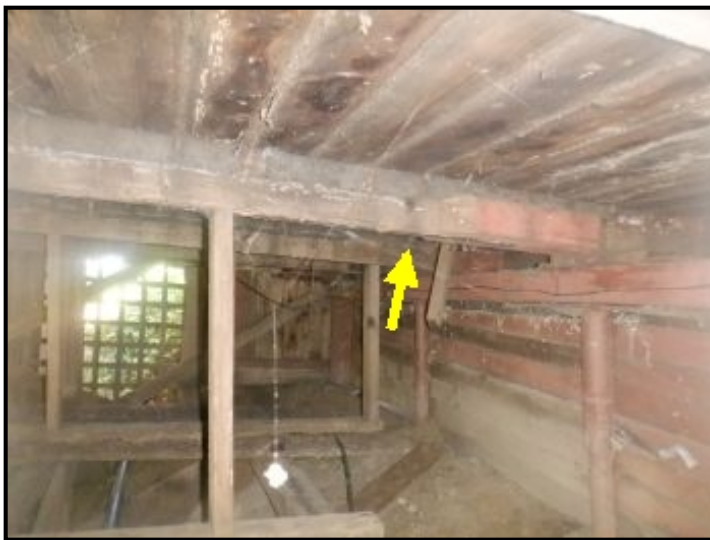
Page 20 Item: 4	Foundation/Framing	<p>Maintenance</p> <p>There is a small portion of the deck that has older framing members installed. There was wood damage, sagging support beams sub standard supports and missing fasteners to the framing at the under side of this portion of decking. Majority of the deck is modern pressure treated framing. We recommend contacting a qualified contractor for evaluation and recommendations for repairs.</p> <p>There is what appears to be fungus growth to wood members at the older section of the deck. Wood destroying organisms and or decay/fungal rot at any location within the subject property is not within the scope of this home inspection. This company is not a state licensed pest control company. Review the current pest report for any related conditions.</p> <p>UPON REINSPECTION ON 2/17/23 IT WAS NOTED THAT THE OLDER DAMAGED SECTIONS OF DECK FRAMING HAVE BEEN REMOVED AND REPLACED WITH PRESSURE TREATED FRAMING AND THE APPROPRIATE FASTENERS AND SUPPORTS AS NEEDED.</p>

Sagging support beam under deck.

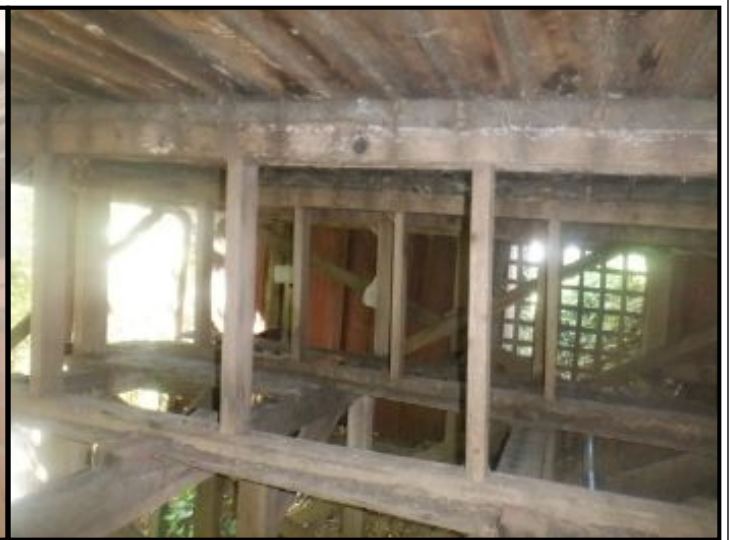
Sub standard and damaged supports under deck.

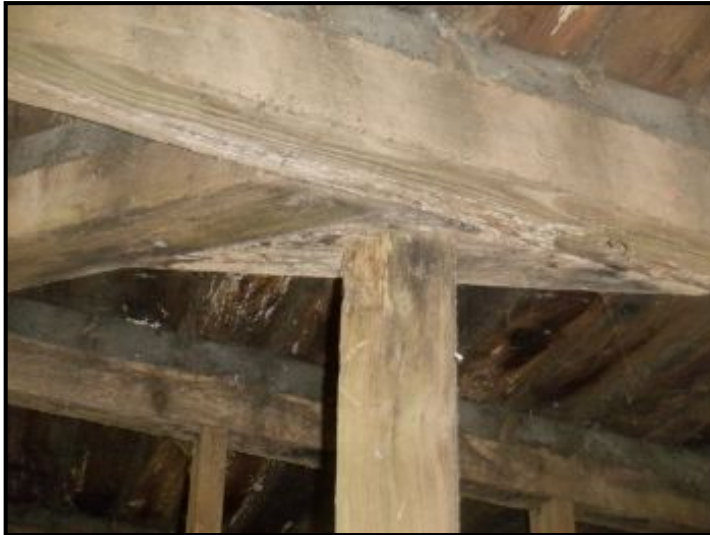
Damage to under side of deck.

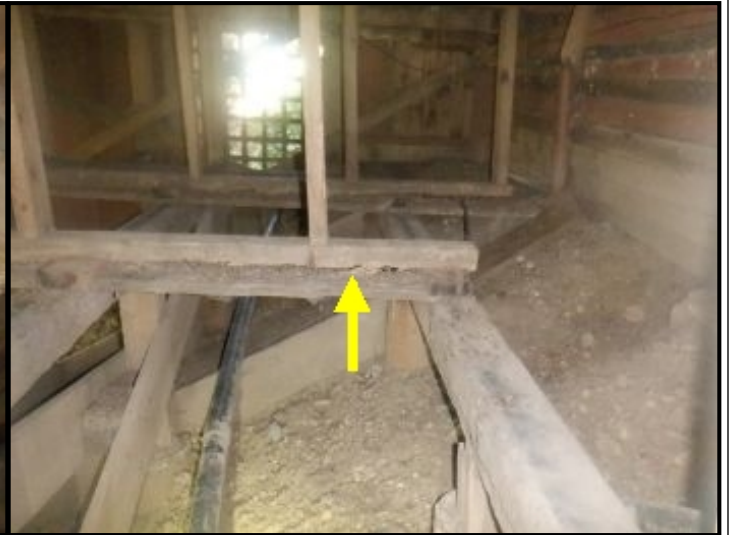
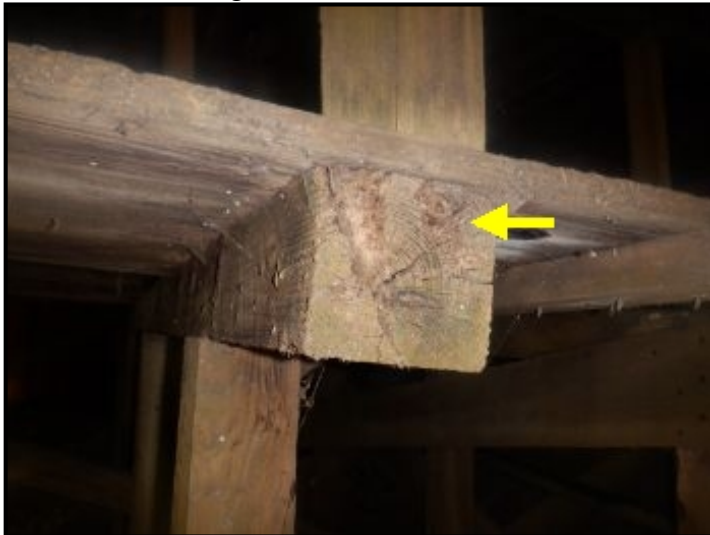
Damage to framing under deck.

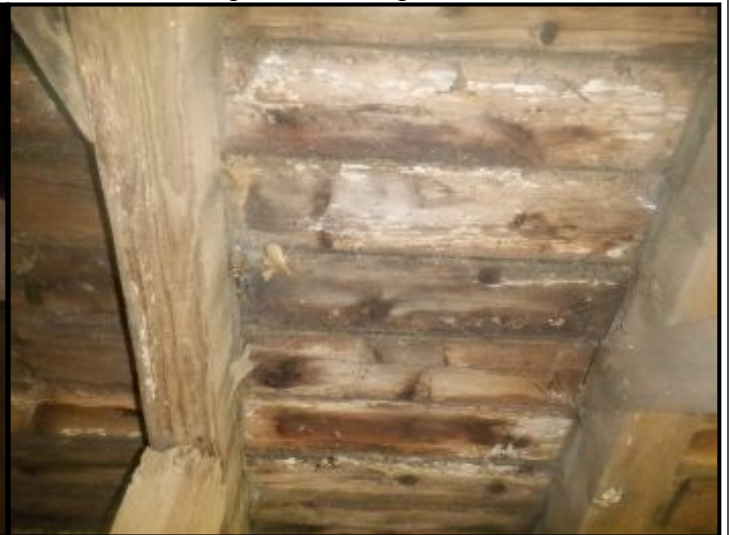
Fungus to under side of deck.

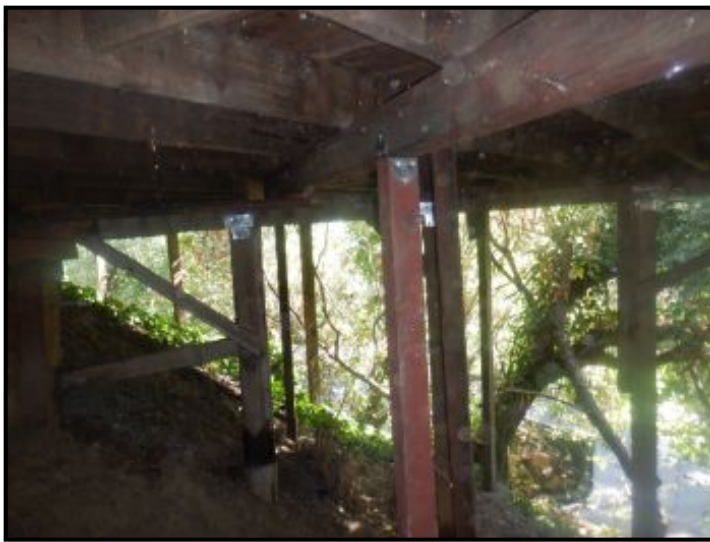
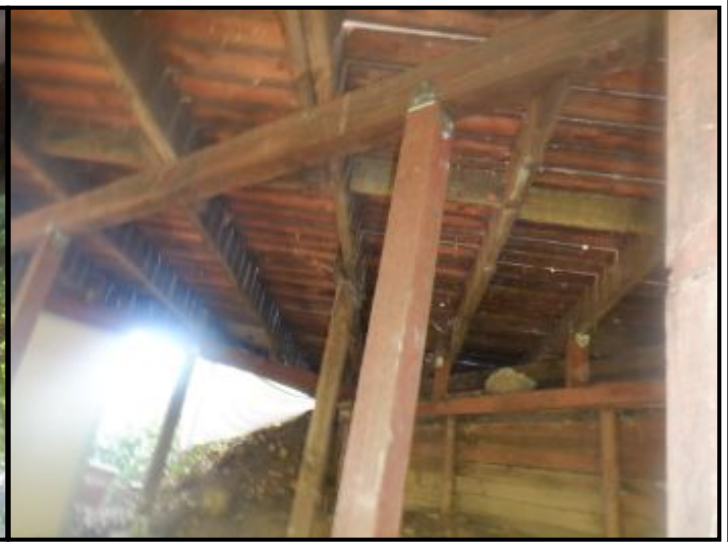
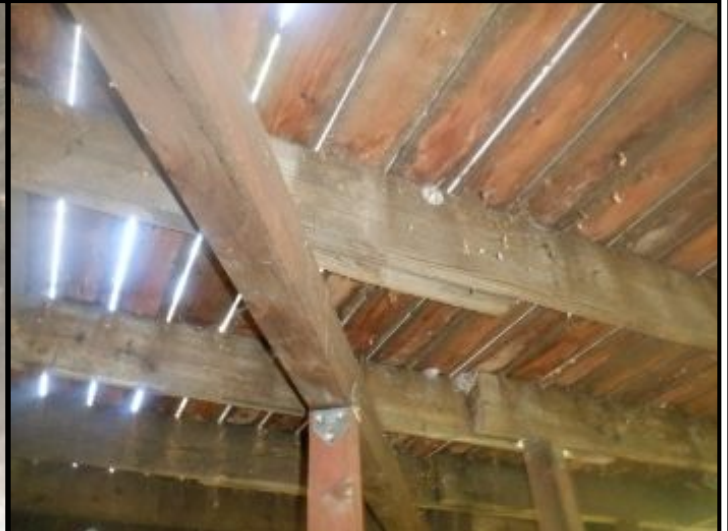
New deck framing installed.

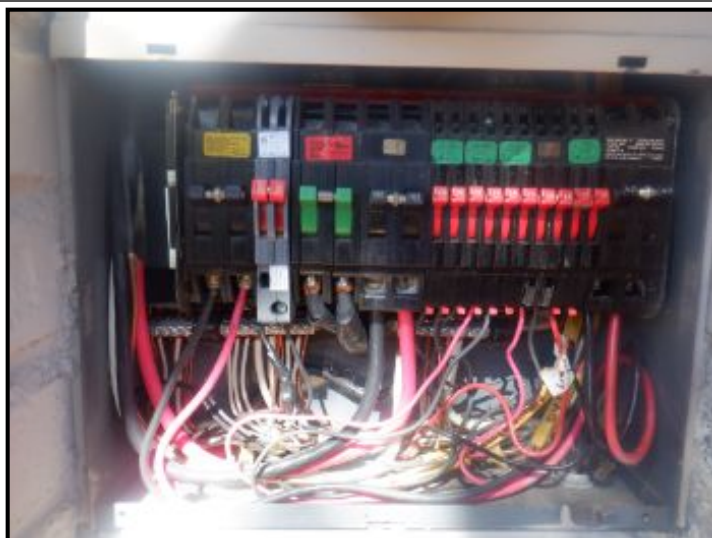
<p>Page 38 Item: 7</p>	<p>Breaker Configuration</p>	<p>Maintenance The main electrical panel is a Zinsco brand panel. This product line is discontinued and several reports of failure over time with this equipment has been report. Failures include excessive corrosion and loose connections at the bus bar, many times leading to poor breaker connections arching and over heating. Although no adverse conditions were noted inside this particular panel, due to its historically poor reliability, electricians often advocate replacement. We suggest consulting with a qualified and licensed electrician on this issue.</p>
------------------------	------------------------------	---

Zinsco panel installed at home.

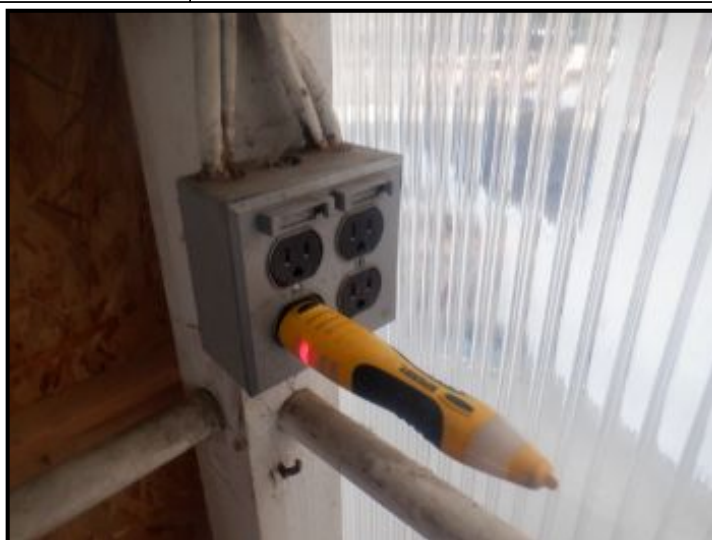
The inspector has discovered on or more three prong 110 volt outlets that do not have a correct ground in the garage. This is a common condition to homes of this age. For more information on ground receptacles contact a qualified electrician for evaluation.

Ungrounded outlets in garage.

UPON REINPSECTION ON 4/27/23 THE UNGROUND ELECTRICAL OUTLETS IN THE GARAGE WERE REMOVED.

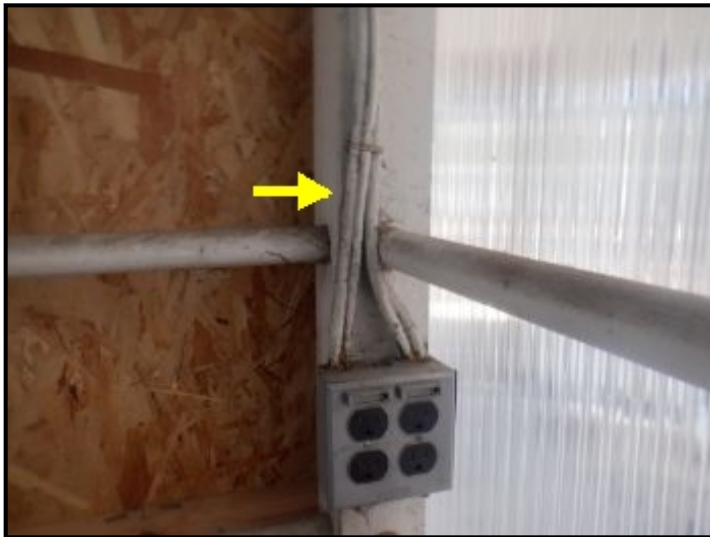
<p>Page 40 Item: 12</p>	<p>Outlets, Switches, Junction Boxes, Lighting, Misc</p>	<p>Attention</p> <p>Unprotected Romex wiring was noted in the garage. Electrical cable is subject to physical damage and is typically installed in attics and inside walls. Any exposed wiring must be protected from damage below the height of 7 feet. Repairs should be made to properly protect the wiring system inside conduit. Contact a qualified electrician for repairs.</p> <p>UPON REINSPECTION ON 7/17/23 IT WAS NOTED THAT THE SECTION OF THE UNPROTECTED ROMEX WIRING IN THE GARAGE WAS REMOVED WHILE OTHER EXPOSED WIRING WAS ENCLOSED INSIDE OF PROTECTIVE CONDUIT.</p>
-------------------------	--	---

Unprotected Romex in garage area.

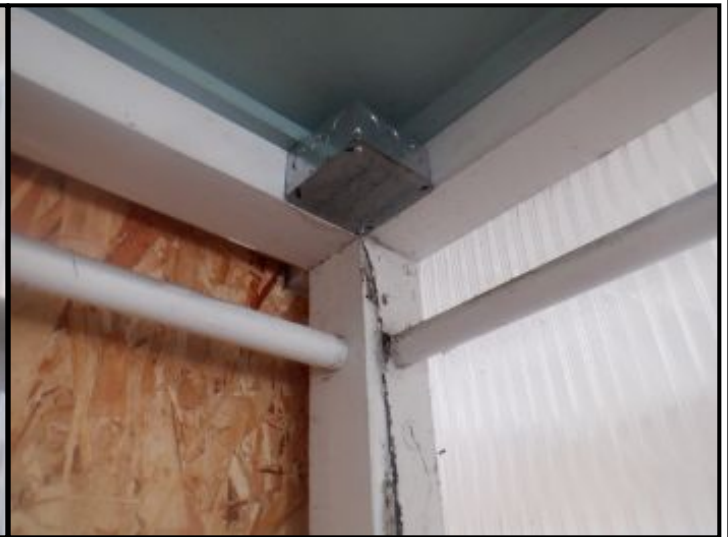
Exposed electrical removed.

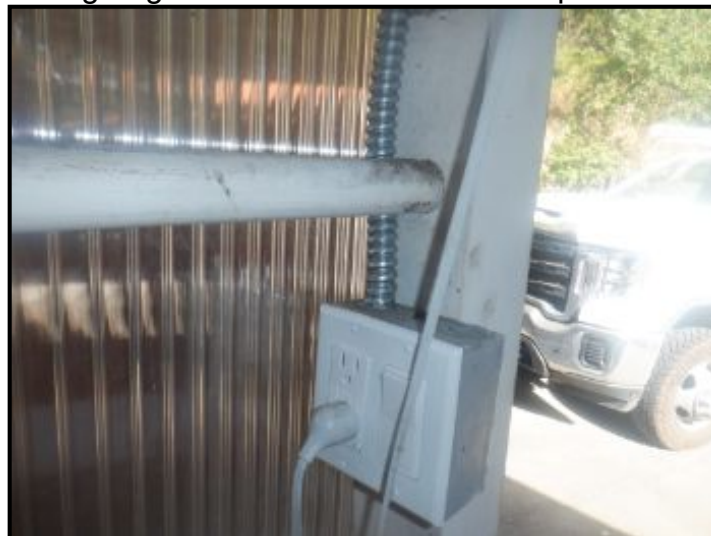
Conduit installed at exposed electrical.

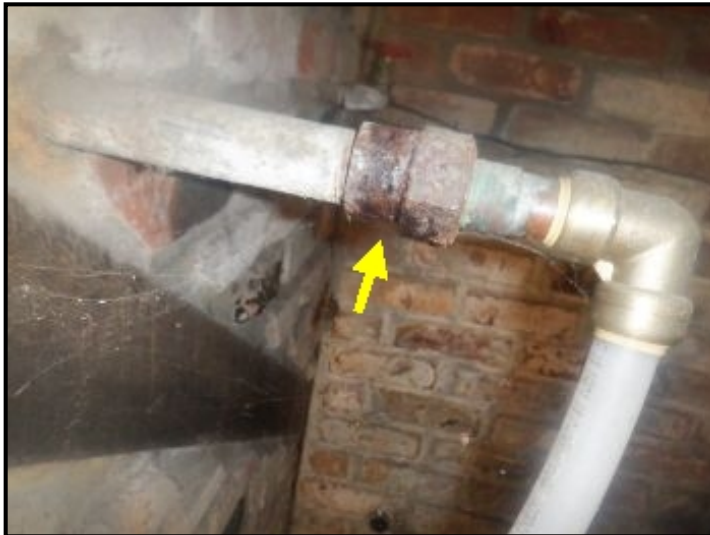
Page 42 Item: 8	Evidence Of Leaks	<p>Maintenance</p> <p>The inspector has found evidence of a plumbing leak. We advise the use of a qualified plumbing contractor to make final determination of the cause and to provide estimates for repairs. Location of the leak is a supply line fitting under the granny unit.</p> <p>UPON REINSPECTION ON 7/17/23 THE LEAKING PLUMBING WAS REMOVED UNDER THE GRANNY UNIT.</p>
-----------------	-------------------	---

Leaking at supply line under granny unit.

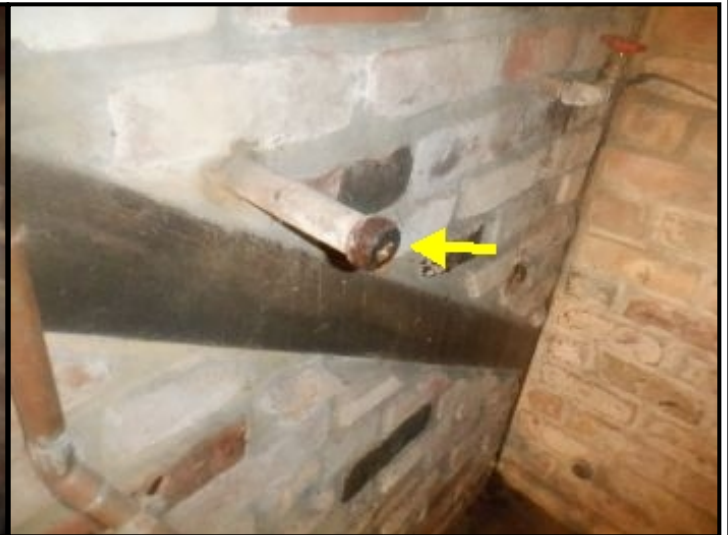
Old leaking plumbing removed.

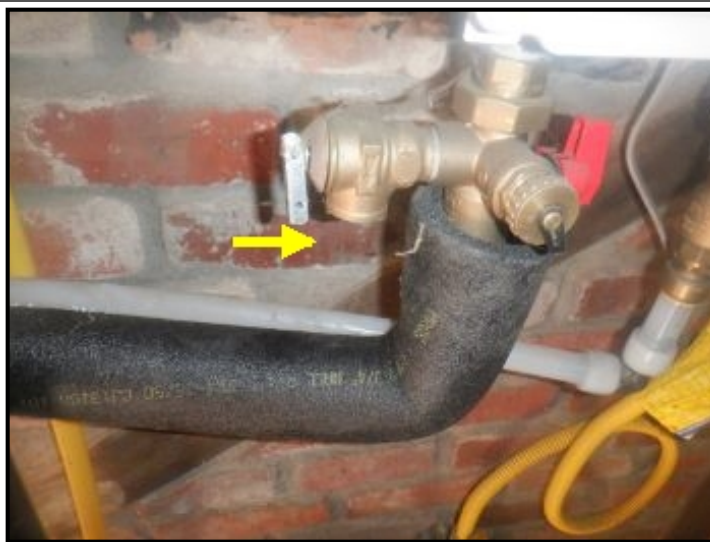
Page 45 Item: 7	Discharge Pipe	<p>Maintenance</p> <p>There is no discharge pipe installed at the water heater TPRV under the granny unit. Installation of a proper drain line discharging no more than 6" above the ground is needed as a health and safety consideration.</p> <p>UPON REINSPECTION ON 7/17/23 THE DISCHARGE LINE AT THE WATER HEATER WAS PROPERLY INSTALLED.</p>
-----------------	----------------	--

Missing drain pipe at water heater TPR valve.

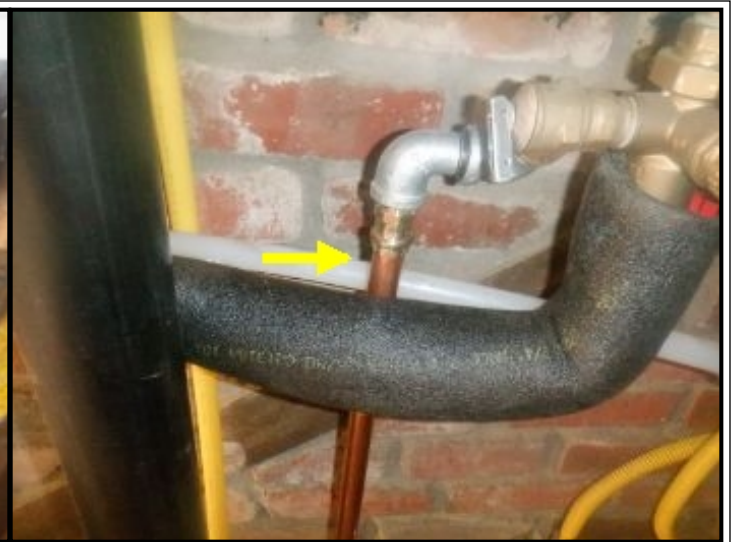
Discharge pipe installed at water heater.

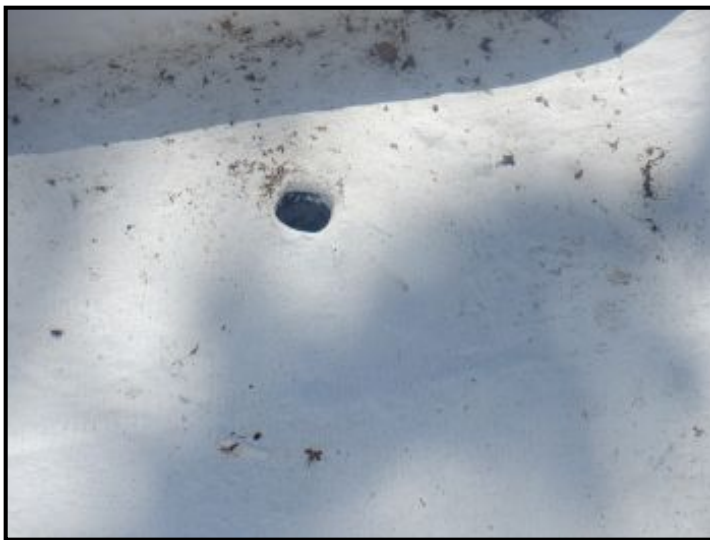
It is recommended to install screens at the roof top drains to help prevent potential debris blockage.

Install screens at drains to prevent blockage.

UPON REINSPECTION ON 7/17/23 SCREENS HAVE BEEN INSTALLED AT THE ROOF TOP DRAINS TO PREVENT BLOCKAGE AND THE DOWNSPOUT WAS SECURED TO THE STRUCTURE.

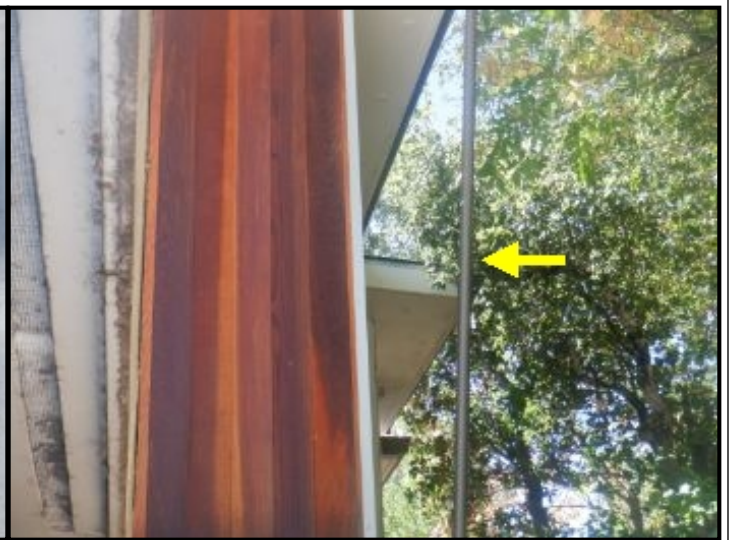
There are down spouts that are not secured to the structure. It is recommended to secure the downspouts to the home to maintain proper drainage.

Downspout not secured to structure.

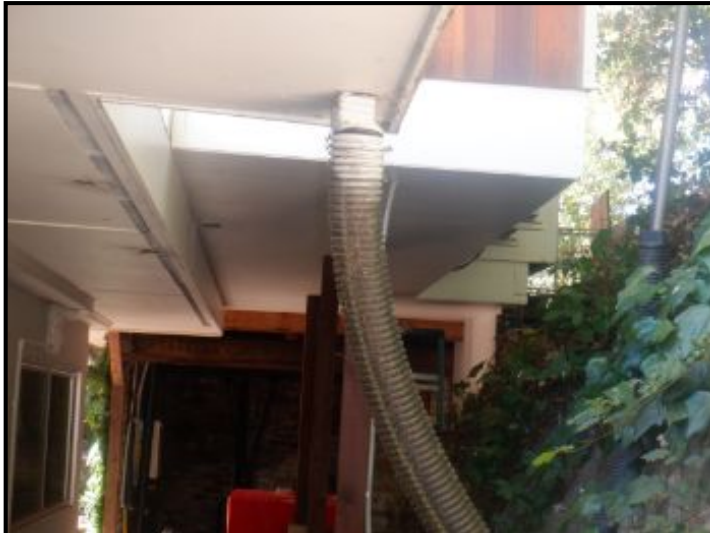
Loose drain pipe used at downspout.

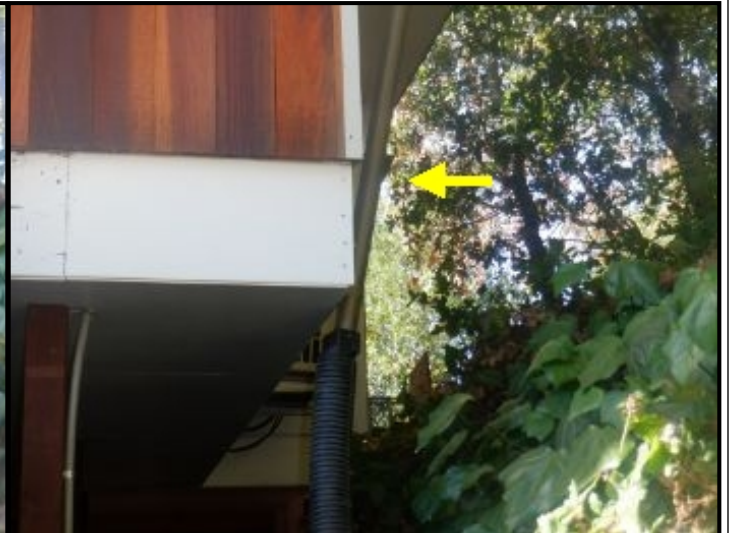
Downspout secured to structure.

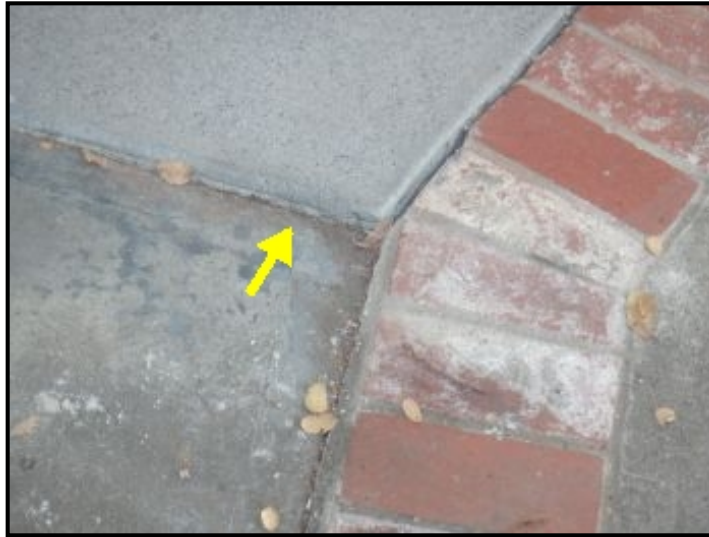
There are some uneven concrete walkways at the driveway area that may cause potential tripping hazards. Repairs/patching is recommended as a health and safety consideration.

Uneven concrete walkway at front of home.

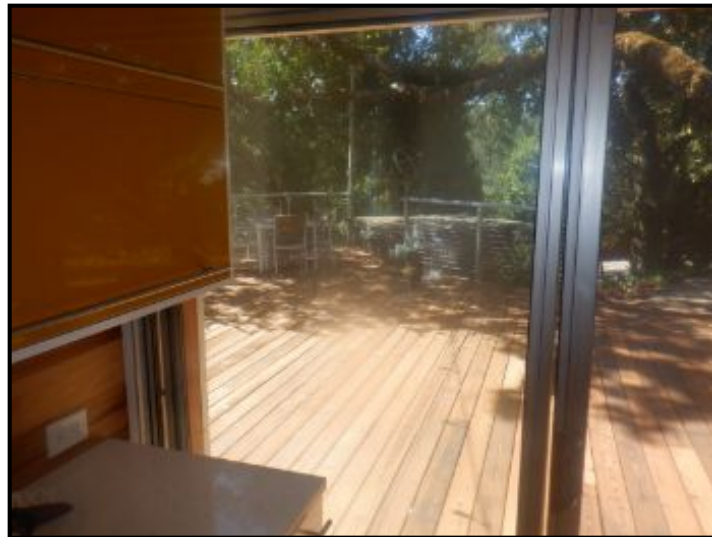
There is a double pane insulating window that has lost the vacuum seal between the panes of glass. The location is the glass slider in the kitchen. The conditions is identified by signs of fogging, a halo effect or condensation build up between the panes of glass. Recommend contacting a glass company for complete window evaluation and estimates for replacement. The deficiency on any other windows is sometimes only visible under certain climatic conditions.

Lost seal at glass slider.

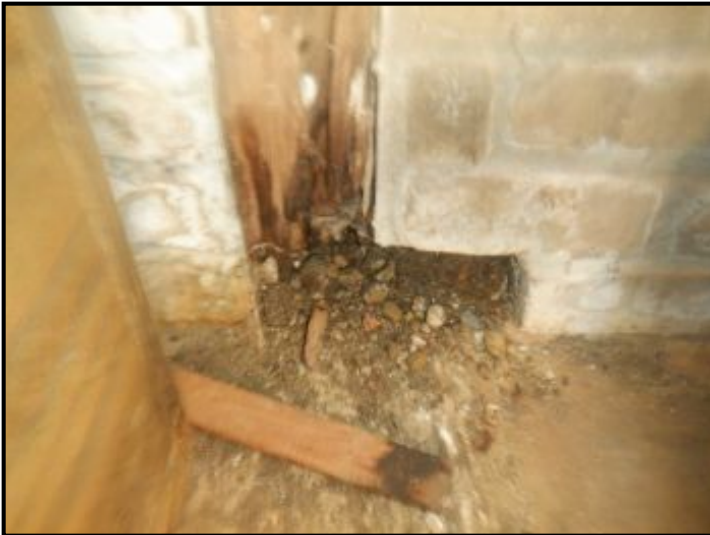
There is damage to the bottom of the posts at the granny unit brick foundation wall. One of the posts appears to be support at the end of a beam. Future replacement of the support post with pressure treated wood is recommended. Contact a qualified contractor for evaluation.

Post damage at brick foundation.

UPON REINPSECTION ON 7/17/23 THE DAMAGED SECTIONS OF POSTS AT THE BRICK FOUNDATION WALL HAVE BEEN REMOVED WITH NEWER PRESSURE TREATED WOOD MEMBERS INSTALLED.

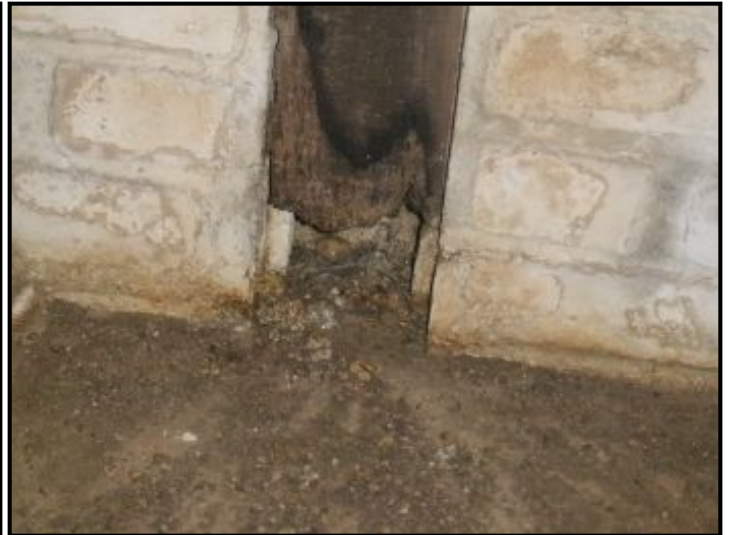
Post damage at brick walls.

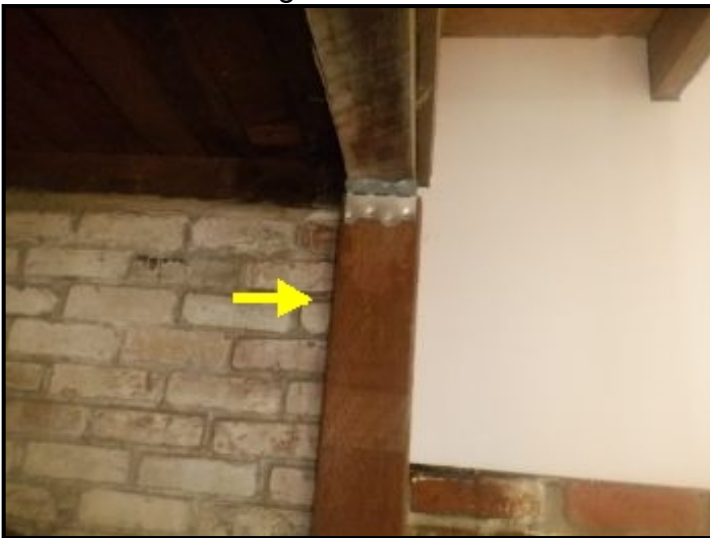
Damaged posts replaced under granny unit.

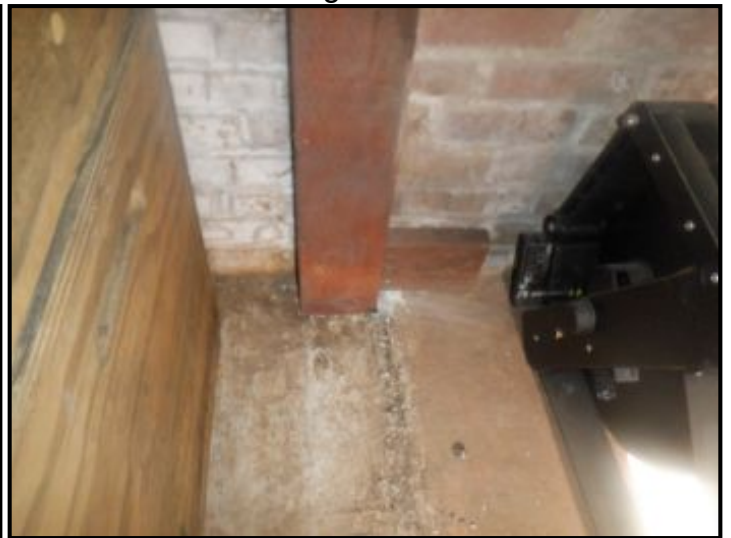
Damaged wood members replaced under granny unit.

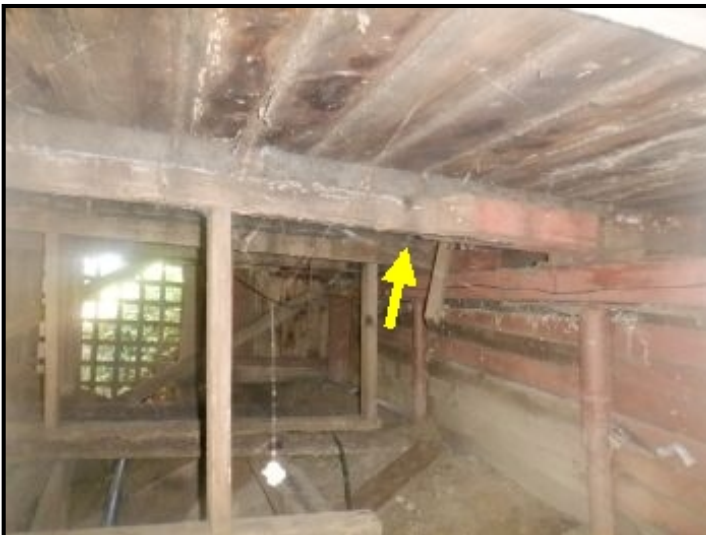
There is a small portion of the deck that has older framing members installed. There was wood damage, sagging support beams sub standard supports and missing fasteners to the framing at the under side of this portion of decking. Majority of the deck is modern pressure treated framing. We recommend contacting a qualified contractor for evaluation and recommendations for repairs.

Sagging support beam under deck.

UPON REINSPECTION ON 2/17/23 IT WAS NOTED THAT THE OLDER DAMAGED SECTIONS OF DECK FRAMING HAVE BEEN REMOVED AND REPLACED WITH PRESSURE TREATED FRAMING AND THE APPROPRIATE FASTENERS AND SUPPORTS AS NEEDED.

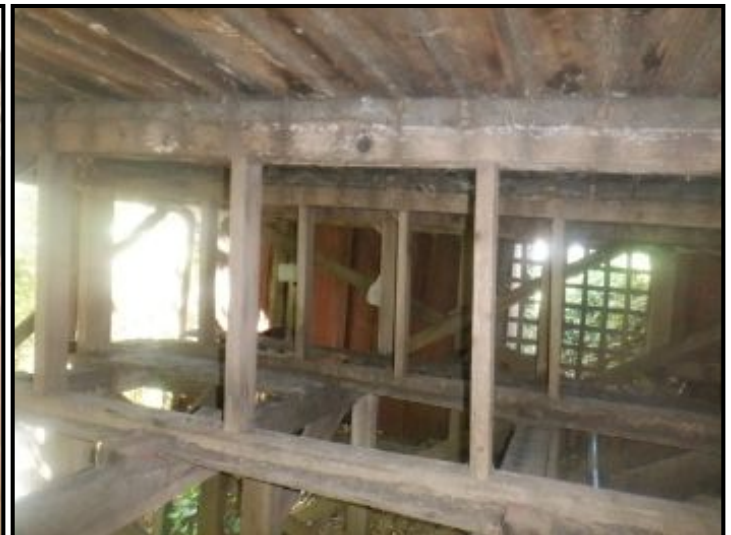
Sub standard and damaged supports under deck.

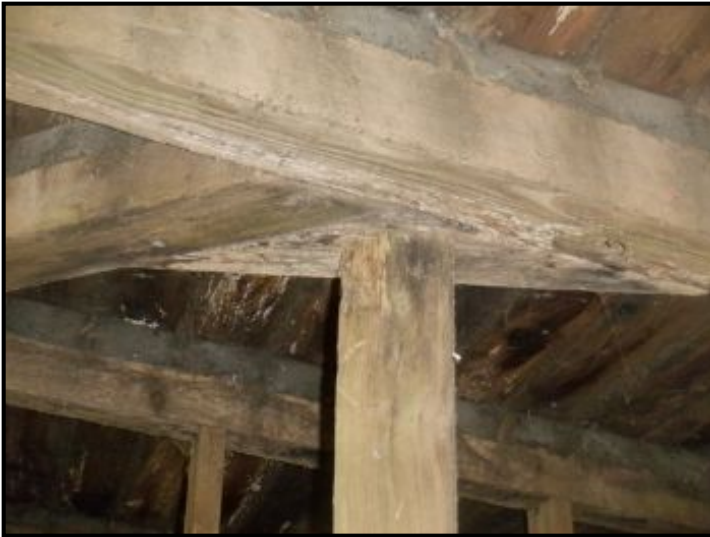
Damage to under side of deck.

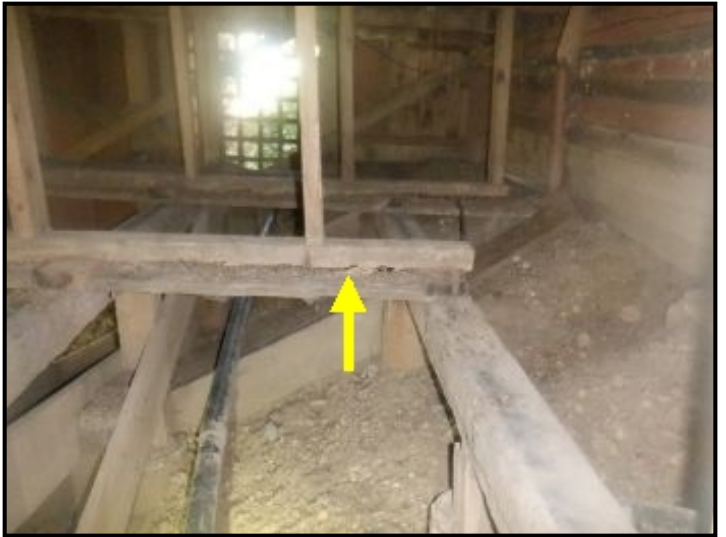
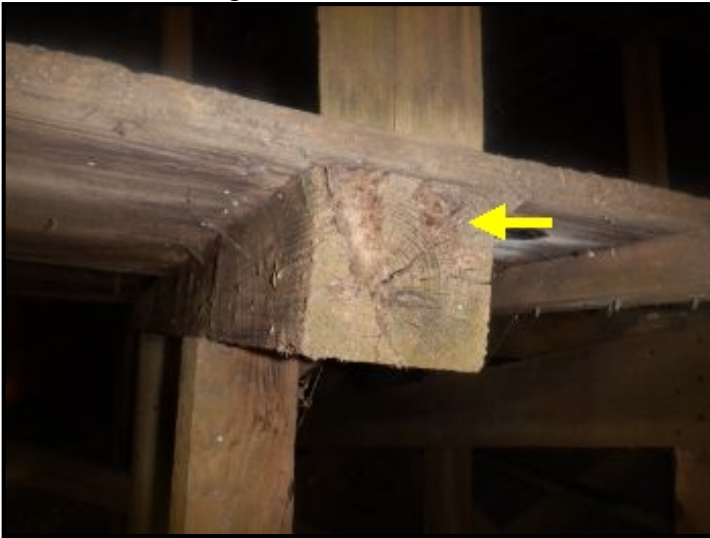
Damage to framing under deck.

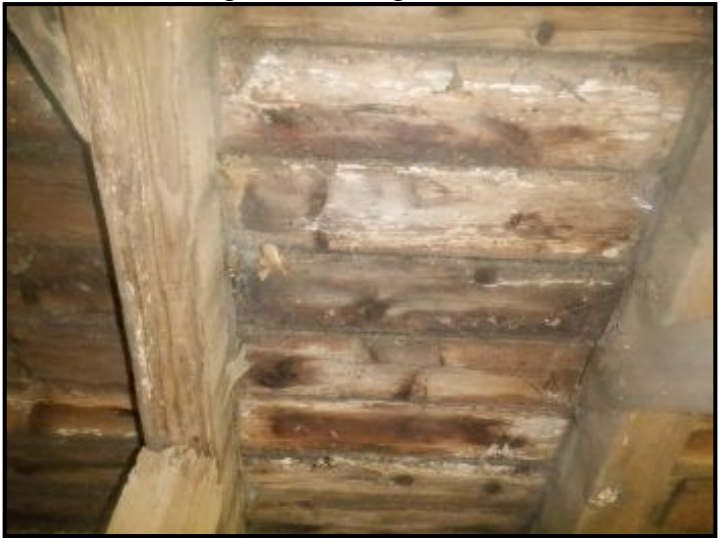
There is what appears to be fungus growth to wood members at the older section of the deck. Wood destroying organisms and or decay/fungal rot at any location within the subject property is not within the scope of this home inspection. This company is not a state licensed pest control company. Review the current pest report for any related conditions.

Fungus to under side of deck.

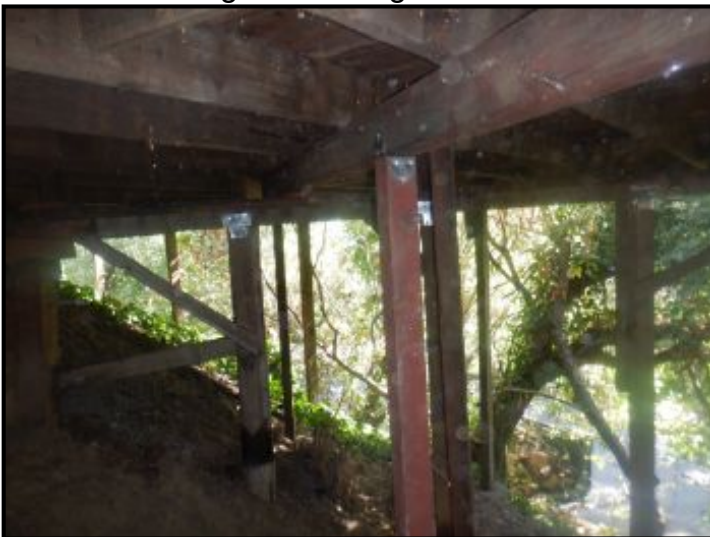
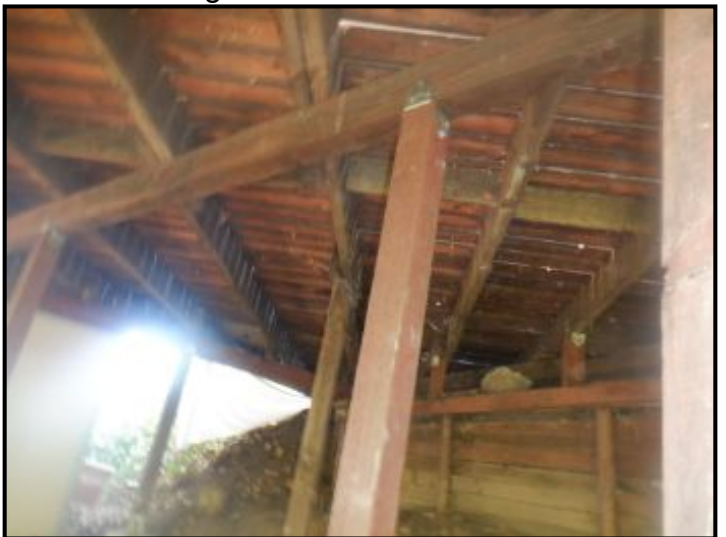
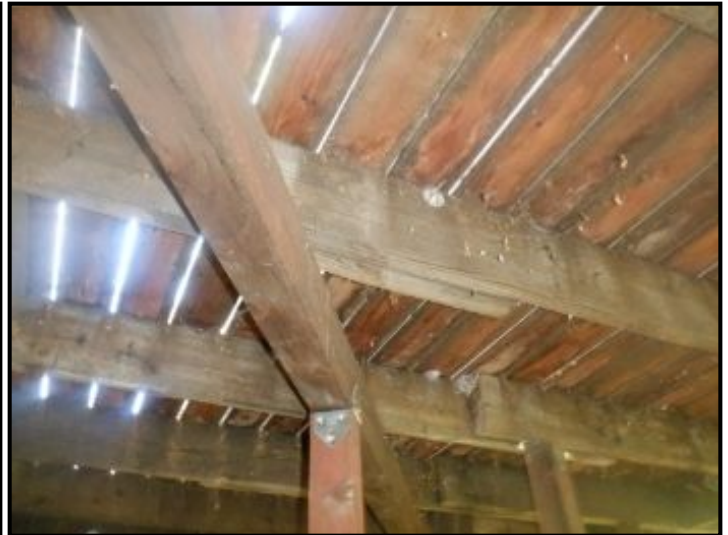
New deck framing installed.

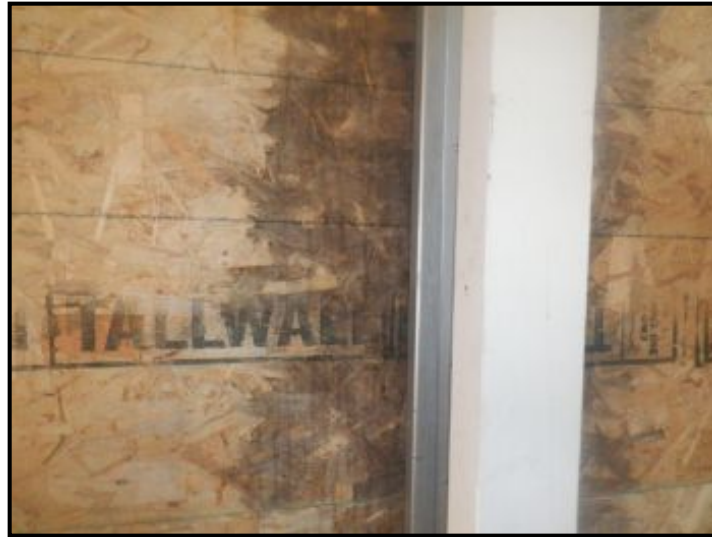
There is moisture staining noted to the OSB boards on the garage. It was not determined if this is caused by a current active moisture issue. No major adverse conditions were noted at the time of the inspection. It is recommended to keep the exterior wood members in a well sealed condition as part of preventative maintenance.

Moisture staining to garage door.

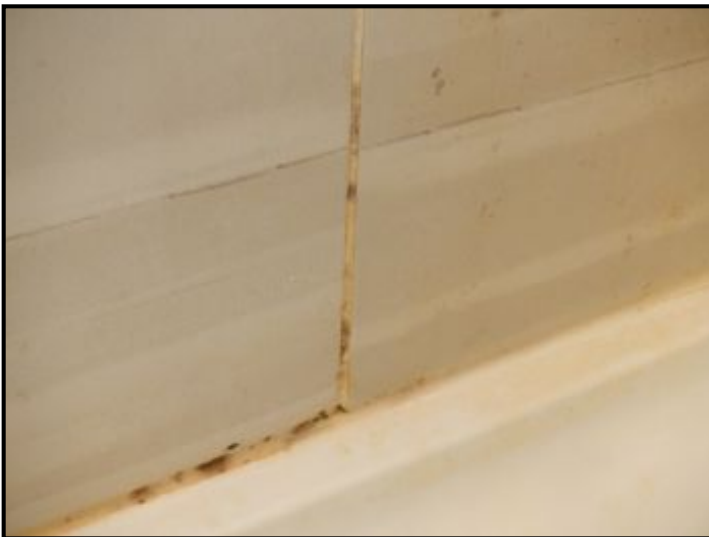
• There is mildew noted to the caulking around the granny unit shower. Mildew in the bathroom can be a health hazard, in addition to contributing to odor problems. Chemical cleaning is indicated and additional ventilation in this area should be considered.

Mildew at granny unit shower caulking.

• UPON REINPECTION ON 7/17/23 THE MILDEW GROWTH WAS REMOVED AND THE SHOWER RECAULKED AT THE GRANNY UNIT.

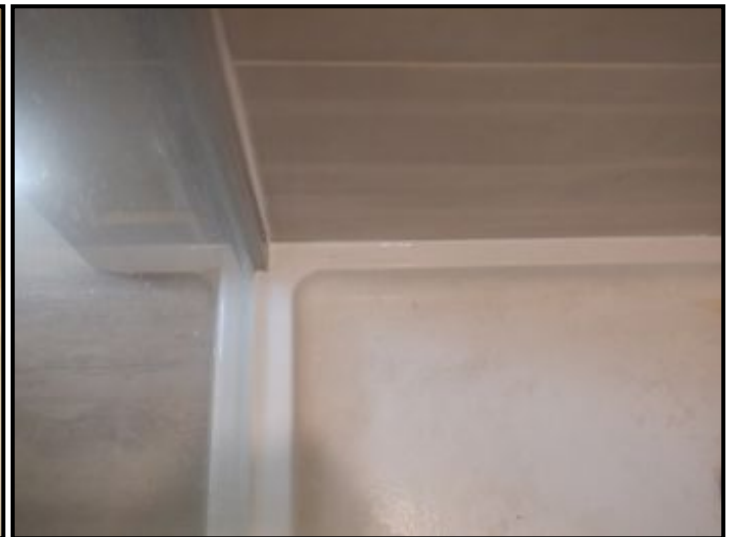
New caulking installed at granny unit shower.

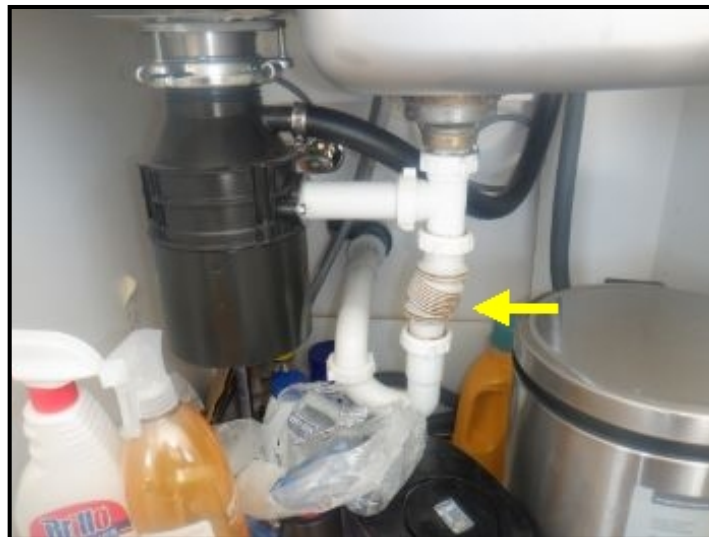
A flex drain line has been installed under the kitchen sink at the granny unit. Though functional these types of drains are known to be more susceptible to clogging. Future replacement with a rigid drain line is recommended.

Flex drain line installed in granny unit.

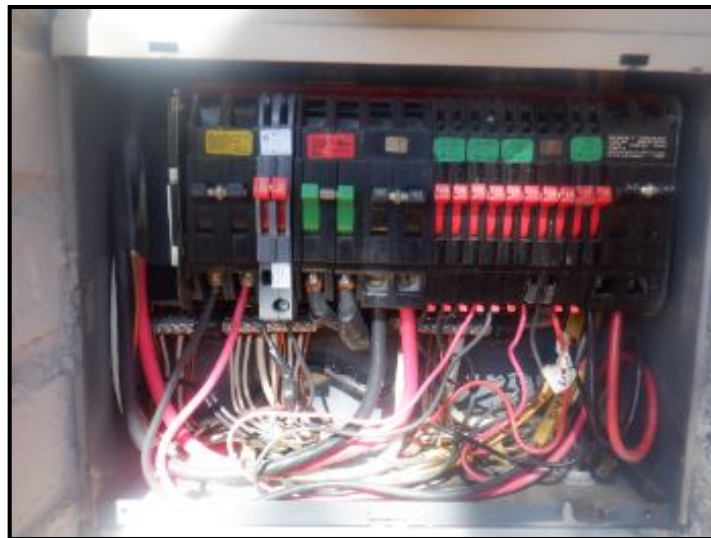
The main electrical panel is a Zinsco brand panel. This product line is discontinued and several reports of failure over time with this equipment has been report. Failures include excessive corrosion and loose connections at the bus bar, many times leading to poor breaker connections arching and over heating. Although no adverse conditions were noted inside this particular panel, due to its historically poor reliability, electricians often advocate replacement. We suggest consulting with a qualified and licensed electrician on this issue.

Zinsco panel installed at home.

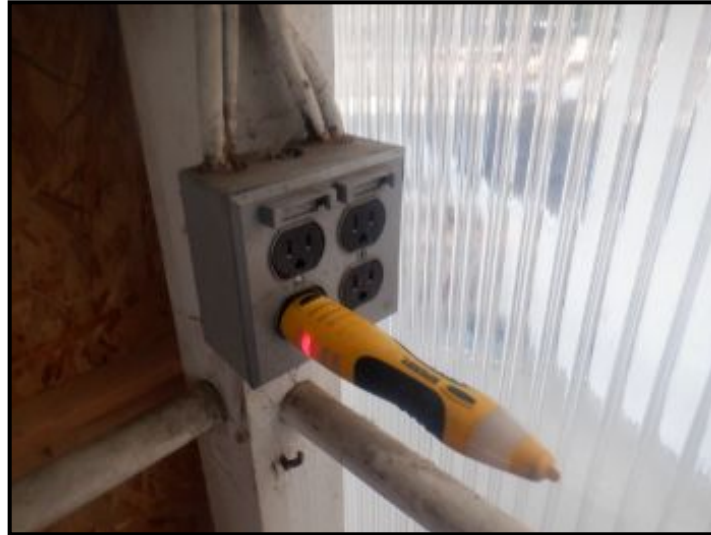
The inspector has discovered on or more three prong 110 volt outlets that do not have a correct ground in the garage. This is a common condition to homes of this age. For more information on ground receptacles contact a qualified electrician for evaluation.

Ungrounded outlets in garage.

UPON REINPSECTION ON 4/27/23 THE UNGROUND ELECTRICAL OUTLETS IN THE GARAGE WERE REMOVED.

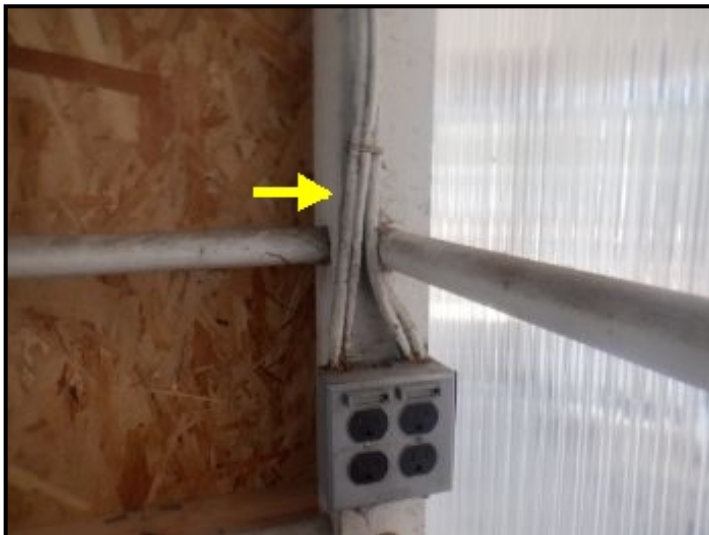
Unprotected Romex wiring was noted in the garage. Electrical cable is subject to physical damage and is typically installed in attics and inside walls. Any exposed wiring must be protected from damage below the height of 7 feet. Repairs should be made to properly protect the wiring system inside conduit. Contact a qualified electrician for repairs.

Unprotected Romex in garage area.

UPON REINSPECTION ON 7/17/23 IT WAS NOTED THAT THE SECTION OF THE UNPROTECTED ROMEX WIRING IN THE GARAGE WAS REMOVED WHILE OTHER EXPOSED WIRING WAS ENCLOSED INSIDE OF PROTECTIVE CONDUIT.

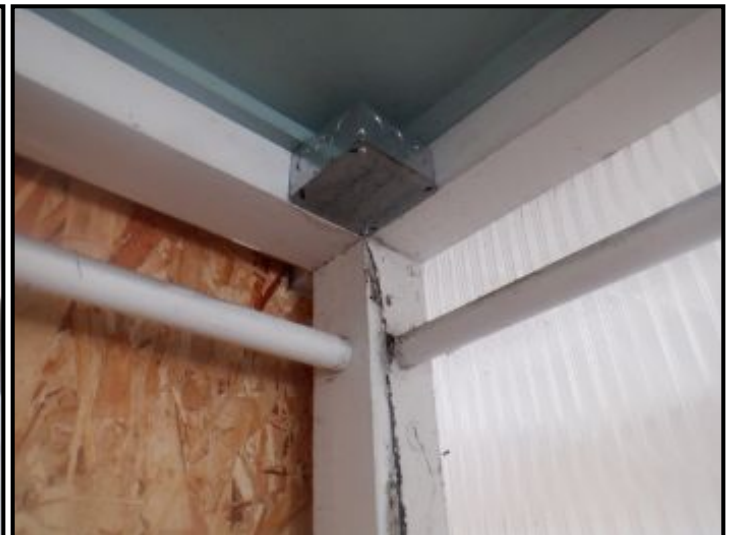
Exposed electrical removed.
