Gage Inspection Services

Property Inspection Report

1617 Ronne Dr, Santa Rosa, CA 95404
Inspection prepared for: Bill Cileo
Real Estate Agent: Doug Swanson -

Date of Inspection: 7/13/2023 Time: 9:00 AM
Order ID: 1344

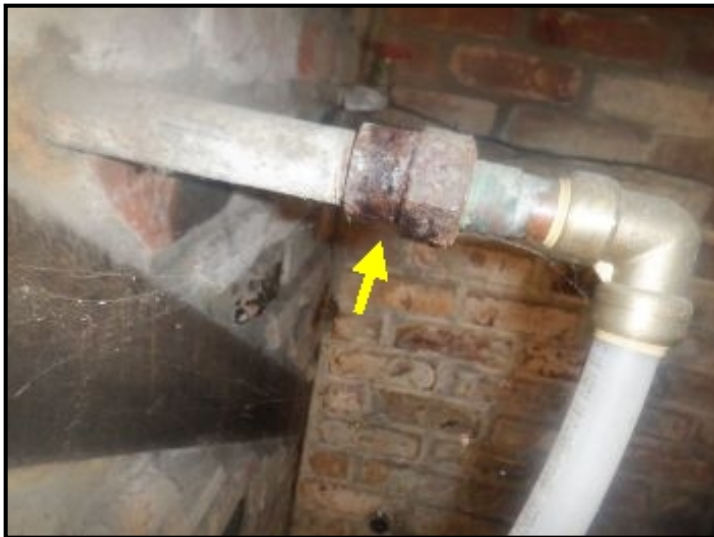
The inspector has found evidence of a plumbing leak. We advise the use of a qualified plumbing contractor to make final determination of the cause and to provide estimates for repairs. Location of the leak is a supply line fitting under the granny unit.

Leaking at supply line under granny unit.

UPON REINSPECTION ON 7/17/23 THE LEAKING PLUMBING WAS REMOVED UNDER THE GRANNY UNIT.

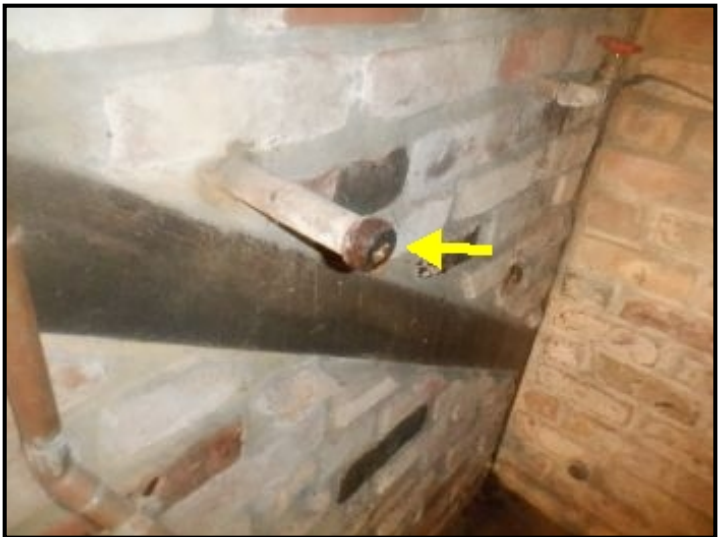
Old leaking plumbing removed.

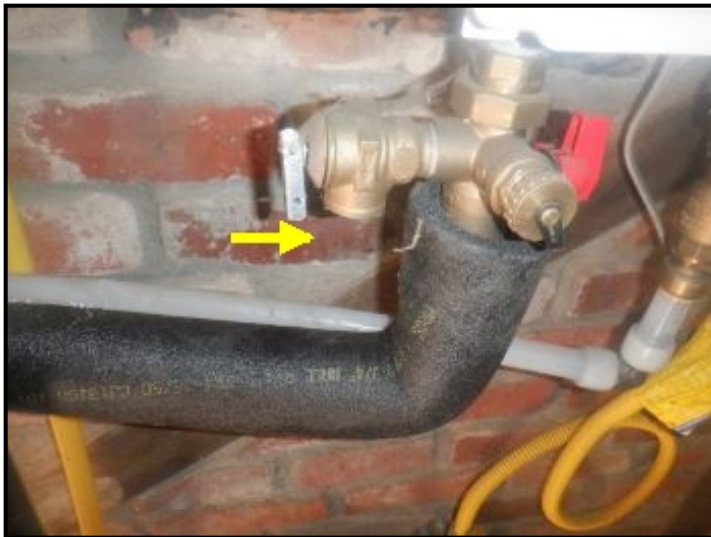
There is no discharge pipe installed at the water heater TPRV under the granny unit. Installation of a proper drain line discharging no more than 6" above the ground is needed as a health and safety consideration.

Missing drain pipe at water heater TPR valve.

UPON REINSPECTION ON 7/17/23 THE DISCHARGE LINE AT THE WATER HEATER WAS PROPERLY INSTALLED.

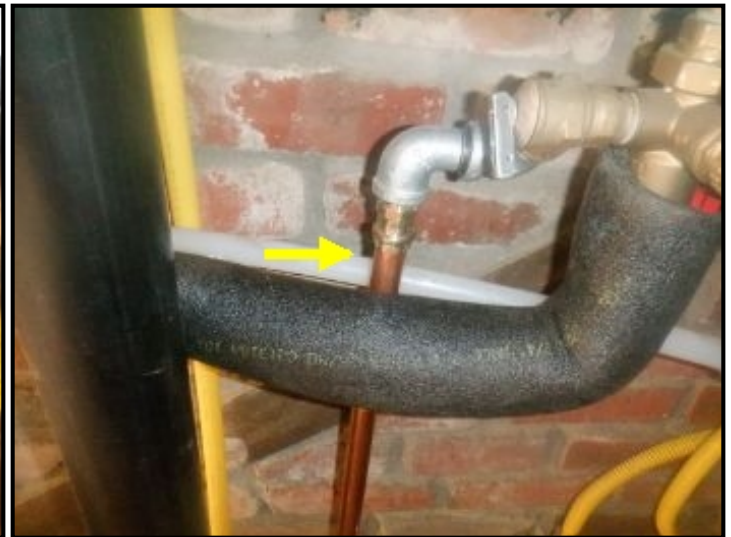
Discharge pipe installed at water heater.

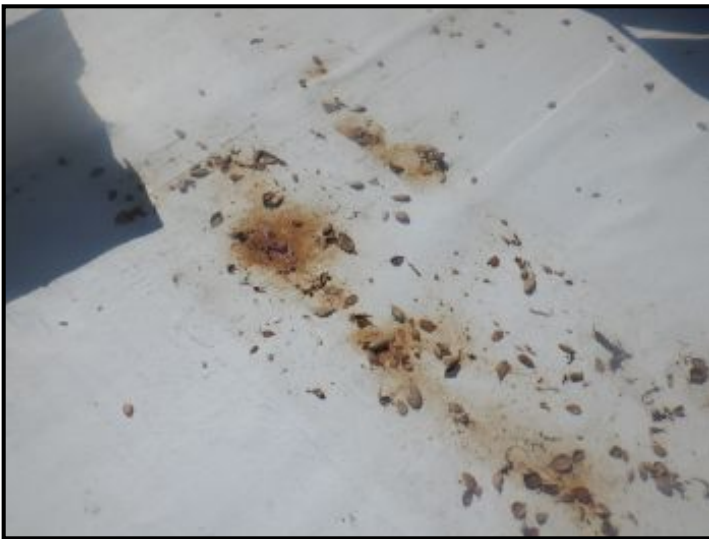
Due to the low and flat pitch roof there is staining on the roof top indicating past standing water. Excessive standing water can lead to premature deterioration. Recommend monitoring the roof top during the rains to determine if modifications are needed.

Staining indicating past standing water.

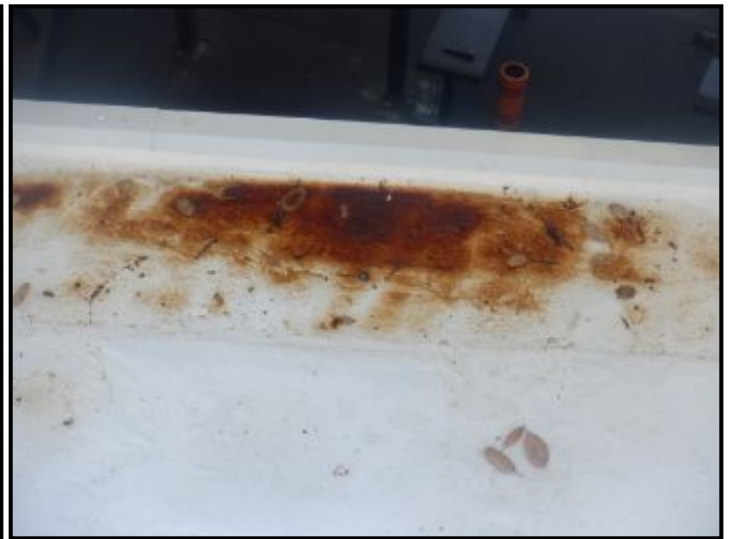
Indications of past standing water at roof top.

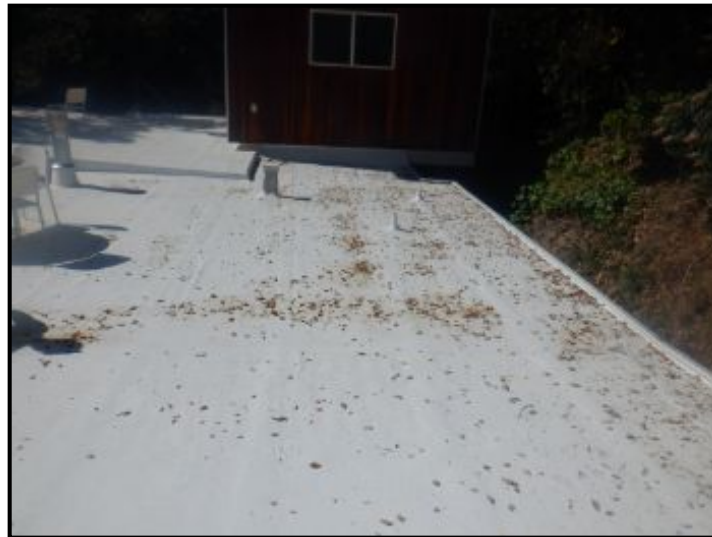
There is debris on the roof. Leaves, branches, and other material should be removed at some time in the near future. The debris can clog valleys, gutters, down spouts and or drains and cause roof leaks. Debris can hold moisture that can cause damage to the roof system if large accumulations develop. Debris should be cleaned off the roof surface on an annual basis as a proper care and maintenance recommendation.

Debris on roof.

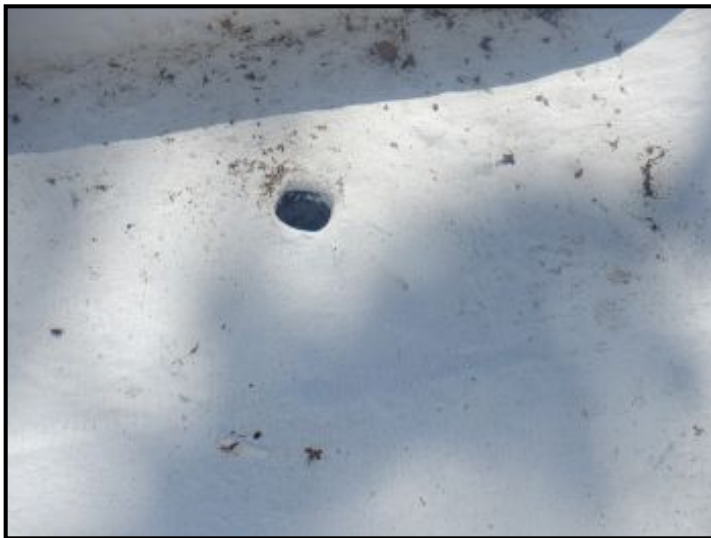
It is recommended to install screens at the roof top drains to help prevent potential debris blockage.

Install screens at drains to prevent blockage.

UPON REINSPECTION ON 7/17/23 SCREENS HAVE BEEN INSTALLED AT THE ROOF TOP DRAINS TO PREVENT BLOCKAGE AND THE DOWNSPOUT WAS SECURED TO THE STRUCTURE.

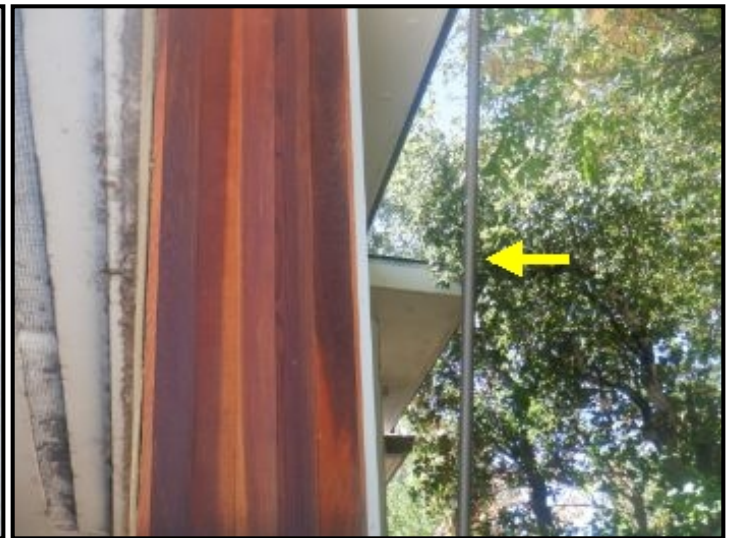
Downspout not secured to structure.

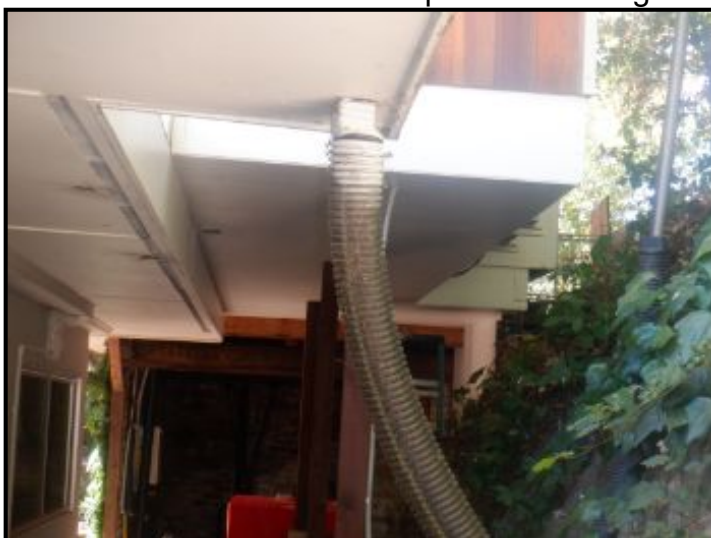
Loose drain pipe used at downspout.

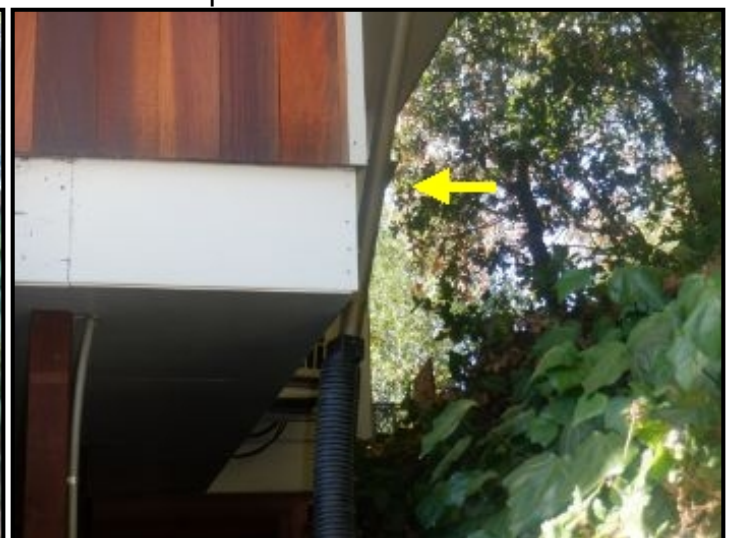
Downspout secured to structure.

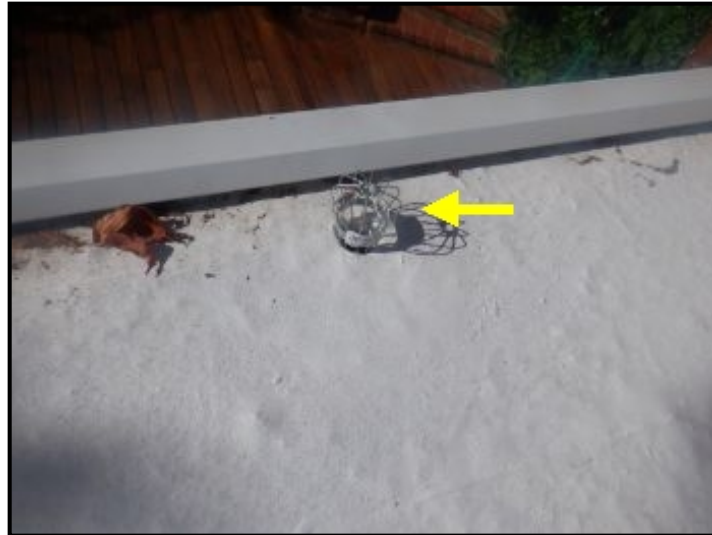
Screens installed at roof top drains.
