WOOD DESTROYING PESTS AND ORGANISMS INSPECTION REPORT

Building No. 1617	Street RONNE DR.	City SANTA ROSA	Zip 95404	Date of Inspection 7-17-2023	Number of Pages 5
----------------------	---------------------	--------------------	--------------	---------------------------------	----------------------

PAT'S AFFORDABLE
FUMIGATIONS AND INSPECTIONS

COMPANY REGISTRATION NO. PR 5074
COMPANY REPORT NO. 23-759

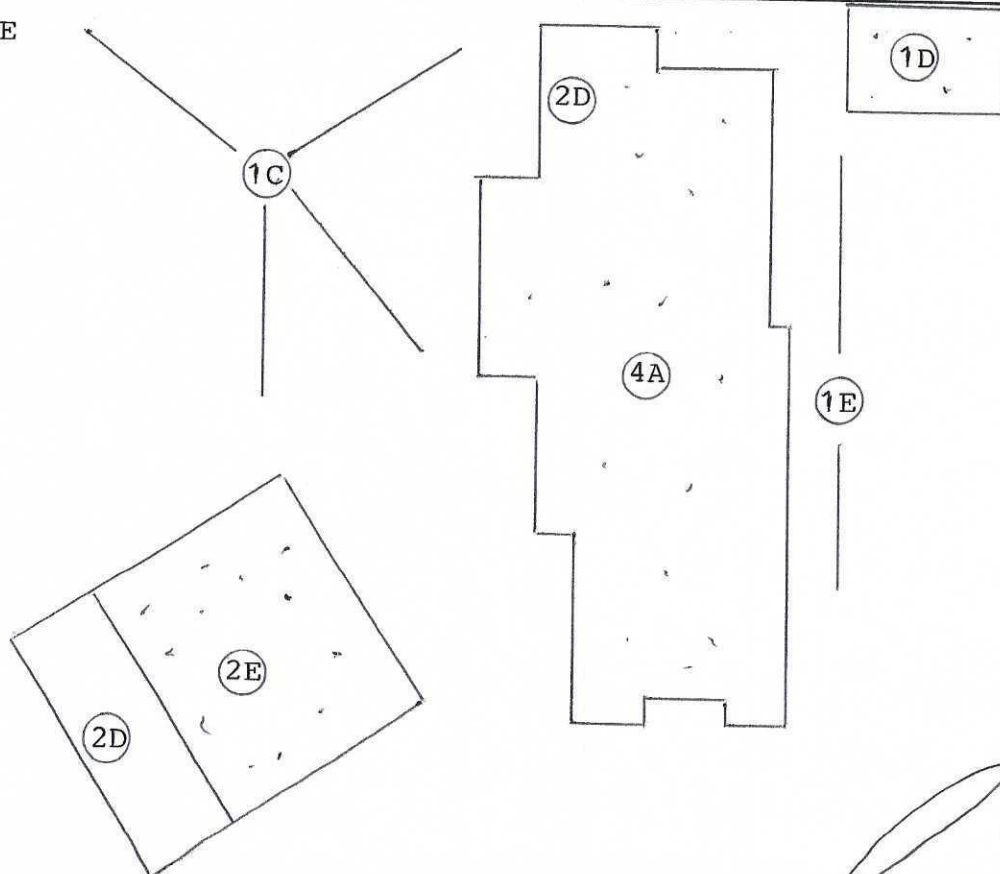
NOT TO SCALE

THE DECK ASSEMBLIES AT 1C ON THE DIAGRAM WERE EXPOSED TO WEATHER. PORTIONS OF THE UNDERSIDE WERE INACCESSIBLE FOR INSPECTION DUE TO LACK OF CLEARANCE BETWEEN SOIL AND WOOD MEMBERS. THE DECKS APPEARED TO BE CONSTRUCTED ON PRESSURE TREATED LUMBER. THE DECKS APPEARED TO HAVE BEEN RE-SEALED RECENTLY. THERE WERE RETAINING WALLS BELOW THE DECK. THE RETAINING WALLS WERE NOT INSPECTED BY THIS COMPANY.

THERE APPEARED TO BE DRAINAGE AT THE REAR OF THE HOUSE AT 1E ON THE DIAGRAM. THERE WAS ALSO A RETAINING WALL IN THIS AREA THAT WAS NOT INSPECTED BY THIS COMPANY. IT WAS DETACHED FROM THE STRUCTURE.

MINOR STAINING WAS NOTED TO THE WOOD BACK SPLASH AT THE KITCHEN SINK AREA AT 2C ON THE DIAGRAM.

THERE WAS A ROOM CONSTRUCTED OFF THE GARAGE AT 2D ON THE DIAGRAM THAT HAD A PRESSURE TREATED PLYWOOD SUBFLOOR. THE UNDER-STRUCTURE APPEARED TO BE COMMERCIALY PRESSURE TREATED LUMBER.

IT IS IMPORTANT TO KEEP THE DECK ASSEMBLIES IN A WELL SEALED AND PRESERVED CONDITION AS PART OF GOOD PROPERTY MAINTENANCE. **GENERAL INFORMATION.**

IF INTERESTED PARTIES HAVE QUESTIONS REGARDING RETAINING WALL AND/OR DRAINAGE, REFER TO APPROPRIATE TRADES FOR FURTHER INSPECTIONS AND EVALUATIONS. **GENERAL INFORMATION.**

THESE AREAS SHOULD BE KEPT IN A WELL SEALED AND PRESERVED CONDITION TO PREVENT ADVERSE CONDITIONS. **GENERAL INFORMATION.**

IF INTERESTED PARTIES HAVE QUESTIONS REGARDING ANY CONSTRUCTION DETAILS, REFER TO APPROPRIATE TRADES FOR FURTHER INSPECTIONS AND EVALUATIONS. **GENERAL INFORMATION.**
