# WOOD DESTROYING PESTS AND ORGANISMS INSPECTION REPORT

Building No.	Street	City	Zip	Date of Inspection	Number of Pages
2703	Brush Creek Rd	Santa Rosa	95404-1626	09/19/2024	1 of 16

**Stellar Termite Services, Inc.**  
**5225 Winter Creek Road**  
**Santa Rosa, CA 95404**  
 Tel 707-575-7827 Fax  
 Registration #: PR 7241

General Description: Two-story single family dwelling, furnished	Inspection Tag Posted: Storage Room
	Other Tags Posted: None noted

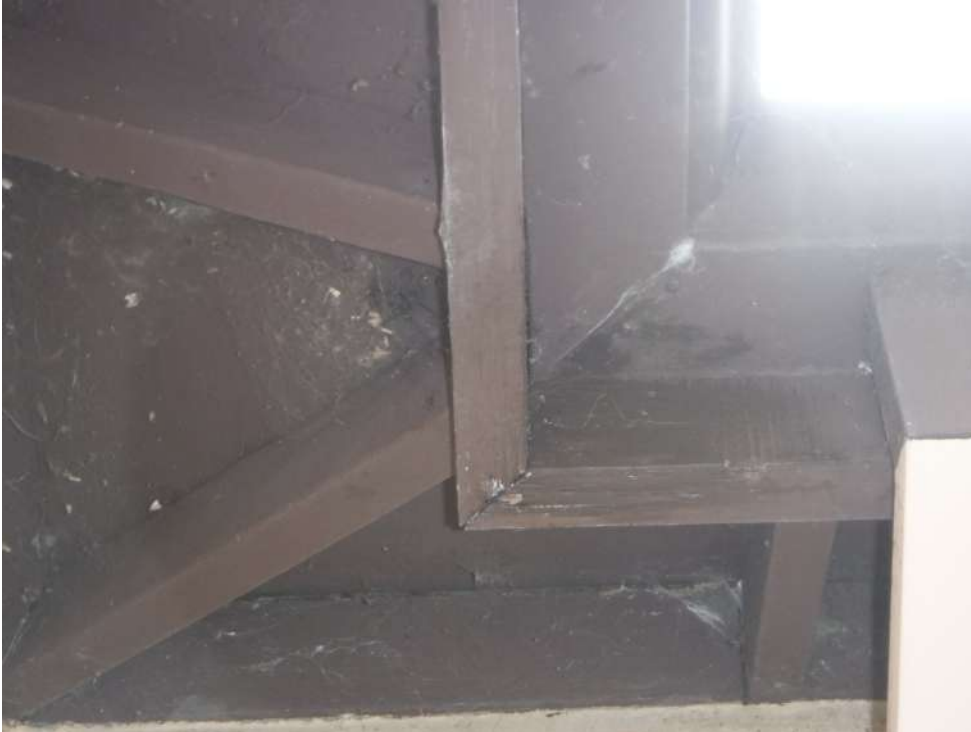
Finding: 1G Fungus wood damage was noted to perimeter roof eaves and/or fascia boards as indicated on the diagram.

Recommendation: Homeowner is advised to engage a contractor to probe/survey damaged area(s) noted in our report and perform repairs and/or modifications deemed necessary to remove all damages.

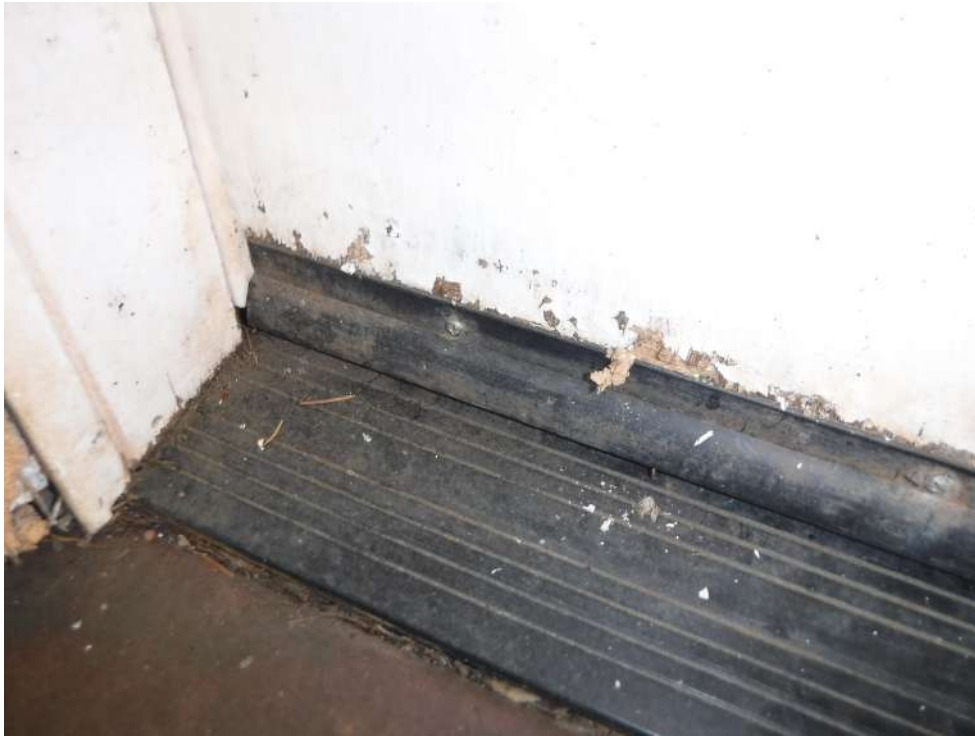
Finding: 1N Fungus wood damages were noted to base of garage service door, jambs, and/or trim as indicated on the diagram.

Recommendation: Homeowner is advised to engage a contractor to probe/survey damaged area(s) noted in our report and perform repairs and/or modifications deemed necessary to remove all damages.

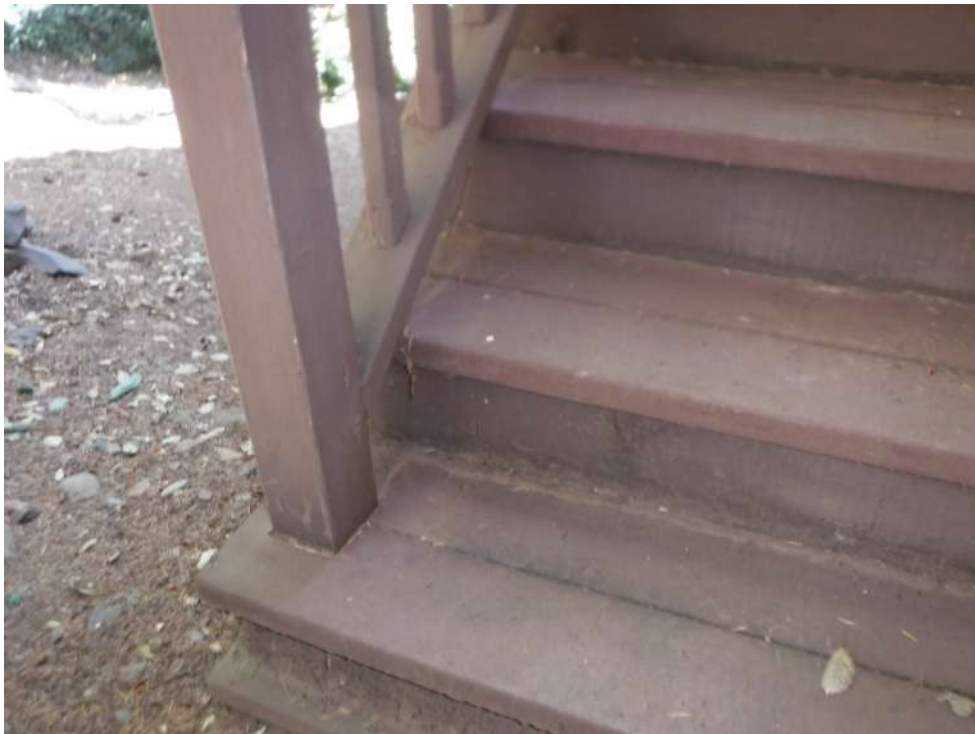
Finding: 10 Fungus and wood damages were noted to various wood members of the handrail assembly and stair steps raisers. NOTE: DUE TO THE CONSTRUCTION DETAILS/DESIGN OF THE STAIRS/DECK/HANDRAIL ASSEMBLY, THIS INSPECTION CANNOT POSSIBLY INCLUDE EACH AND EVERY ISSUE OR DEFECT. NOTE: IF ADDITIONAL DAMAGES AND/OR INFESTATIONS ARE FOUND DURING REPAIRS AND/OR IN PREVIOUSLY INACCESSIBLE AREAS, IF NECESSARY, CONTACT THIS COMPANY TO PERFORM FURTHER INSPECTION. A SUPPLEMENTAL REPORT WILL BE ISSUED WITH FINDINGS AND RECOMMENDATIONS.

Recommendation: Homeowner is advised to engage a contractor to probe/survey damaged area(s) noted in our report and perform repairs and/or modifications deemed necessary to remove all damages.

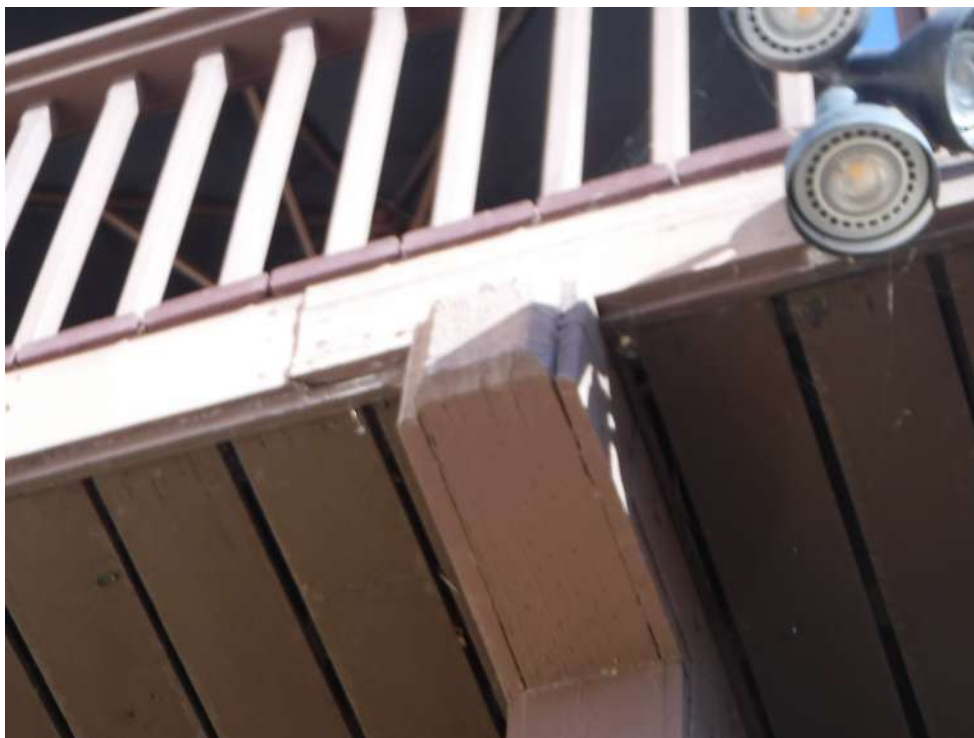
Finding: 1P Fungus wood damages were noted to various wood members of the rear balcony handrail assembly, base of left post, and facias boards/lower boards below the balcony decking. NOTE: DUE TO THE CONSTRUCTION DETAILS/DESIGN OF THE BALCONY/HANDRAIL ASSEMBLY, THIS INSPECTION CANNOT POSSIBLY INCLUDE EACH AND EVERY ISSUE OR DEFECT. NOTE: IF ADDITIONAL DAMAGES AND/OR INFESTATIONS ARE FOUND DURING REPAIRS AND/OR IN PREVIOUSLY INACCESSIBLE AREAS, IF NECESSARY, CONTACT THIS COMPANY TO PERFORM FURTHER INSPECTION. A SUPPLEMENTAL REPORT WILL BE ISSUED WITH FINDINGS AND RECOMMENDATIONS.

Recommendation: Homeowner is advised to engage a contractor to probe/survey damaged area(s) noted in our report and perform repairs and/or modifications deemed necessary to remove all damages. NOTE: THIS STATEMENT COVERS ALL SECTION 1 REPAIR ITEMS DISCUSSED IN THIS REPORT. IF ADDITIONAL DAMAGES AND/OR INFESTATIONS ARE FOUND DURING REPAIRS AND/OR IN PREVIOUSLY INACCESSIBLE AREAS, IF NECESSARY CONTACT THIS COMPANY TO PERFORM FURTHER INSPECTION. A SUPPLEMENTAL REPORT WILL BE ISSUED WITH FINDINGS AND RECOMMENDATIONS.

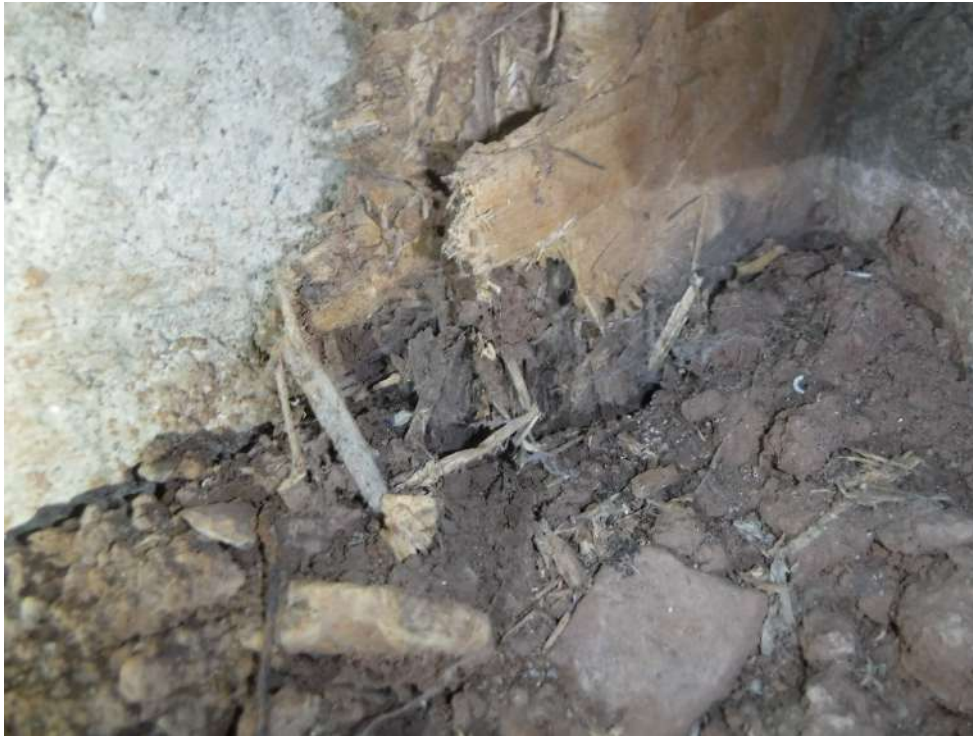
Finding: 4B Evidence of active subterranean termite infestation was noted to foundation form wood in various areas of the lower subarea.

Recommendation: HIGHLY RECOMMEND; please contact Stellar Termite Services to perform a full complete lower subarea dwelling treatment by chemically treating subarea soil with Premise 75/ADONIS 75 (imidacloprid) for the control of subterranean termites in conjunction with label directions and local regulations. Remove and dispose of foundation form wood from the subarea as practical. NOTE: IF ADDITIONAL DAMAGES AND/OR INFESTATIONS ARE FOUND DURING THE COURSE OF TREATMENT, A SUPPLEMENTAL REPORT WILL BE ISSUED WITH FINDINGS, DIRECTION OF REPAIRS AND/OR TREATMENT AND ADDITIONAL COST FACTORS. \*TREATMENT GUARANTEE NOTE: THE SUBTERRANEAN TERMITE TREATMENT PERFORMED BY THIS COMPANY IS GUARANTEED TO AREAS TREATED FOR 1 YEAR FROM THE DATE OF COMPLETION. IF TERMITE REINFESTATION OCCURS WITHIN THIS PERIOD, STELLAR TERMITE SERVICES WILL RETREAT INFESTED AREAS AT NO CHARGE. HOWEVER AREAS THAT MIGHT BECOME REINFESTED WILL ONLY REQUIRE TREATMENT TO THOSE AREAS ONLY AND DOES NOT REQUIRE US TO PERFORM A FULL DWELLING TREATMENT AGAIN. NOTE: TRIP FEES WILL APPLY. NOTE: THIS COMPANY DOES NOT GUARANTEE AGAINST TERMITE DAMAGE. NOTE: IF REPAIRS, REMODELING, AND/OR RECONSTRUCTION HAS DISTURBED ANY SOIL TREATED AREAS, GUARANTEE WILL BE NULLIFIED.

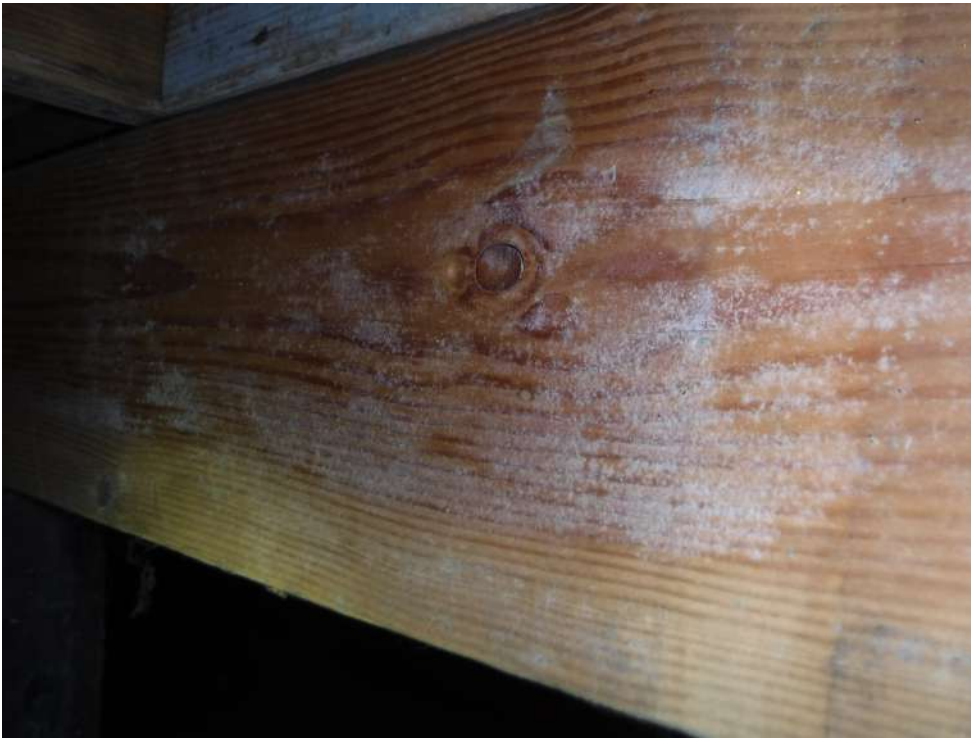
Finding: 4F Surface fungus was noted to lower substructure wood framing in various areas. Conditions found at this time do not warrant wood replacement.

Recommendation: HIGHLY RECOMMEND; please contact Stellar Termite Services to scrape off built-up surface fungus as practical. Treat infested areas with Tim-bor (disodium octaborate tetrahydrate) for fungus control. NOTE: IF ADDITIONAL DAMAGES AND/OR INFESTATIONS ARE FOUND DURING THE COURSE OF FUNGUS TREATMENT, A SUPPLEMENTAL REPORT WILL BE ISSUED WITH FINDINGS, DIRECTION OF REPAIRS, AND ADDITIONAL COST FACTORS.

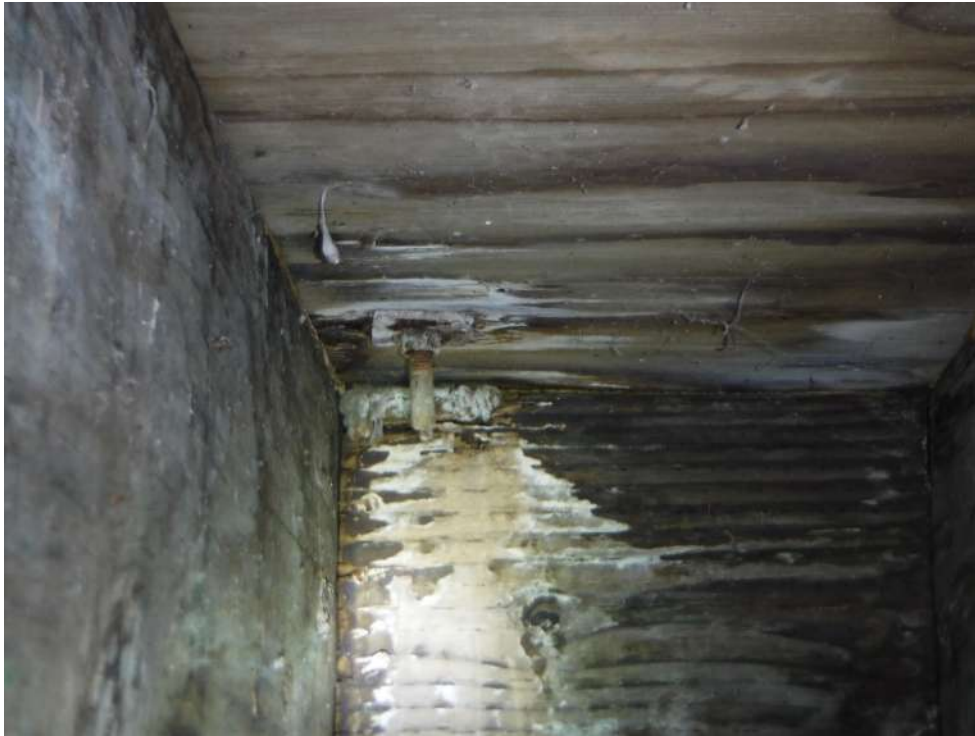
Finding: 11 Wood damage was noted to wood members located under the front tiled platform as indicated on the diagram. This platform was constructed to be isolated from dwelling by not having wood on wood contact with dwelling. Metal brackets and/or stucco materials help and prevent damage between platform and dwelling. Current damages noted will be classified as a section 2 item in a wood destroying pest report.

Recommendation: Homeowner is advised to contact the appropriate trades to perform any repairs and/or modifications deemed necessary to correct this condition.

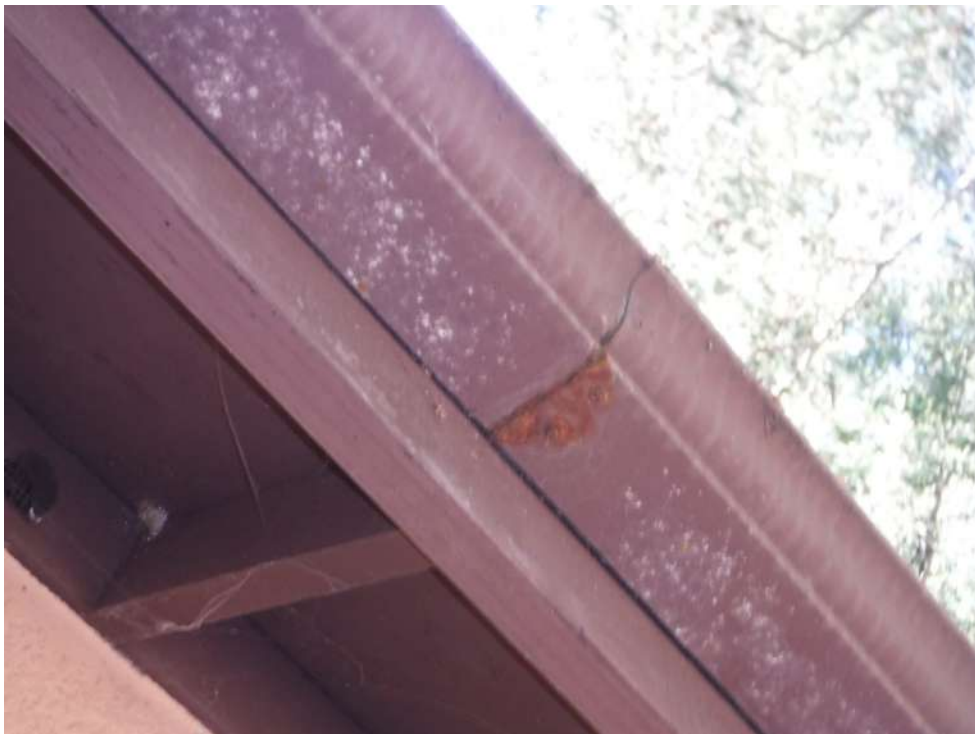
Finding: 1J Dry staining was noted to perimeter roof eaves/gutters as viewed from ground levels.  
Recommendation: Homeowner is advised to contact appropriate trades for a complete survey and evaluation of the condition of roof coverings, gutters, and/or flashing, and to make any repairs deemed necessary.

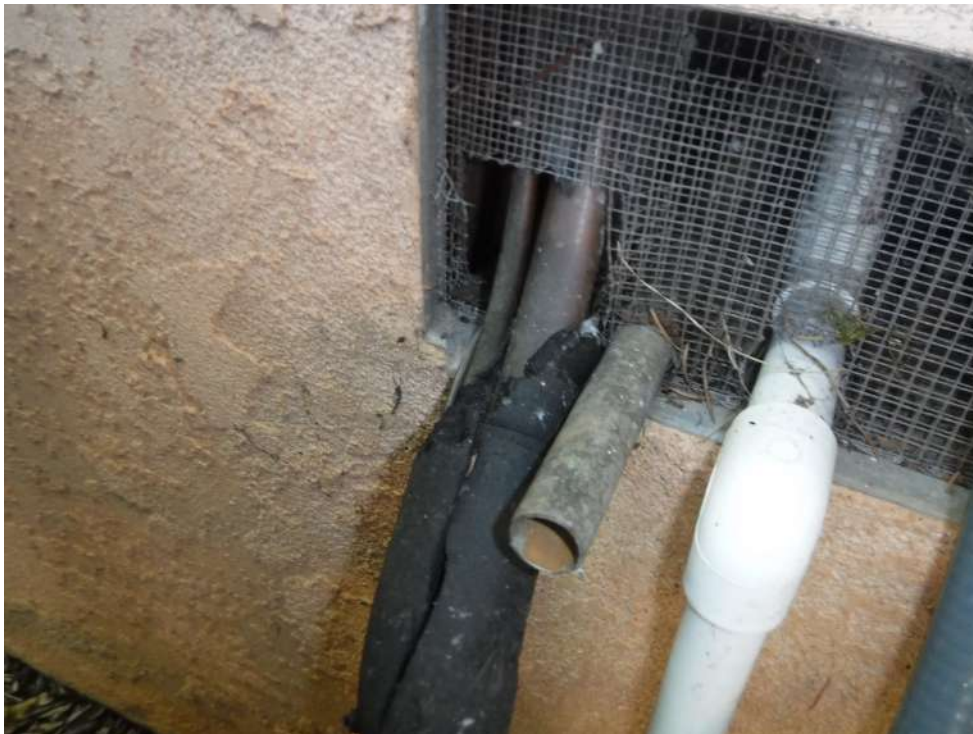
Finding: 1M Foundation vent screen was noted to be damaged and/or have voids which is allowing rodents to enter the substructure at the approximate area as indicated on the diagram.

Recommendation: Homeowner is advised to repair screen to prevent rodent entry.

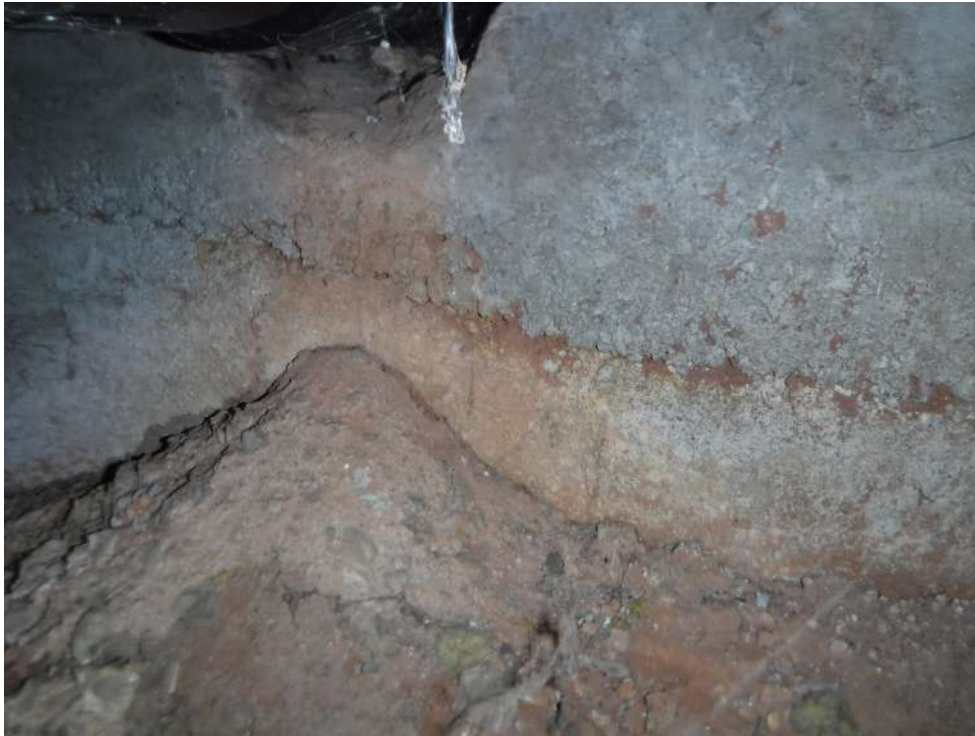
Finding: 4C Subarea soil was noted to be dry at the time of this inspection. There are indications that standing water may exist in the substructure during inclement weather and/or the rainy season.

Recommendation: Homeowner is advised to perform periodic inspections of the subarea. Homeowner is further advised to divert exterior drainage away from dwelling perimeter to minimize moisture penetration to the substructure.

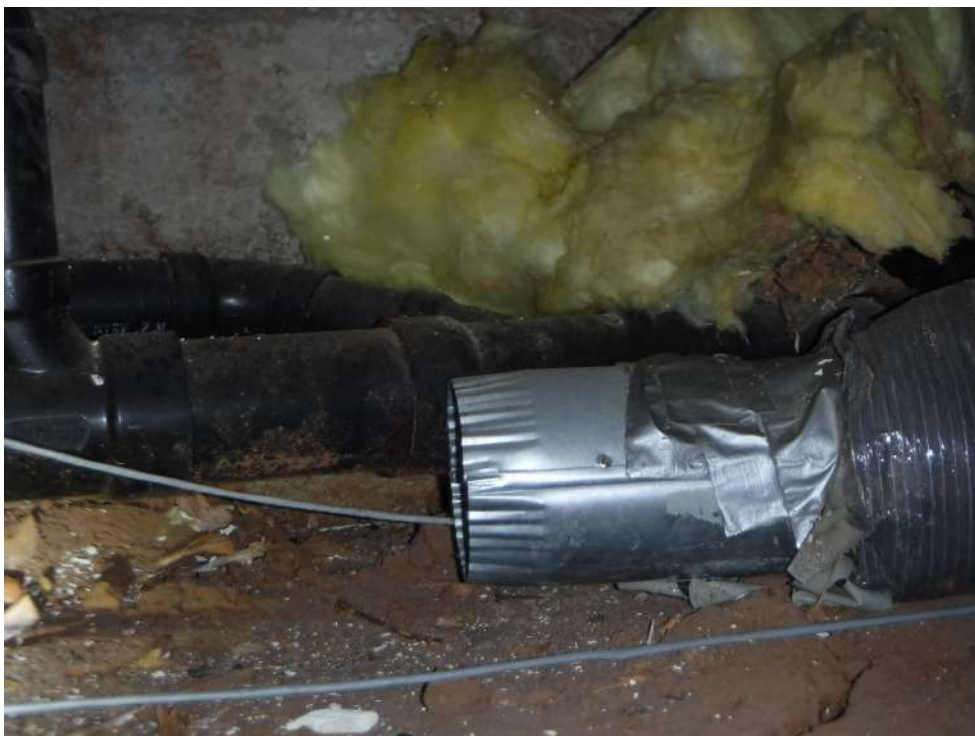
Finding: 4D Heater duct in the lower subarea was noted to be disconnected.  
Recommendation: Homeowner is advised to contact the appropriate trades to perform any repairs and/or modifications deemed necessary to correct this condition.
