Gage Inspection Services

Property Inspection Report

301 Conor Ct, Forestville, CA 95436
Inspection prepared for: Mike O'Connor
Real Estate Agent: Doug Swanson -

Date of Inspection: 2/27/2024 Time: 9:00 AM
Order ID: 1461

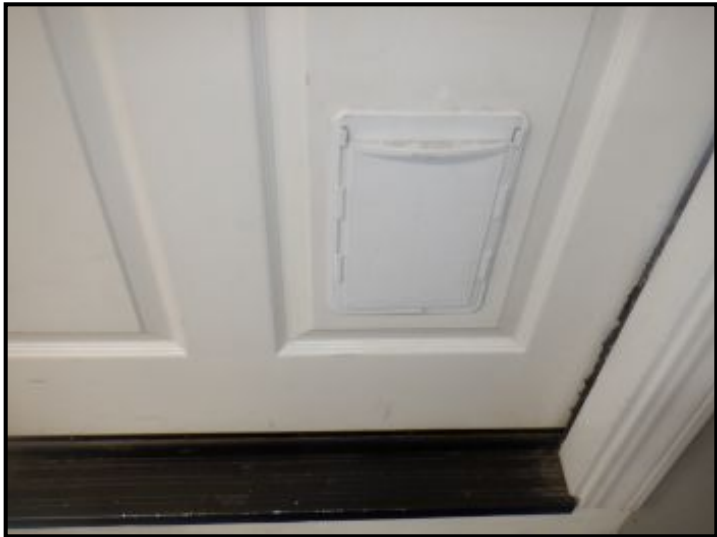
Garage		
Page 12 Item: 10	Door(s) Garage-Building	<p>Maintenance A pet door has been installed compromising the fire rating of the door and protection from potential exposure to carbon monoxide. Replacement with a proper fire rated door is recommended.</p>

<p>Pet door installed at garage door.</p>		
Fireplace

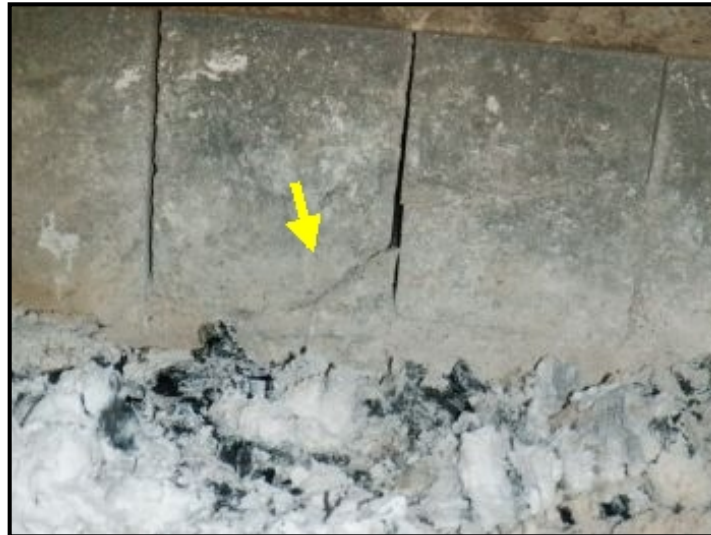
Page 23 Item: 2	Solid Fuel/Gas Logs/Gas Appliances	<ul style="list-style-type: none"> • Maintenance • There are cracks at the interior fire bricks. Recommend contacting a qualified chimney specialist for evaluation/recommendations.
-----------------	------------------------------------	--

Cracked bricks at interior of fireplace.

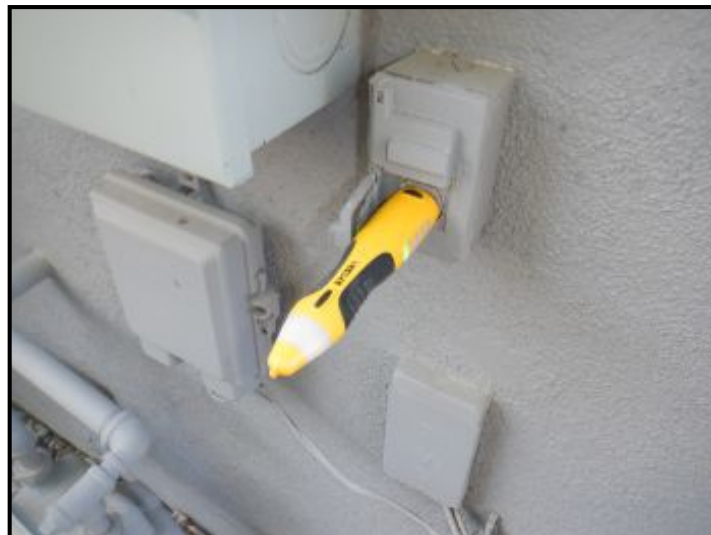
Page 29 Item: 10	GFCI Protection	<p>Attention Current electrical standards require that ground fault interrupters (GFCI) be located in areas where there is a potential danger of electrical shock. Areas such as kitchens, bathrooms, garages and exterior outlets. The inspector recommend installing GFCI outlets at the exterior as a preventative health and safety consideration.</p>
------------------	-----------------	---

Exterior outlets are not GFCI protected.

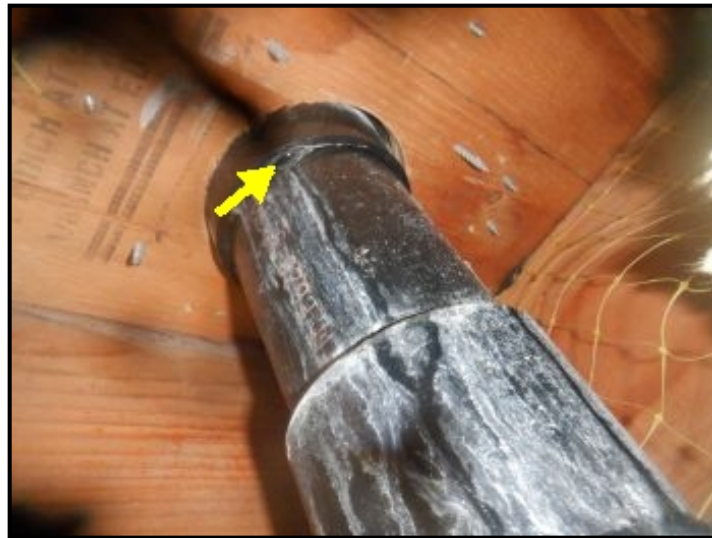
Page 31 Item: 8	Evidence Of Leaks	<p>Maintenance The inspector has found evidence of a plumbing leak. We advise the use of a qualified plumbing contractor to make final determination of the cause and to provide estimates for repairs. Location of the leak is the hallway bathroom.</p>
-----------------	-------------------	---

Leaking from toilet drain line.

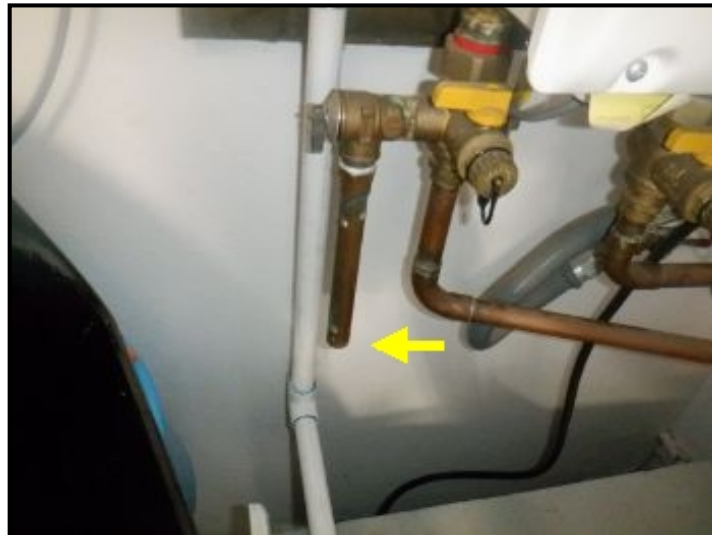
Page 33 Item: 7

There is a discharge pipe installed, however, the pipe does not terminate to the ground. Industry standards require installation of a 3/4" copper, galvanized, or cpvc pipe that terminates to the ground no higher than 6" or exterior as a safety consideration.

Discharge line does not terminate to the ground.

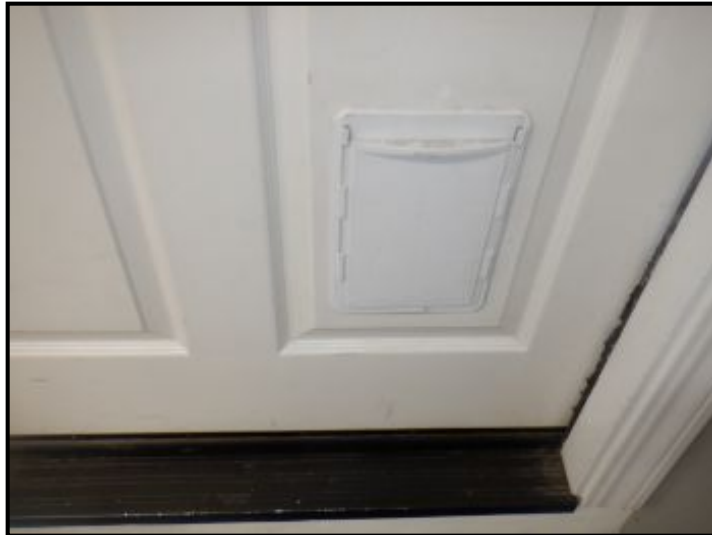
A pet door has been installed compromising the fire rating of the door and protection from potential exposure to carbon monoxide. Replacement with a proper fire rated door is recommended.

Pet door installed at garage door.

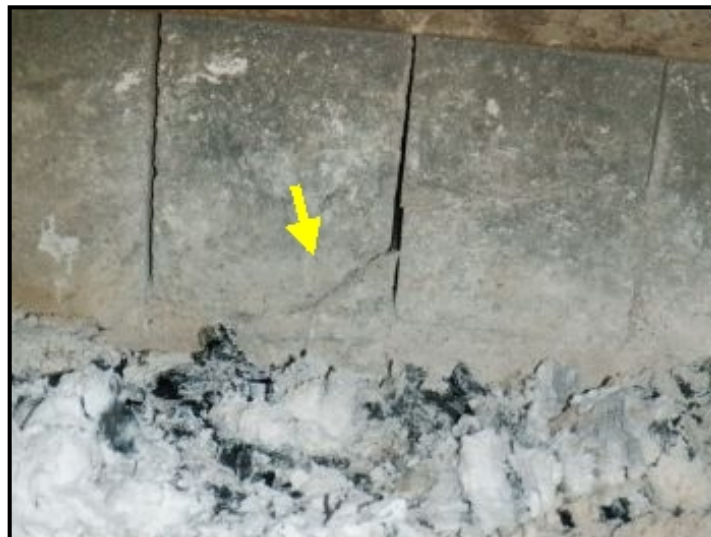
2. Solid Fuel/Gas Logs/Gas Appliances

- There is a gas burning appliance in this home. This inspection does not cover flue draft, code clearances and improper installation. When turned on condensation may appear which is common.
- There is a solid-fuel heating system/fireplace in this home. This inspection does not cover code clearances and improper installation. If additional information and certification is desired, contact a qualified chimney sweep company.
- **Maintenance**
- **There are cracks at the interior fire bricks. Recommend contacting a qualified chimney specialist for evaluation/recommendations.**

Cracked bricks at interior of fireplace.

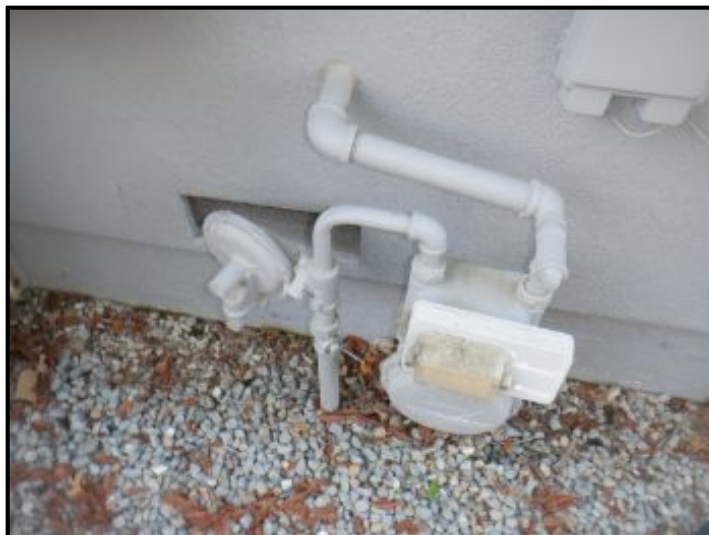
7. Gas Service

No bonding wire was visible at the gas line near the meter. Ideally a bonding wire should be present, as it provides additional electrical safety should the pipes become energized.

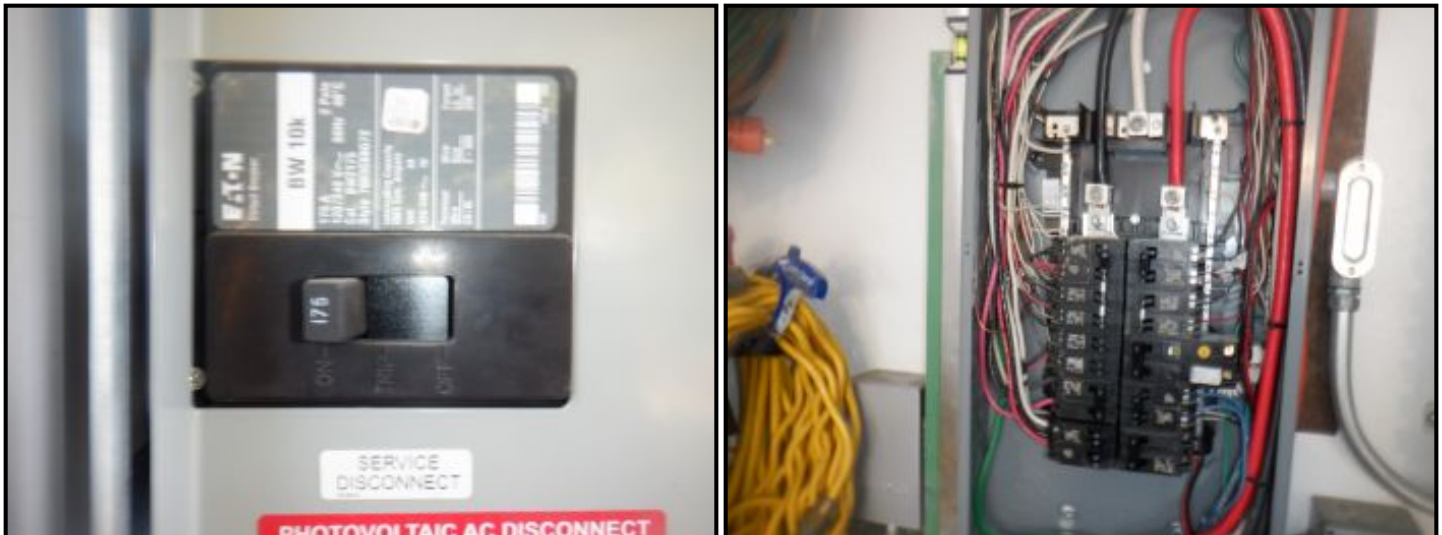
There is a solar system installed at the home that is outside the scope of this inspection. Contact the appropriate specialist to evaluate the system.

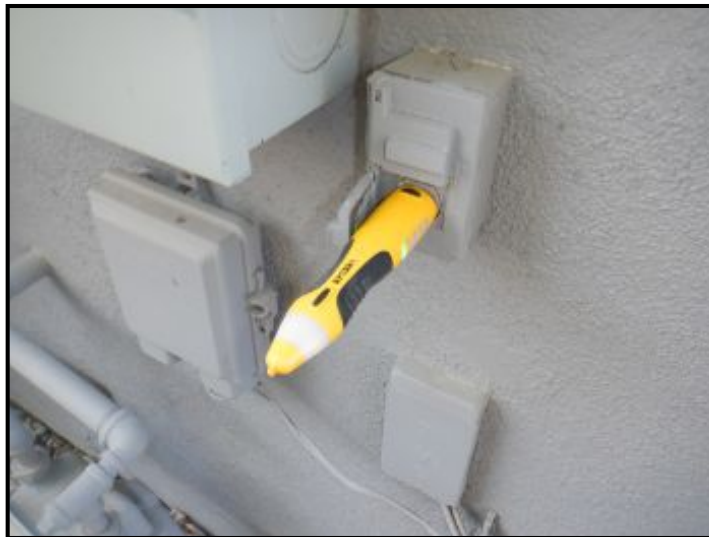
10. GFCI Protection**Attention**

Current electrical standards require that ground fault interrupters (**GFCI**) be located in areas where there is a potential danger of electrical shock. Areas such as kitchens, bathrooms, garages and exterior outlets. The inspector recommend installing GFCI outlets at the exterior as a preventative health and safety consideration.

Exterior outlets are not GFCI protected.

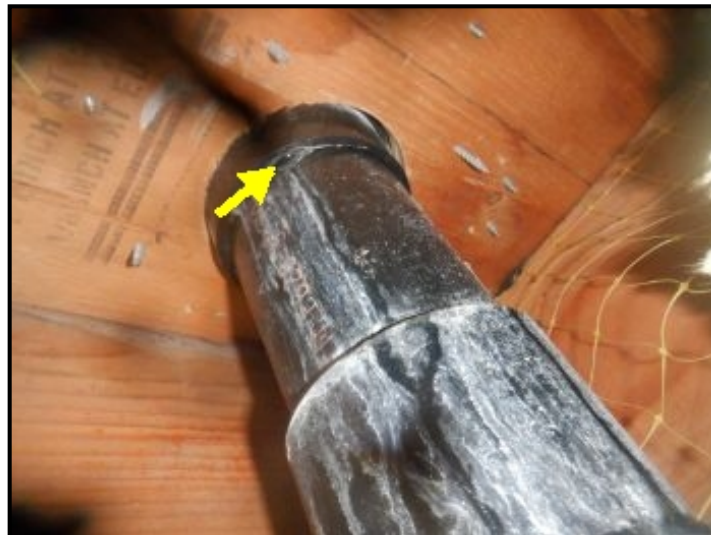
8. Evidence Of Leaks

The inspector has found evidence of a plumbing leak. We advise the use of a qualified plumbing contractor to make final determination of the cause and to provide estimates for repairs. Location of the leak is the hallway bathroom.

Leaking from toilet drain line.

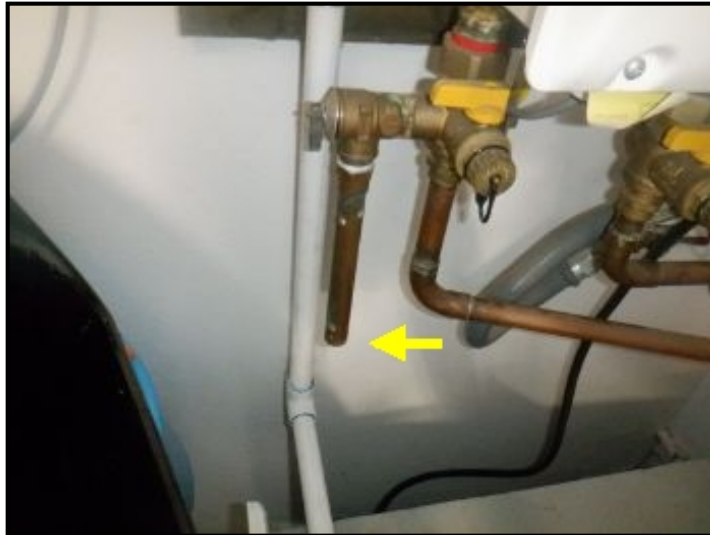
There is a discharge pipe installed, however, the pipe does not terminate to the ground. Industry standards require installation of a 3/4" copper, galvanized, or cpvc pipe that terminates to the ground no higher than 6" or exterior as a safety consideration.

Discharge line does not terminate to the ground.

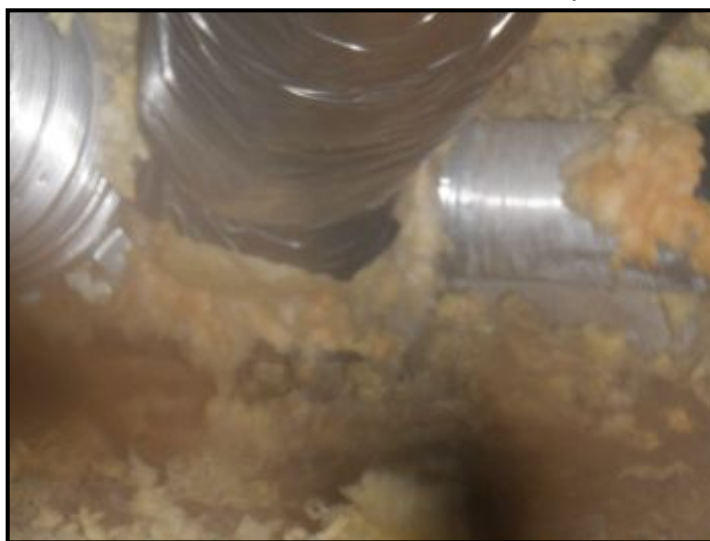
- There are areas of the ducting that the insulation wrap is in a deteriorated condition in the sub area. Keeping the ducting insulated is recommended to help with the heating/cooling efficiency of the home. Contact a qualified HVAC contractor for evaluation/repairs.

Insulation pulled away from sub area heating ducts.

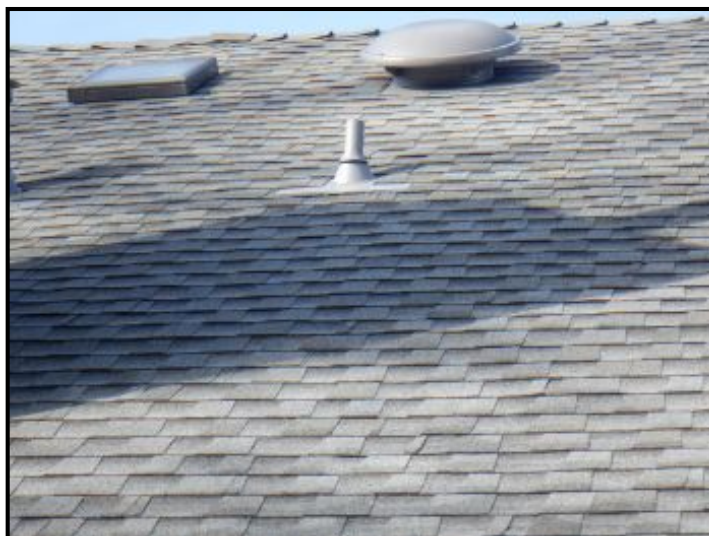
6. Cover Material Condition

The roof cover material appears to have been recently installed and appears to be in satisfactory condition. Inquire with seller for permit, licensed roofing contractor information.

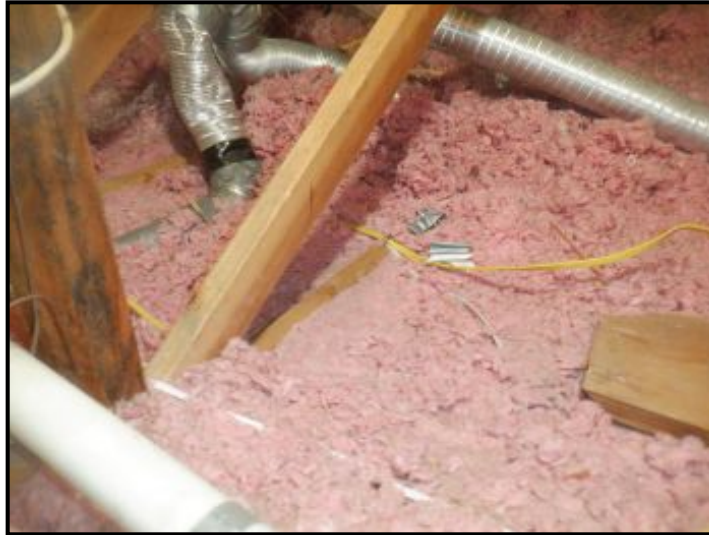
There are low levels of insulation in the home. Adding additional insulation in the attic is recommended to help with the heating/cooling efficiency of the home. Contact the appropriate specialist for evaluation.

Low levels of insulation in attic.

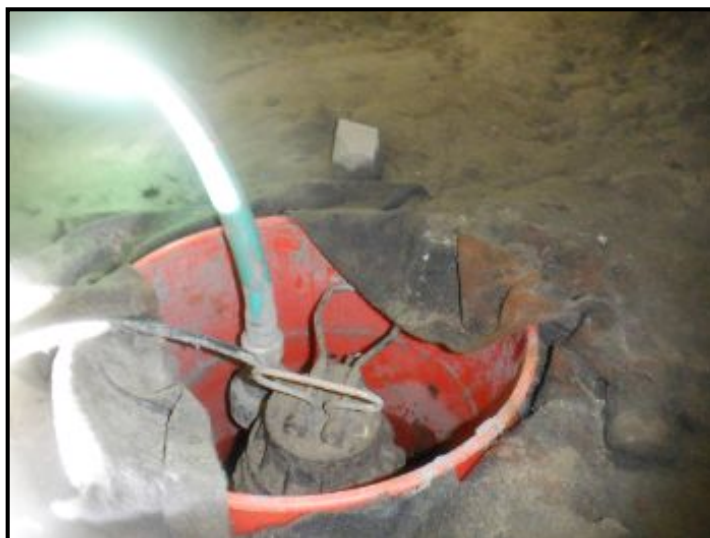
17. Drainage/Sump Pumps

There is a functioning sump pump installed in the sub area of the home. Typically it is preferred to have holes in the bucket and install drain rock around the outside of the bucket to increase efficiency and protect the pump.
