Inspected for:  
Travis Rowe  
3607 Wallace Rd.  
Santa Rosa, CA

**July 29, 2009**

Re: 3607 Wallace Rd.  
Santa Rosa, CA

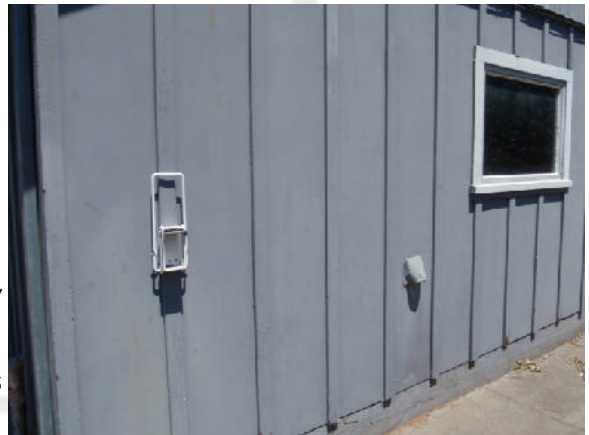
**Trim is decayed/damaged at the garage door jambs.** As this is not a pest inspection and other areas of damage may be present, a licensed pest inspection company should inspect this building and repairs should be made, as needed.

Sealing all cracks/voids between siding and trim is recommended to prevent moisture intrusion to the interior surfaces of the wall.

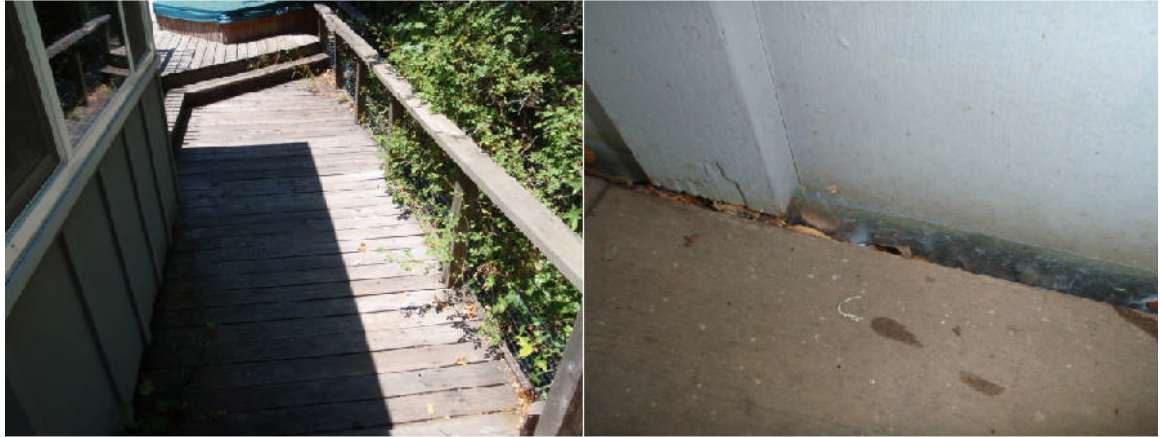
**Low elevation of deck restricts view of area under the deck structure.**

**Deck has been supported directly from the house with a wood ledger board.** Moisture can penetrate behind the ledger and become trapped for extended periods. This can lead to hidden moisture damage to the siding and structure. Unable to determine the condition of wood behind the ledger board. A licensed pest inspection company should review this area for damage as a part of a routine pest inspection. There are several methods to correct this condition. One is to completely detach the deck from the house and support with post & piers. Another method is to separate the ledger from the house with metal hardware that is designed to provide an air space between the house and deck.

**Loose boards were found at various areas.** These should be properly resecured or repairs made, as needed.

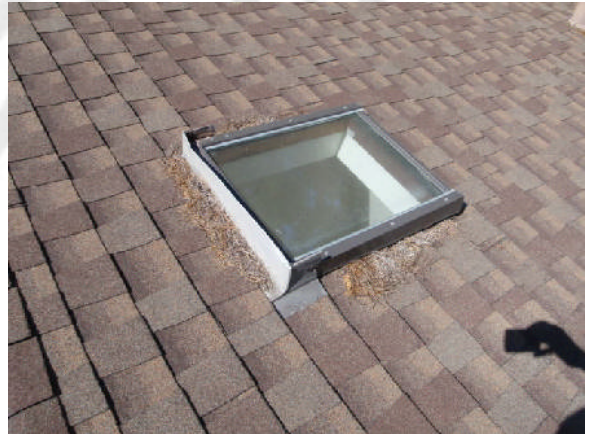
**Skylight Flashings:**

Intact.

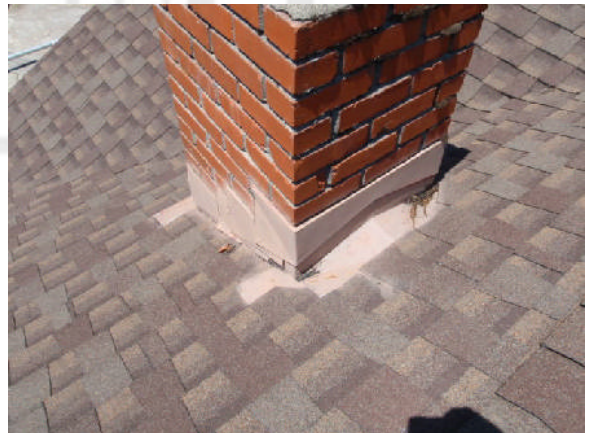
**Chimney Flashings:**

Intact.

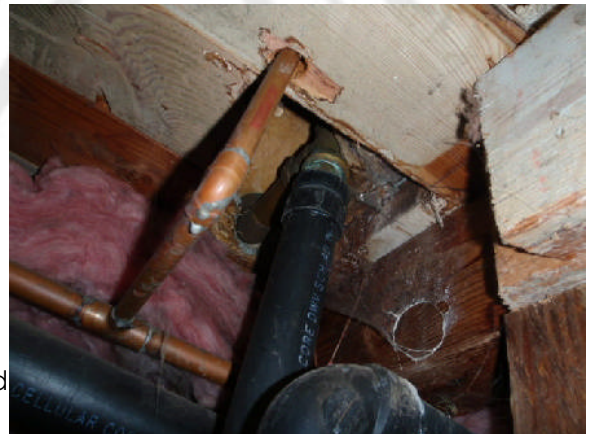
**Openings were found in the subfloor sheathing.** These openings can allow rodents access into areas under bathtubs and into wall cavities. While not required at time of original construction, I suggest screening any openings with a metal mesh.

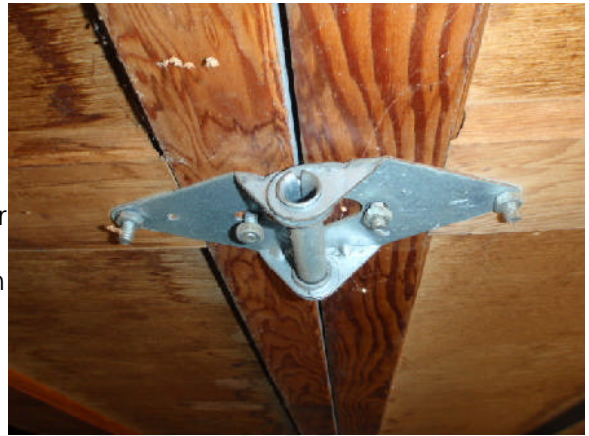
**Nuts are loose on door hardware.** These routinely become loose over time and periodic tightening is necessary as a part of routine maintenance.

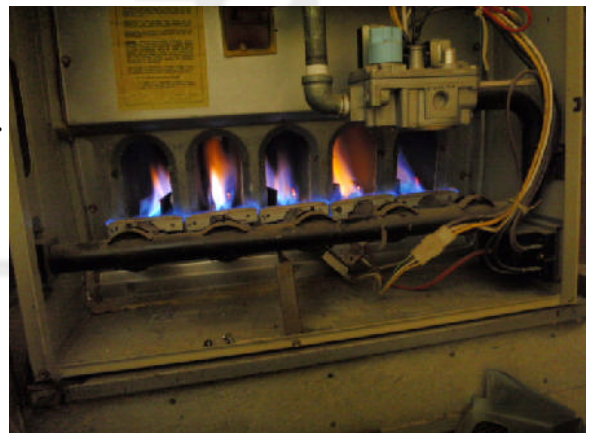
### **This heater is in the last third of its expected life.**

While the furnace did operate when tested, there is no indication that it has had any regular maintenance. As such, a licensed heating contractor should be hired to service and inspect the heating system concurrently with repairs noted above. Regular maintenance is necessary to ensure continued operation.

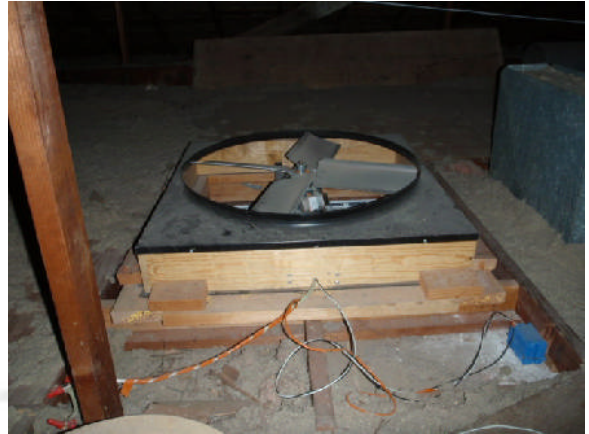
**As noted in the electrical section of this report, the wiring to this fan unit is improper and should be corrected.**

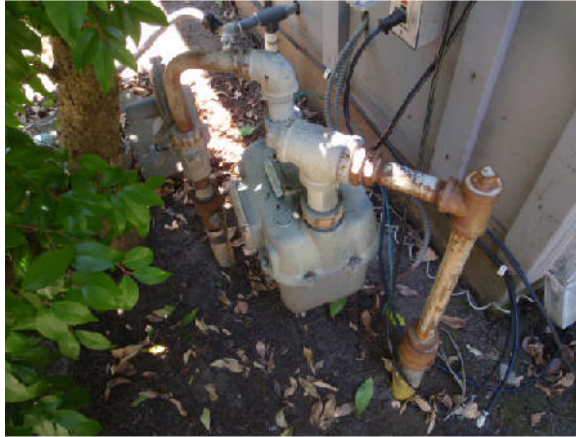
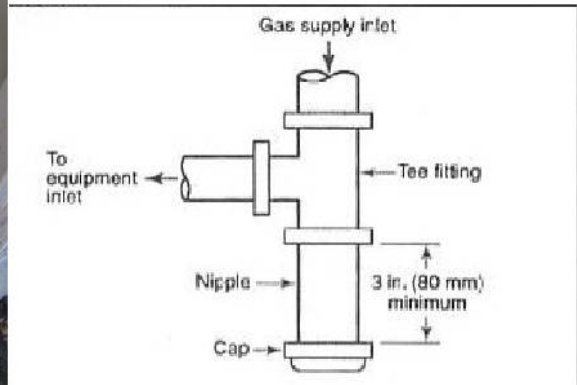
Gas is supplied by local utility. Meter is located at the right/front corner. Ideally, a wrench would be kept near the meter to allow the gas to be shut off in the event of an emergency.

**Gas odor noted near the garage water heater.** PG&E should be consulted for review for a possible gas leak.

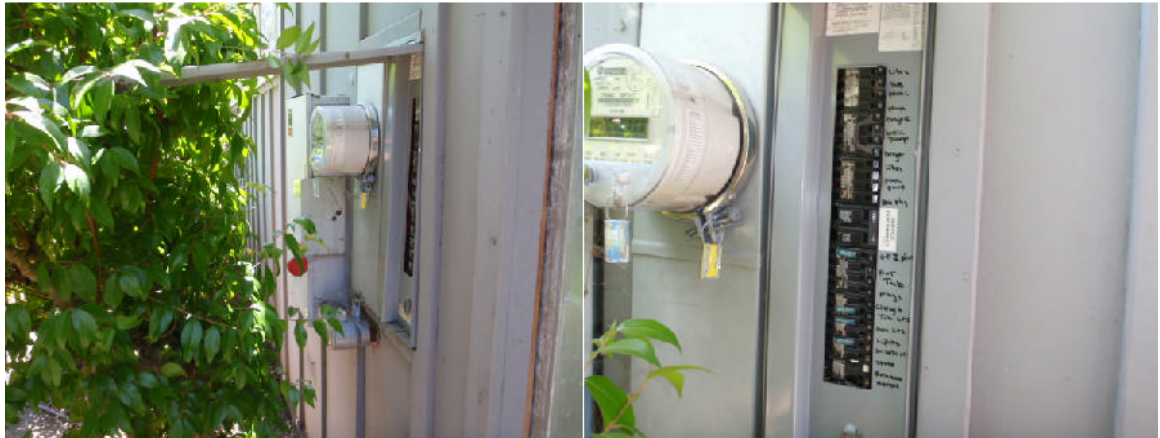
Service equipment is located at the right/front corner of the structure.

**Plants/vegetation adjacent to the panel restrict access to the interior of the panel.** Typically, a minimum clear workspace that is 30 inches wide by 36 inches deep is required in front of the panel. Removing or trimming vegetation away is advised to allow adequate access to the panel and electrical wiring.

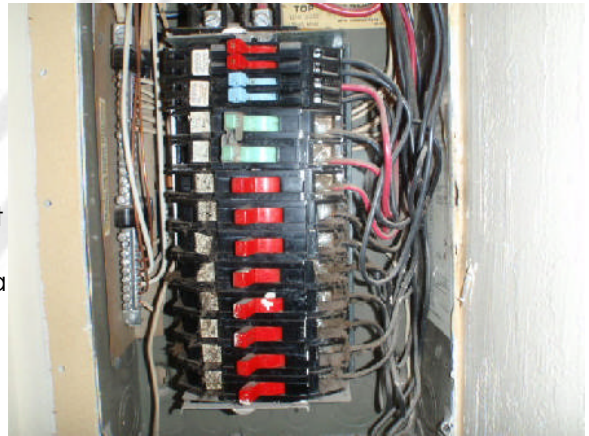
**Conditions have been reported with this brand of electrical panel (Zinsco/Sylvania) that include arcing at the circuit breaker/buss bar connections.** This is likely due to way the circuit breaker attaches to the buss bar. As a result of this design, this panel is more likely to fail than a newer panel. This brand of panel was very commonly used in structures built between the early 1960s through the mid 1980s.

Consequently, I find this brand of panel in the vast majority of similarly aged homes that I inspect. Some electrical contractors are reluctant to perform work on these panels, typically citing liability concerns. Other electrical contractors suggest examining the connections between the circuit breakers and the buss bars for loose connections and/or arc damage and having all electrical connections in these panels tightened, as needed, to ensure that the proper contact is being maintained. The most prudent course would be to replace the panel. At a minimum, some preventative maintenance seems reasonable as replacement of a panel can be costly. As these panels are no longer being manufactured, upgrade/replacement parts can be difficult and expensive to obtain should the need arise. While no evidence of arcing was observed within this panel at time of inspection, positive determination can only be made by having an electrician remove the circuit breakers in order to inspect the buss bars. If more information or further review is desired, a licensed electrical contractor should be consulted. Requiring documentation or other hard evidence is suggested should an electrician advise replacement.

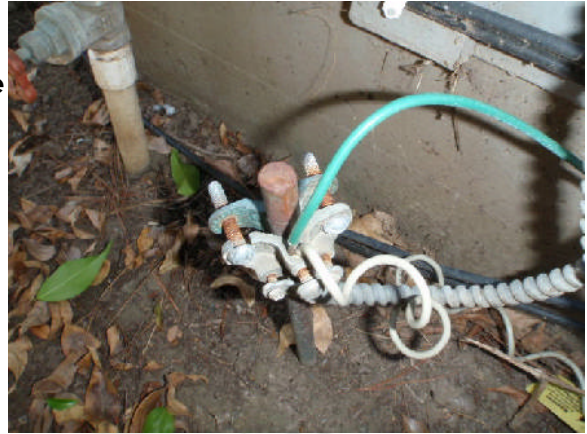
**Many of the receptacle outlets are not grounded.** The receptacle outlets in this home are a combination of older two-pin and three-pin outlets. The three-pin outlets were, most likely, installed in an attempt to "update" the electrical system but were improperly installed. The receptacle outlets originally installed had only two slots and the electrical cable used does not provide a ground wire. This system was standard at the time of construction. While new construction requires that all permanent electrical devices be connected to a grounding circuit, it may not be practical, or absolutely necessary to ground all of the outlets. Most small appliances and light fixtures use a two pin plug and have no need for the grounding circuit. However, large appliances, particularly those with metal chassis (such as clothes washers/dryers, dishwashers, refrigerators and computers) generally do require a ground. Installing an adapter on the appliance cord that attaches to the screw on the face of the receptacle outlet does not provide a ground. The grounding circuit is intended to provide a direct path to ground in the event of a short circuit in an appliance. I suggest replacing ungrounded three-pin receptacle outlets with the original (two-pin) type to avoid confusion. While this is a straightforward replacement, this is typically a project for a licensed electrical contractor. Where needed, individual receptacle outlets can be grounded or new outlets can be installed by a licensed electrical contractor.

**The plumbing system does not appear to be bonded to the electrical grounding system.** All metal piping is currently required to be connected (bonded) to the grounding system. This may not have been required at time of construction. Should the metal piping become energized (through a lightning strike or other means), the bonding will conduct the current to ground. Normally, a bonding wire is attached/clamped to the cold water supply pipe where the main water enters the building, a jumper is clamped to the hot and cold water piping adjacent to the water heater to ensure that both the hot and cold water supply piping is properly bonded, and a bonding wire is clamped to the gas supply piping adjacent to the gas meter or the water heater. Bonding of the metal drain/waste piping is also advised. No bonding wires/clamps were found at these locations. Installation/upgrading of bonding is advised.

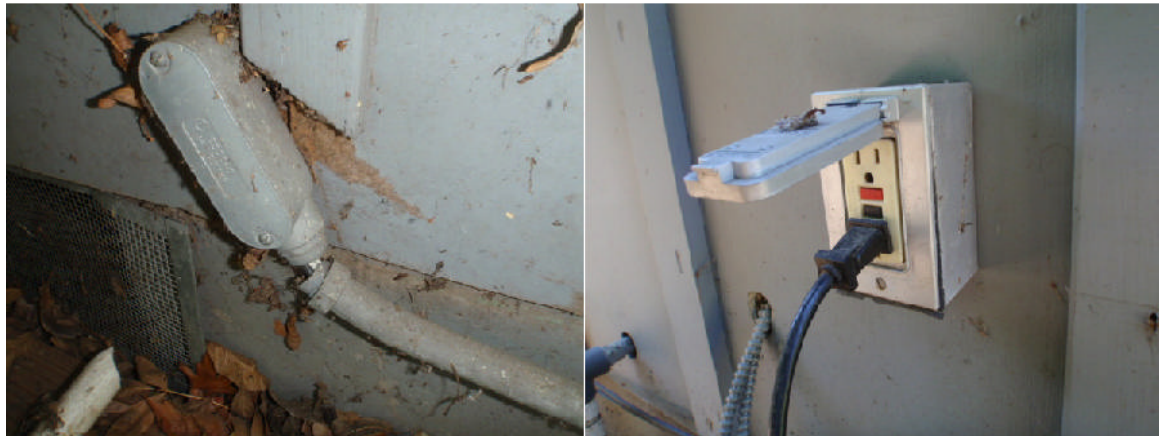
**A disconnected conduit was found at the right side adjacent to the water heater closet.** The conductors are exposed. This should be reconnected/repaired.

**Receptacle outlets are not grounded.** When grounding is not available, installation of GFCI (ground fault circuit interrupter) devices is advised.

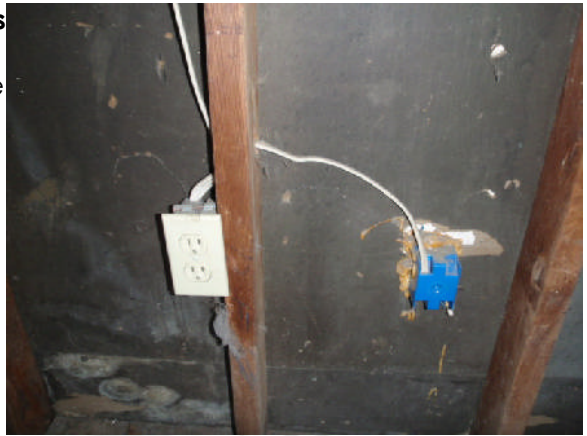
**Terminated electrical cable with exposed leads observed.** Although these wires were not "live" when tested, no determination could be made as to whether these wires have been permanently disconnected. Ends of wire should be properly capped and enclosed in a covered junction box for safety. Unable to determine the purpose for these wires.

**Unprotected nonmetallic sheathed cable (romex) present.** Electrical cables can be damaged by metal tools or other stored items. Electrical cabling that is lower than 7 feet from the floor should be protected from damage by enclosing in a conduit or behind wall material such as drywall.

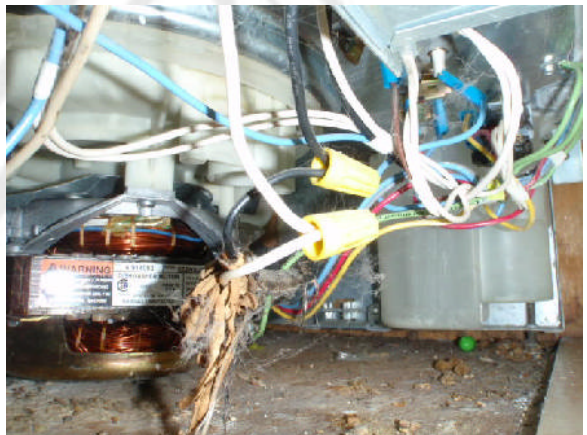
**Wiring at the base of the dishwasher is improper.** Spliced wires should be enclosed in a junction box and the cord should be secured with a strain relief clamp attached to the junction box to prevent separation of the splices.

**Receptacle outlets are the older, two pin, non-grounded type.** Receptacle outlets that serve major appliances with a metal chassis (refrigerators, dishwashers, ranges, etc.) should be grounded. When grounding is not available for receptacle outlets that serve the counter surfaces, installation of GFCI (ground fault circuit interrupter) devices is advised. Please refer to the "Grounding System" and GFCI notes earlier in this section for more information.

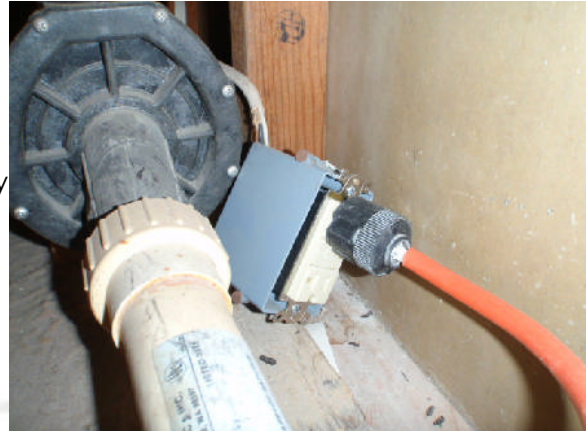
**The electrical cable sheathing for the hall bathroom whirlpool tub has been stripped and the receptacle outlet is loose.** The cable sheathing should be intact until it enters the junction box and the box should be secured to wood framing. Corrections should be made by a licensed electrical contractor.

**Receptacle outlets are not GFCI (ground fault circuit interrupter) protected.** For more information, please refer to the GFCI notes above.

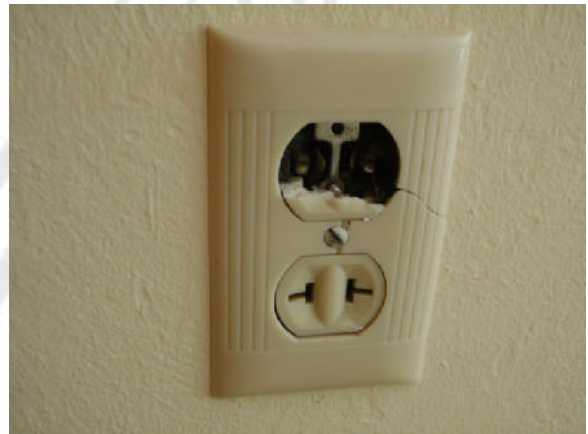
**A damaged receptacle outlet with exposed contacts was found in the living room.** This should be replaced for safety.

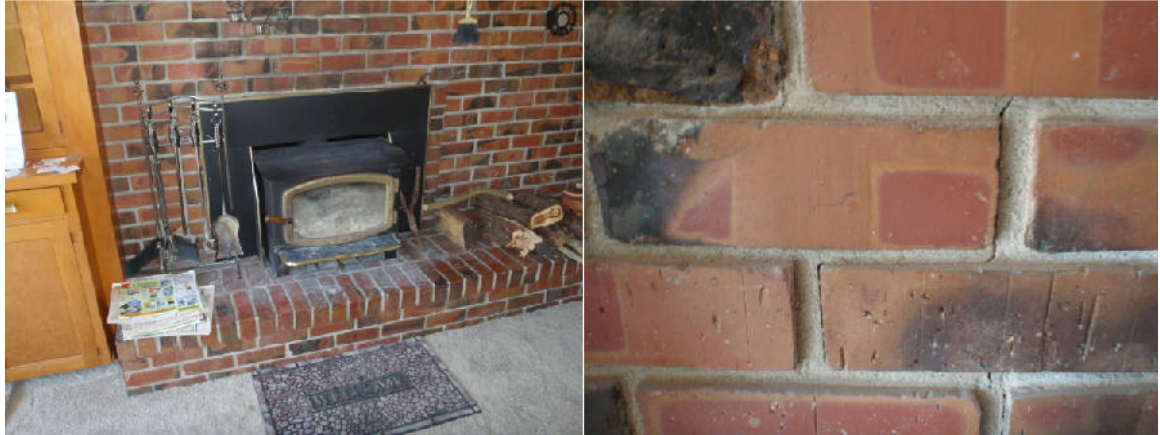
Masonry fireplace.

**Cracks are present in the brick face of the fireplace.** Unable to determine the condition of the firebox due to the presence of the insert.

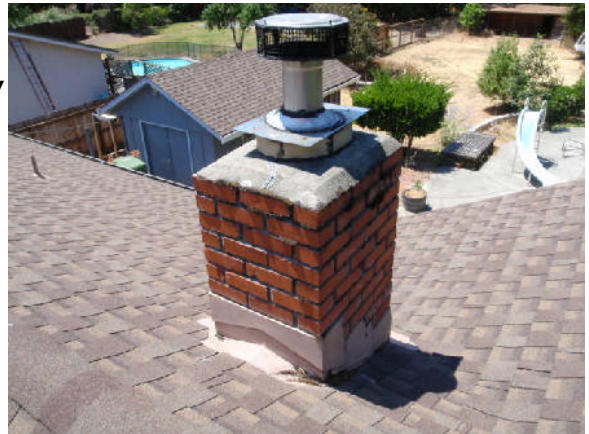
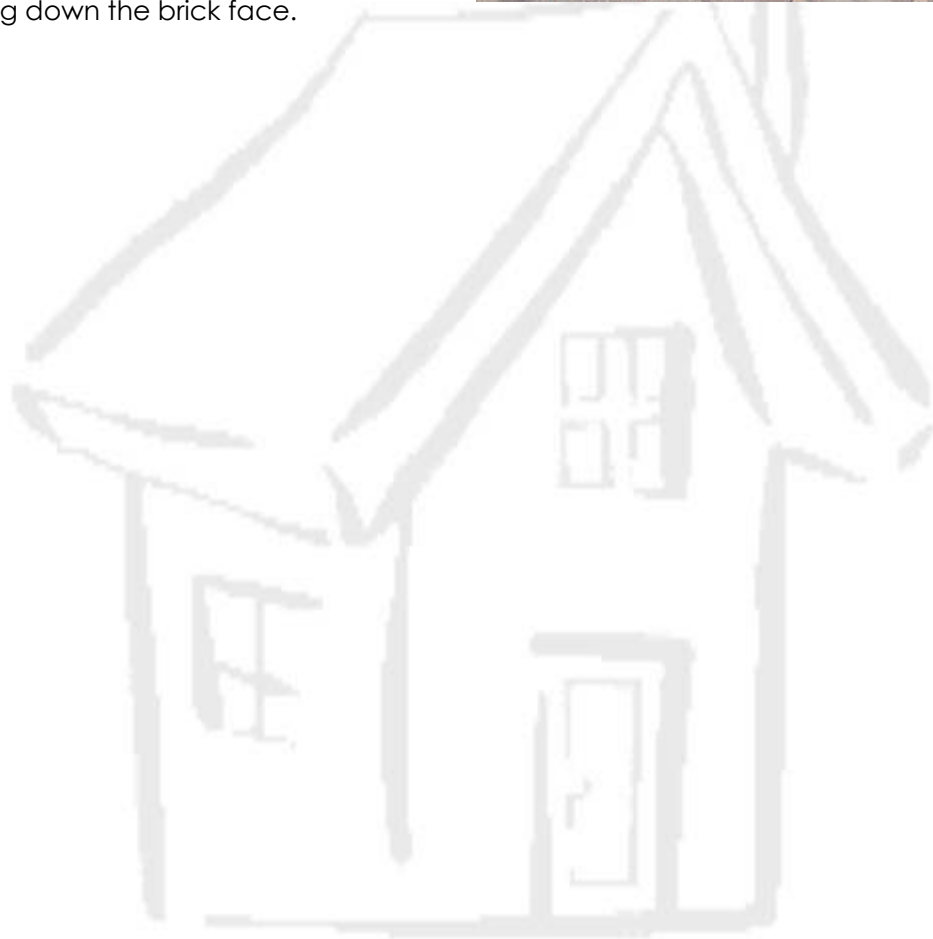
**Sloped mortar crown on the top of the chimney is cracked/deteriorated.** The intent of the crown is to help prevent water from soaking into the brick and mortar which can cause efflorescence (a white powdery substance) to accumulate on the surface of the brick. Removal of the deteriorated mortar and remortaring is advised to direct water away from the masonry. The "Brick Institute of America" recommends that the crown project past the face of the chimney to prevent water from flowing down the brick face.

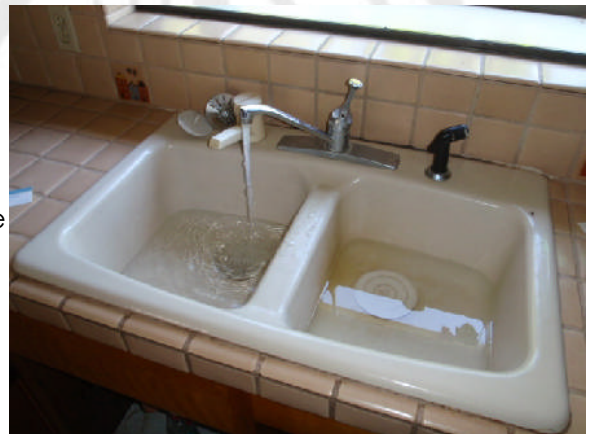
**The faucet will leak at the base of the valve handle when the faucet is operated.** This is typical of this design/brand. Please refer to the plumbing section of this report for related information.

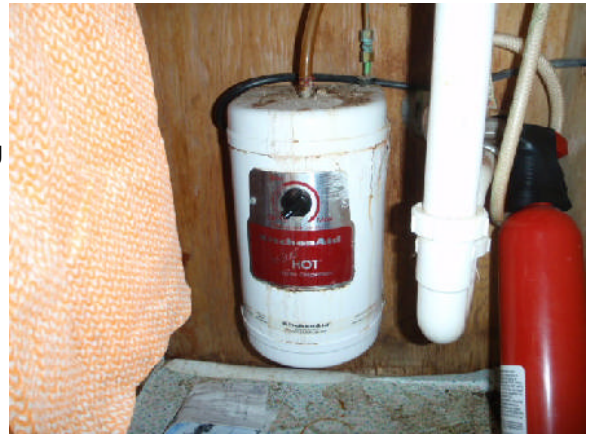
**Stains were found on the exterior housing.** This area was dry at time of inspection, but should be monitored for any reappearance of leaking that would require repair.

**Unable to test as the water was off.** I recommend verification of proper operation once the water service has been restored.

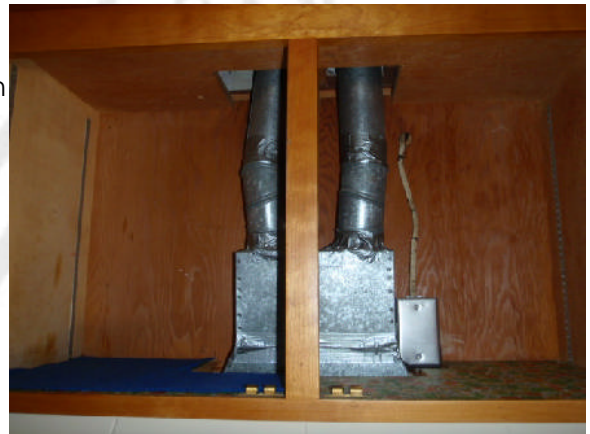
**Exhaust ducts are nonstandard.** Typically, one 8 or 10 inch diameter duct is used. These two small ducts will not be able to exhaust as much air as a single large duct. I suggest replacement of these ducts with a standard single exhaust duct.

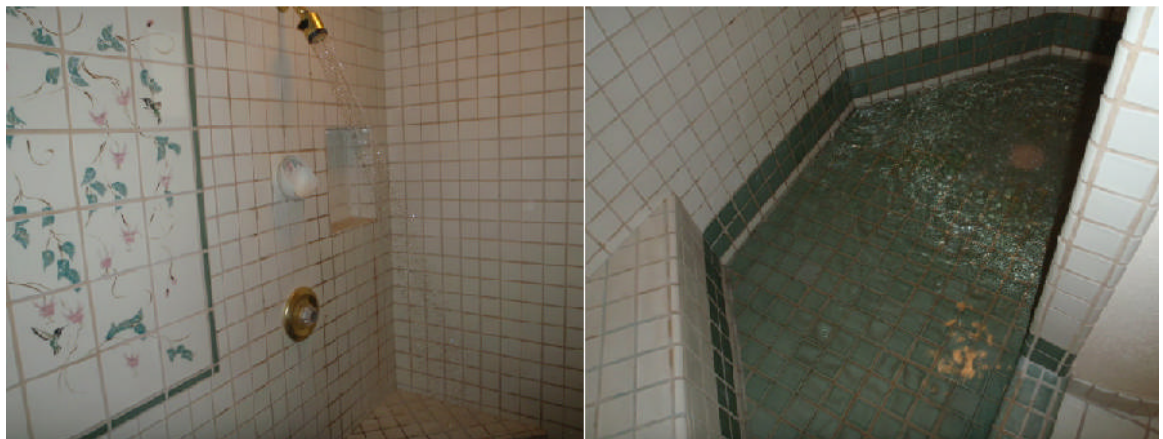
**Cracks/voids present in grout.** While missing grout is common and often recurs, this should be patched or regouted, as needed.

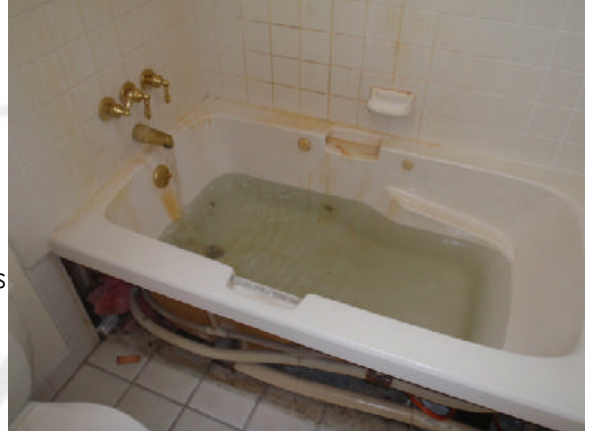
"Whirlpool" type tub did not function when tested. The line for the air switch was disconnected. Unable to determine if reconnecting/repair of the air switch will allow operation. I recommend repair of the air switch to allow testing. If this does not allow operation, further repairs may be necessary. As not all of the plumbing lines were completely visible this review is limited. Regular maintenance of the tub is recommended. The manufacturer's operation, maintenance and safety instructions should be obtained from the seller. If no documentation is provided, a copy should be obtained from the manufacturer and read prior to use.

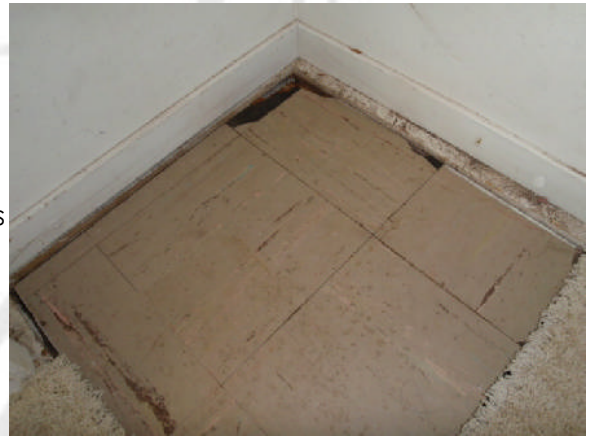
**Tile at the foyer is cracked and chipped.**

**Vinyl flooring was found in the master bathroom closet.** Some vinyl tiles contain asbestos. Identification/verification of asbestos can only be made in a laboratory.

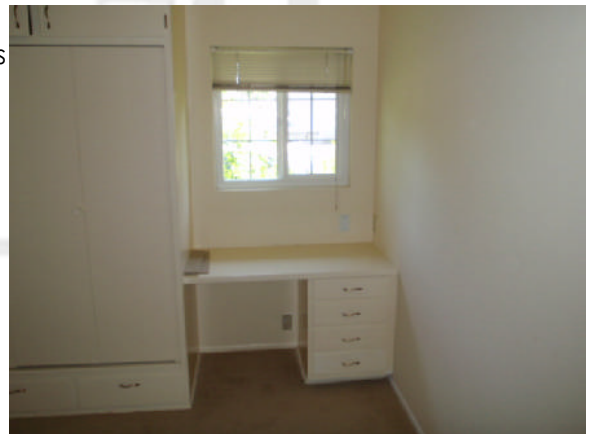
**Windows in the front bedrooms are not an adequate size for emergency egress.** Windows in sleeping areas (bedrooms) should allow for exit in the event of an emergency. Window openings in bedrooms should be no less than 20" wide by 24" high and the sill should be no greater than 44" above floor level. This is a potentially unsafe condition. Corrections should be made to allow for emergency egress. This typically requires replacement of the window.
