Buyers Protection Group

**1415 Leslie Road  
Healdsburg CA 95448**

**Client(s): Zissis  
Inspection Date: 4/24/2015**

**Inspector: Jose Gonzalez #**

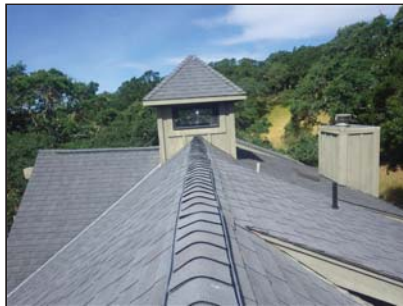
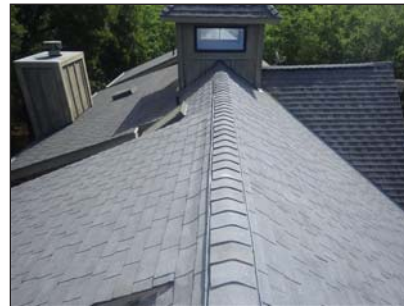
- ☒ 6. Roof appears to be nearing the later stages of its useful life. Dislodged and/or improperly installed shingles noted near ridges and front/left field. Due to the above noted and signs of past leaking observed inside the home, we suggest consulting a licensed roofing contractor for further review.

- ◆ Roof appears to be nearing the later stages of its useful life. Dislodged and/or improperly installed shingles noted near ridges and front/left field. Due to the above noted and signs of past leaking observed inside the home, we suggest consulting a licensed roofing contractor for further review.

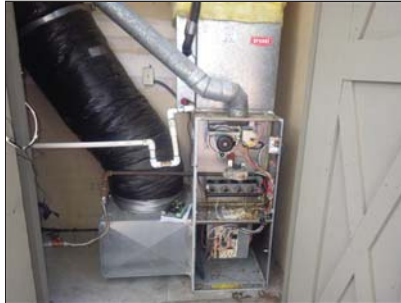
- ◆ The filter installed in this unit is dirty. This can slow airflow and reduce the efficiency of the system. We suggest cleaning or replacing this filter periodically as part of routine maintenance.

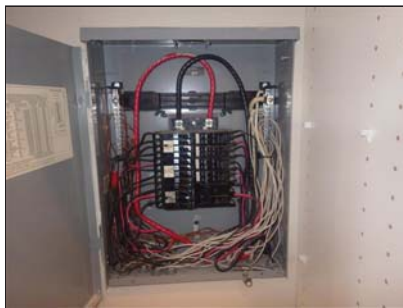
- ❌ 13. Doubled-up circuitry noted at neutral bar (i.e. 2 neutral wires on a single terminal). This condition can cause wiring to become loose, leading to arcing and overheating. Each grounded conductor should terminate within the panel board in an individual terminal that is not also used for another conductor. We recommend review by a qualified professional electrician for correction, as necessary, to ensure proper operation and safety.

- ⊗ ◆ Doubled-up circuitry noted at neutral bar (i.e. 2 neutral wires on a single terminal). This condition can cause wiring to become loose, leading to arcing and overheating. Each grounded conductor should terminate within the panel board in an individual terminal that is not also used for another conductor. We recommend review by a qualified professional electrician for correction, as necessary, to ensure proper operation and safety.

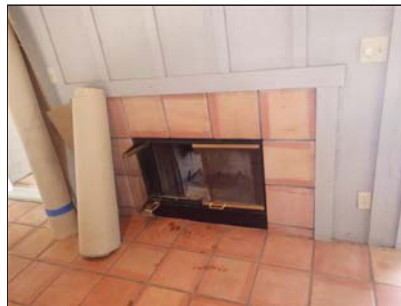
- ◆ The hearth slab should be readily distinguishable from the surrounding or adjacent floor.

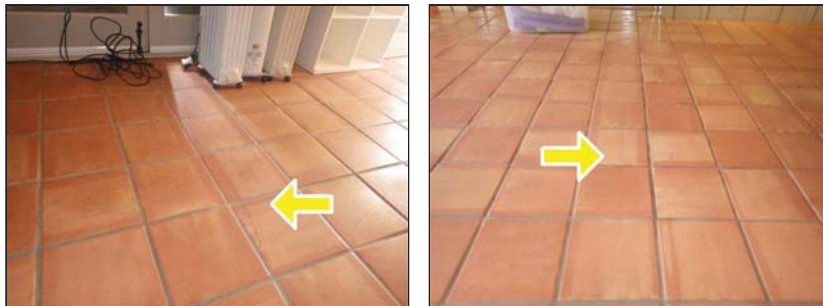
- ☒ ◆ Some deterioration was noted to the floor adjacent to some of the upstairs French doors. We suggest maintenance and repairs, as necessary.

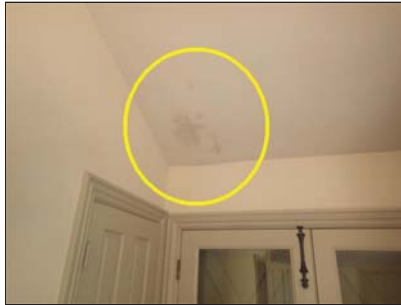
- ◆ Cathedral ceilings were noted as a feature of this home. This type of construction design prevents us from thoroughly inspecting the space between the ceiling and the roof sheathing where these ceilings are present due to limited or no access. Verification of proper ventilation or the presence of insulation may not be possible without destructive investigation.
- ◆ Ceiling is discolored at the upstairs right side bedroom. This is indicative of past moisture intrusion. See **ROOF** Comments for recommendations.
