Inspected for:
Daveen & Stephanie Chopra
2142 Vintage Circle
Santa Rosa, CA

04/29/2015

Report Highlights

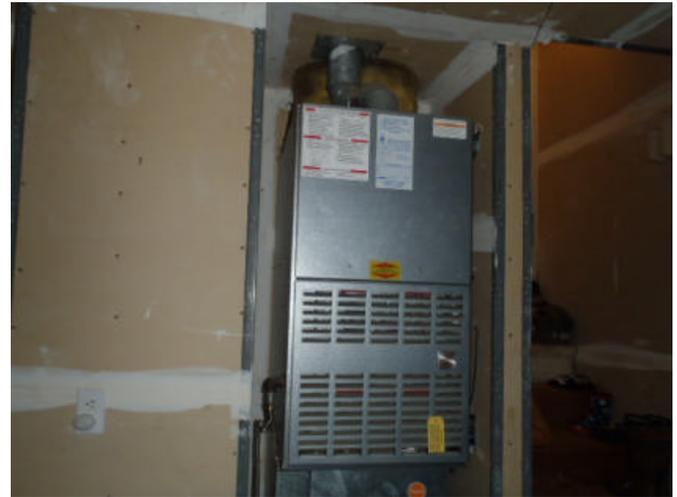
Brand: Payne.

Gas fired forced air unit.

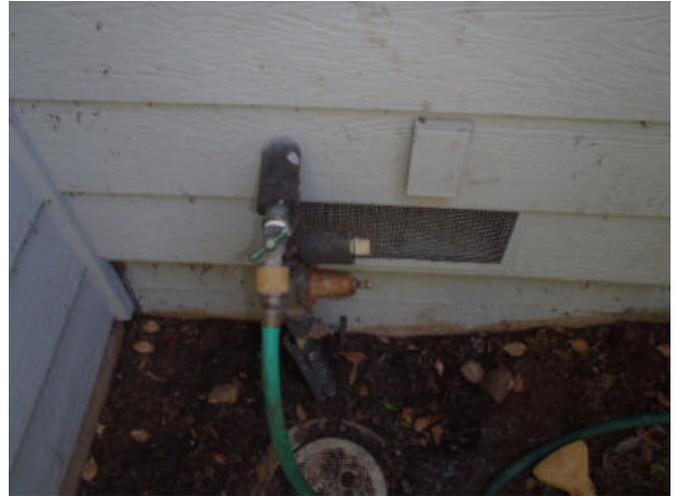
Main water shutoff is located at the front of the structure.

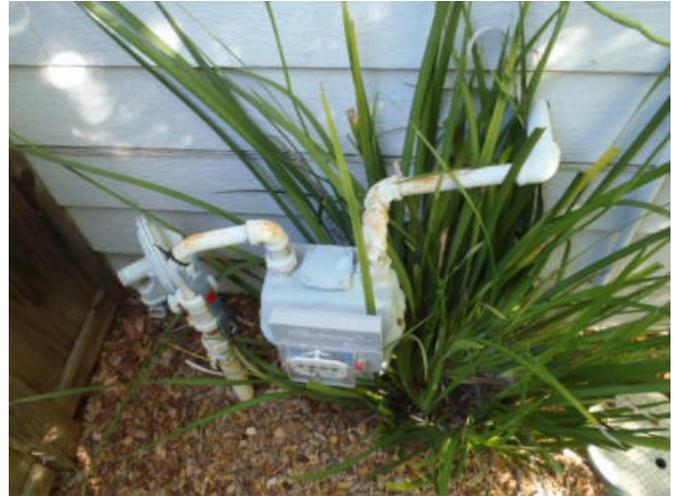
No sediment traps found adjacent to the gas-fired appliances. Often confused with "drip legs" (used when the gas has a high moisture content), sediment traps are typically required to be installed immediately adjacent to specific gas-fired appliances (generally furnaces and water heaters), and are intended to prevent debris within the pipe from entering and obstructing the orifice or control valve of the appliance. This has apparently not been enforced by the local building departments until recently. I recommend review of the installation instructions for each gas fired appliance and installation of sediment traps, as needed.

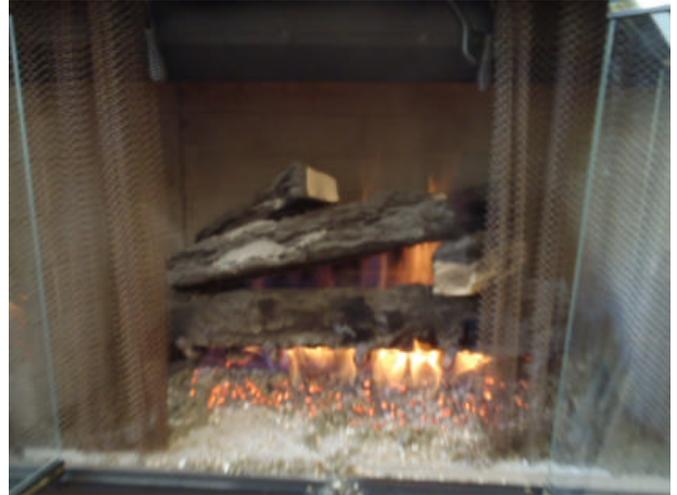
This type of fireplace is typically designed for small, wood burning fires and not intended for a source of primary heat for the home. Large fires can cause damage to the interior of the firebox and chimney. If more information is desired regarding the intended use of the fireplace, the manufacturer should be contacted. A visual review was conducted of the readily accessible areas. If this fireplace has not been cleaned and inspected within the last year, I recommend cleaning and a more complete inspection conforming to NFPA 211 (14.4) "Level II" inspection by a qualified chimney sweep or fireplace specialist.

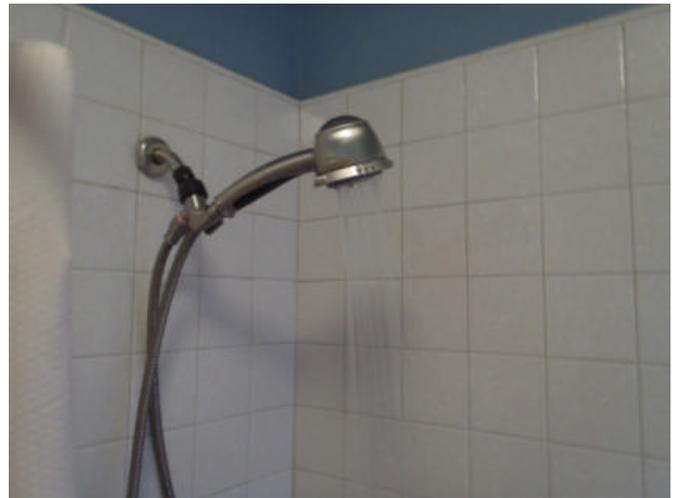
No mechanical ventilation provided. As a window is present, a ventilation/exhaust fan is not required; however, I suggest installation of an exhaust fan to discharge humid air to the exterior of the house.
