Inspected for:
Luke & Ioana Brooks
10643 Chalk Hill Road
Healdsburg, CA

Full Circle Inspections, Inc.

06/19/2013

Re: 10643 Chalk Hill Road
Healdsburg, CA

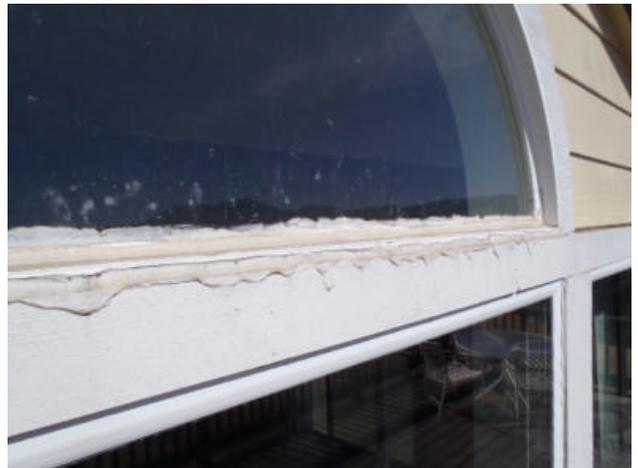
Perimeter of the living room window has been caulked. Stains on the interior wall indicate this was done to repair a leak at the exterior of the window. While keeping the exterior seams well caulked is good practice, Windows should be properly flashed to prevent leaks. My primary recommendation is to remove any trim and/or siding necessary to properly flash the windows.

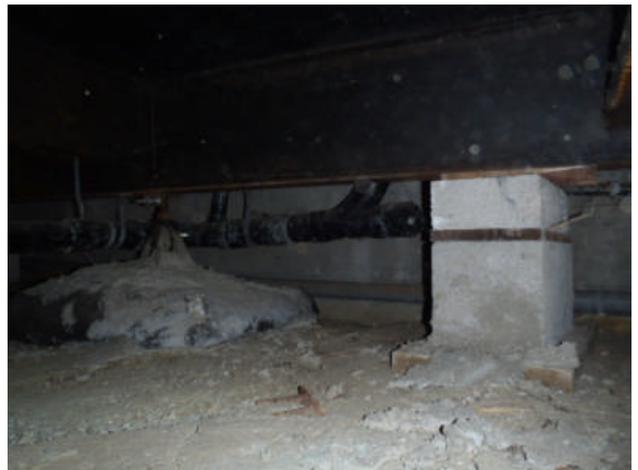
Metal channels under the master bedroom area are bent/distorted. This is the likely cause for the sloped/uneven floors noted in the interior rooms section of this report. Repairs will likely be impractical. If more information is desired, a licensed and qualified structural engineer should be consulted.

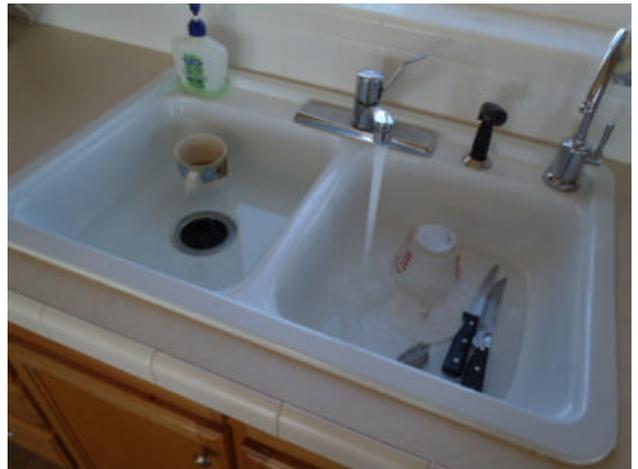
No airgap present on the dishwasher drain line. Please refer to the plumbing section of this report for related information.

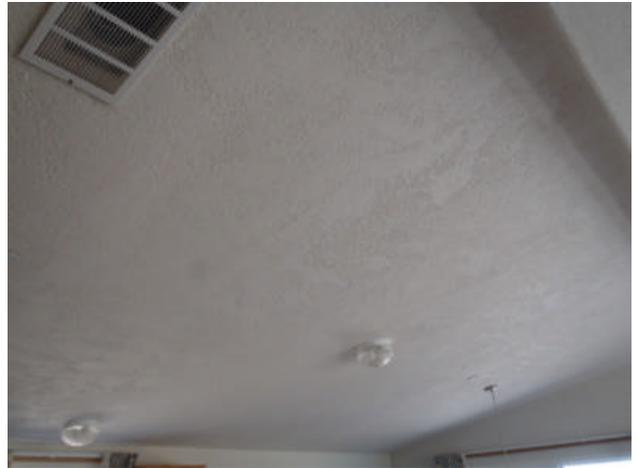
The ceiling above the kitchen and dining area appears to have been patched. I was unable to determine if this was done to repair cracks or if this represents past roof leaks. I suggest consulting with the seller for more information.
