WELL TESTING SERVICE

Ray's Well Testing Service Inc.
4853 Vine Hill Rd, Sebastopol Ca 95472
Phone 707 823 3191 Fax 707 317 0057 Lic# 903708

WATER SYSTEM INSPECTION

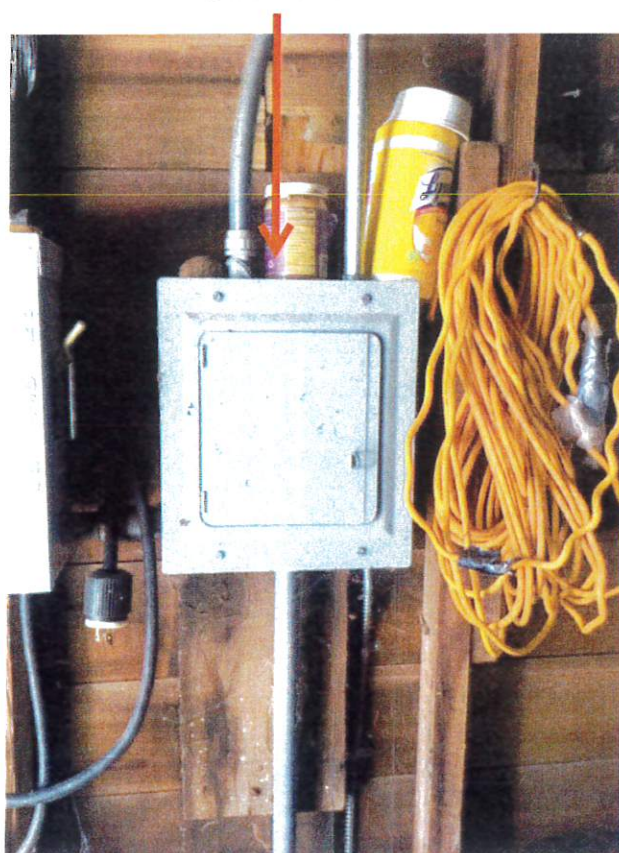
Domestic Float Switch Bypass Toggle

1. There is not a check valve at the well head, recommend installation.
2. If the domestic booster pump electric float switch is bypassed the booster pump is not protected from dry running, recommend installing another float switch at the bottom of tank to prevent damage to pump in an emergency.
3. The electric fill float switch does not have a weight, recommend installation.
4. There is not a sediment pre filter plumbed before the ultraviolet unit. There is not a flow control plumbed after the ultraviolet unit. Recommend installation.
5. Water test results and possible follow up recommendations pending.
