Inspected for:
Wendy or Andrew Welling
88 Calistoga Road
Santa Rosa, CA

Full Circle Inspections, Inc.

09/03/2020

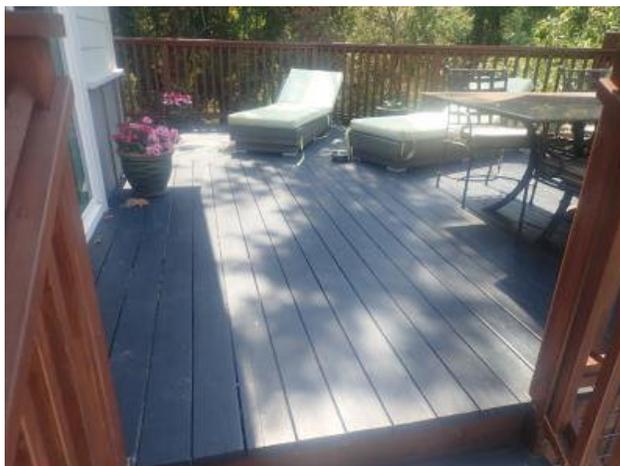
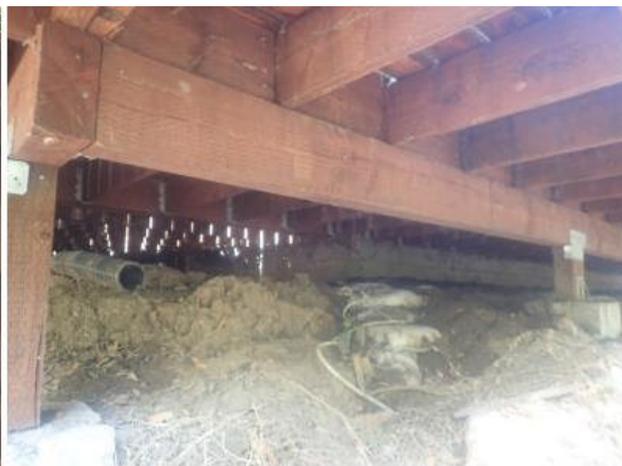
Structure:

Wood deck supported on wood framing.

We do not verify soil stability or footing depth under the deck supports. If information about the foundation is desired, a licensed structural engineer or soils engineer should be consulted.

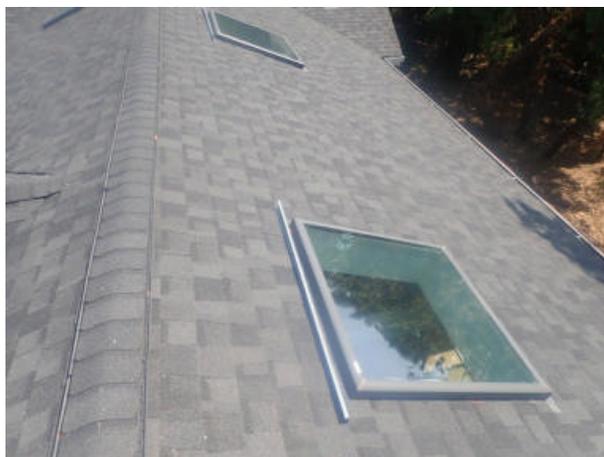
Skylight:

Intact.

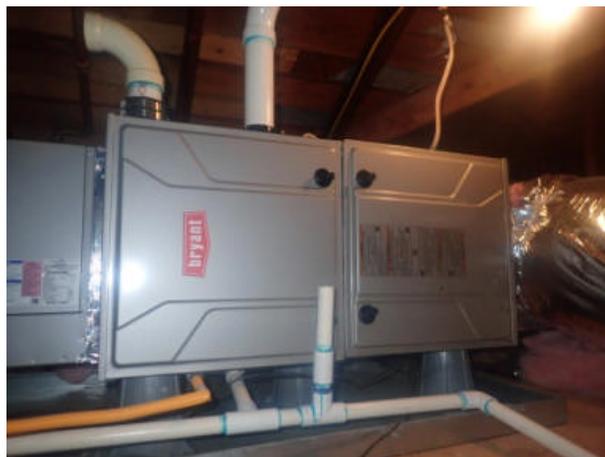
Gas-fired forced air furnace. Input: 60,000 BTU per hour.

The furnace is located in the attic.

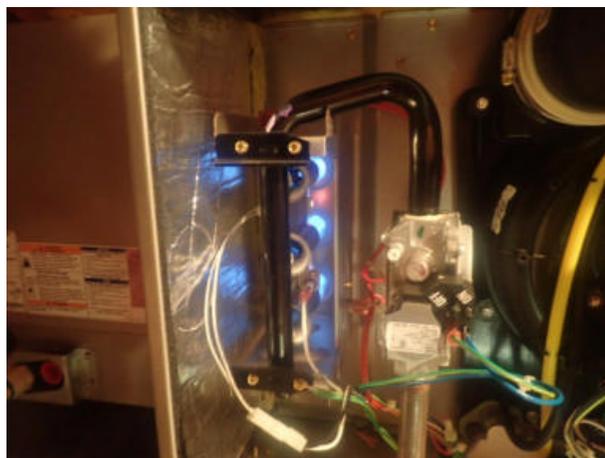
Condition:

Gas shutoff valve and electric disconnect present.

This appliance was operated at time of inspection. Regular maintenance is recommended to ensure continued operation.

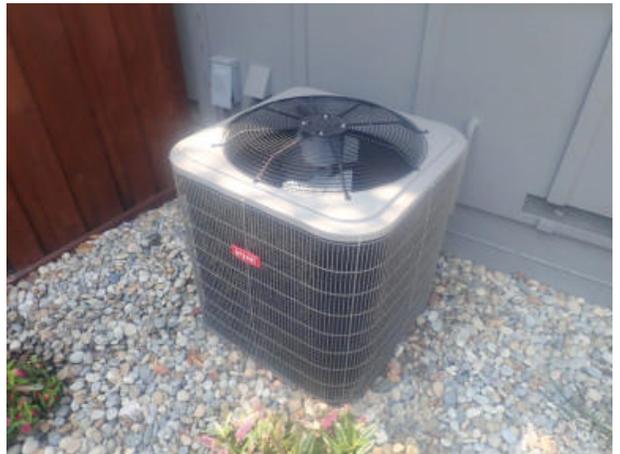
The appliance was operated at time of inspection. Refrigerant line was cold adjacent to the evaporator and cool air was observed at the interior registers. The inspection does not include pressure testing or review for leaking, therefore no representation is made regarding coolant charge or line integrity. I recommend cleaning and servicing by a licensed heating contractor.

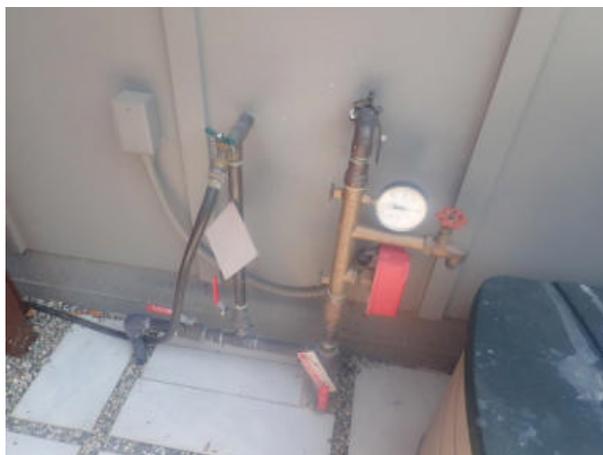
Main Shutoff:

Main water shutoff is located at the right side of the structure.

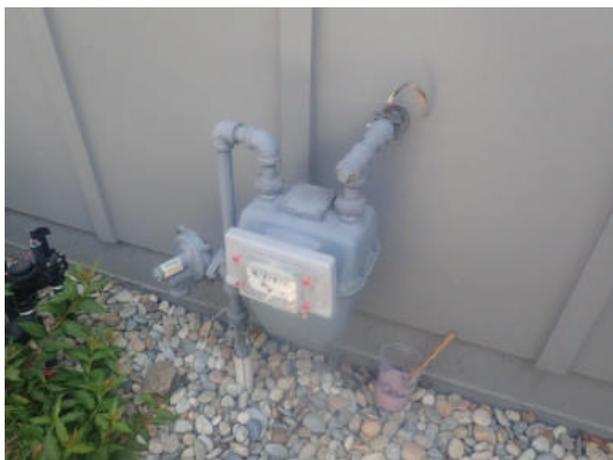
**Fuel Supply:****Location:**

Meter is located at the right side.

I recommend keeping a wrench adjacent to the meter to allow the gas to be shut off, if necessary. PG&E maintains a website with current information regarding gas and when to shut it off. http://www.pge.com/myhome/edusafety/gaselectric_safety/turngasoff/index.shtml If the current owner or occupant removes any existing gas appliances, the valves should be capped to prevent gas leaks.

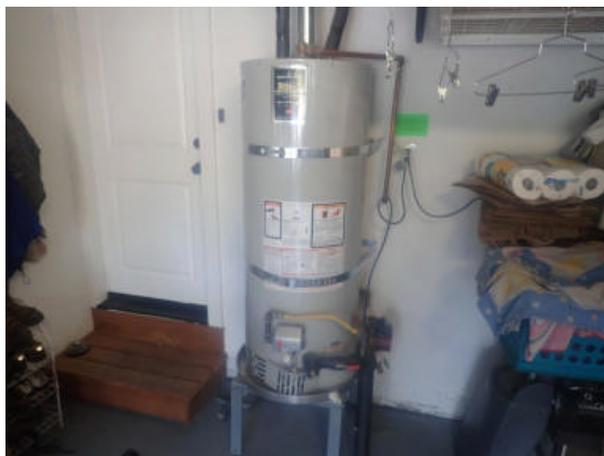
50 gallon gas-fired water heater.

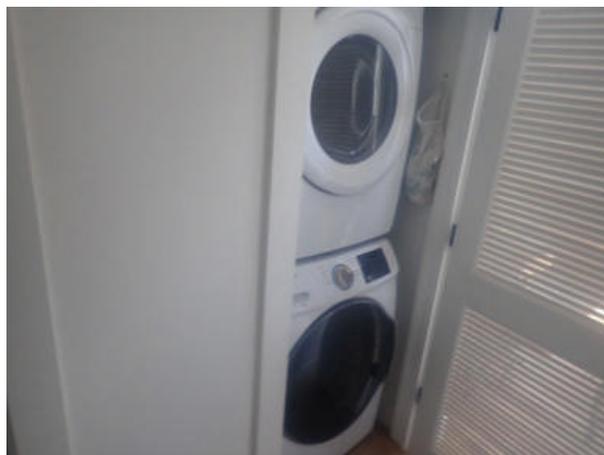
Laundry is located at the hall closet.

Review was limited due to the presence of the laundry appliances. This area can be reviewed once the appliances have been removed.

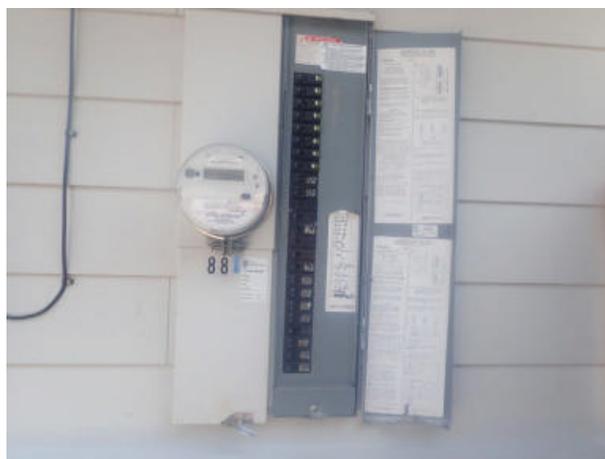
General:

Service equipment is located at the right side of the garage.

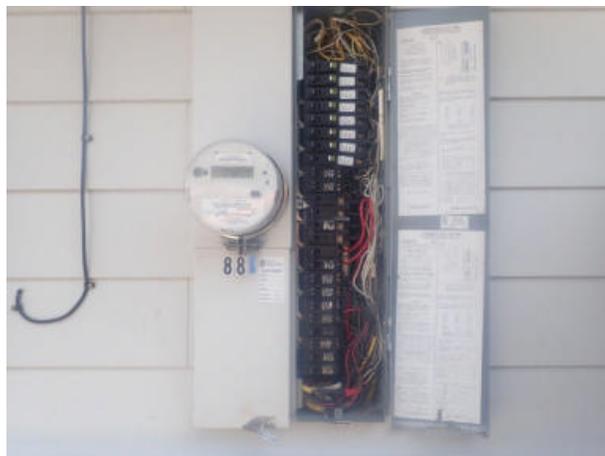
Panel make: Square D.

Service disconnect (main) is present.

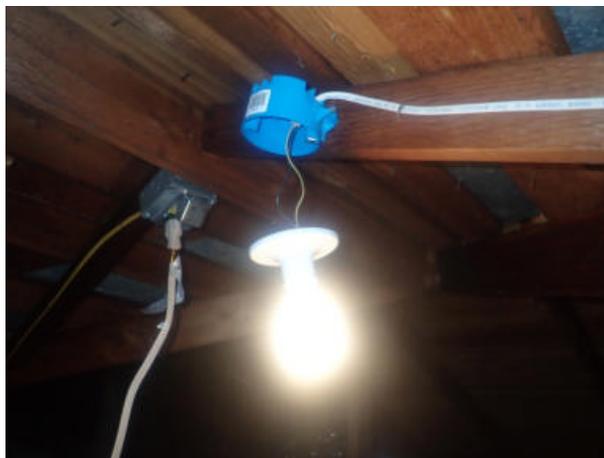
The porcelain light fixture is hanging by the electrical wiring. This should be properly secured/attached to the junction box.

Unable to view the majority of the electrical wiring due to the presence of insulation.

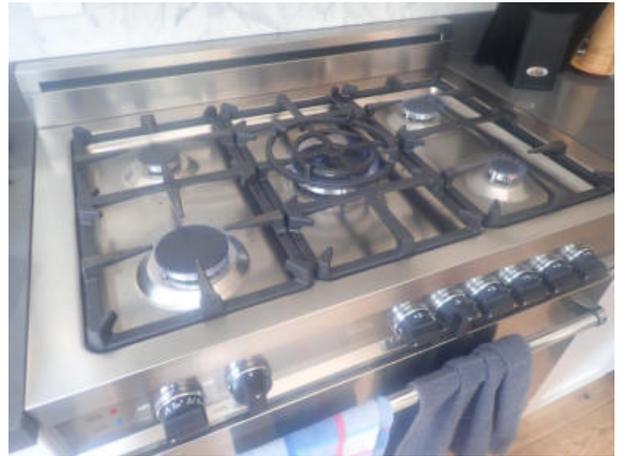
Brand: Bertazzoni, gas range.

Control knobs must be held/pushed-in in order for the burners to ignite. I recommend review of the manufacturer's operation instructions for more information,

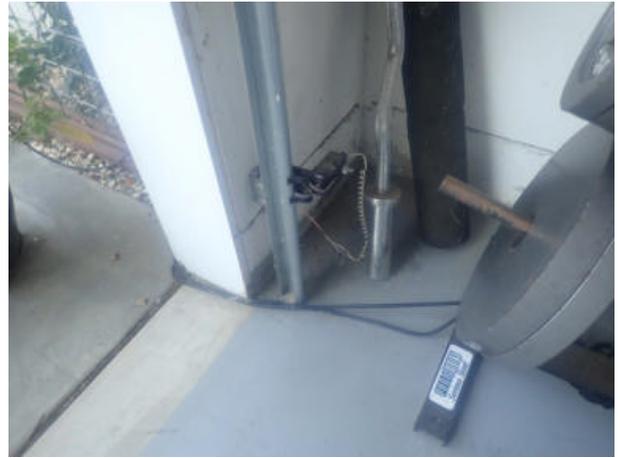
The height of the "electric-eye" sensors for the opener is excessive. Most garage door manufacturers' installation instructions require the sensor to be installed no more than 6" above the slab. The installation instructions for this opener should be reviewed and corrections made, as needed.
