Inspected for:
Paula Skinner
Karen Pearlman
5820 Enterprise Road
Glen Ellen, CA

09/03/2020

Re: 5820 Enterprise Road
Glen Ellen, CA

Gunnar Alquist
Full Circle Inspections, Inc.
122 Calistoga Rd. #196
Santa Rosa, CA 95409
707 528-7010
Gunnar@FullCircleInspect.com

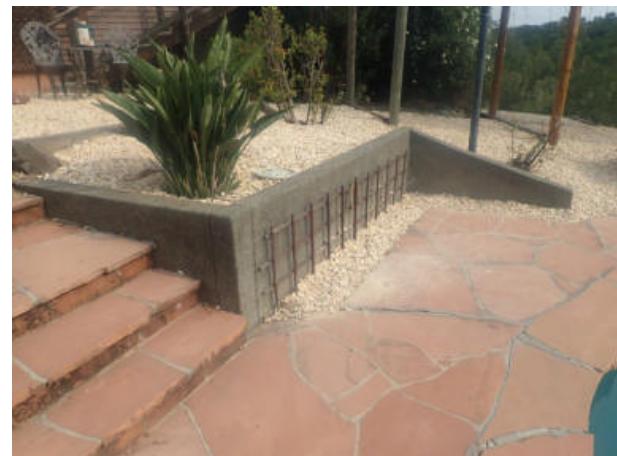
No guardrail present along the top of the retaining wall. While this may not be a requirement, an individual could fall from the top of the wall, resulting in injury. Installation of a guardrail would increase safety.

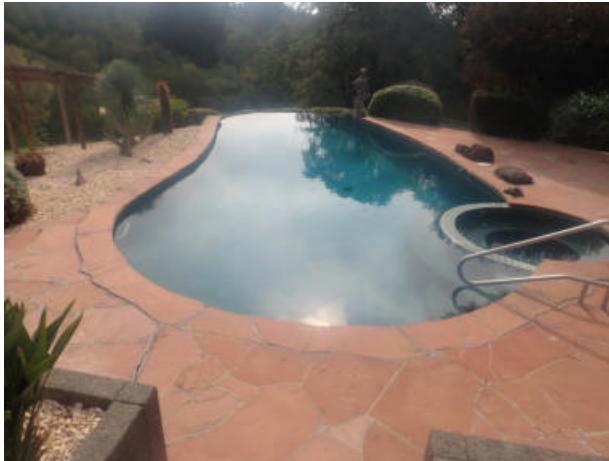
A built-in pool is present. Pools, spas and ponds are a drowning hazard, particularly with children.

Homeowners may be held personally liable for injury or death caused by drowning in a pool, pond or spa. Pools, spas, ponds, piping, pumps, timers, and ancillary equipment are not a part of a home inspection and were not reviewed as a part of this inspection. I recommend having a qualified contractor or technician inspect and verify safety and proper operation. Efforts should be taken to provide any needed effective barriers, fences, covers and alarms to prevent unsupervised individuals, particularly children and anyone temporarily or permanently incapacitated or inebriated, from accessing the pool and to help prevent drowning. Safety upgrades including, but not limited to, installation of

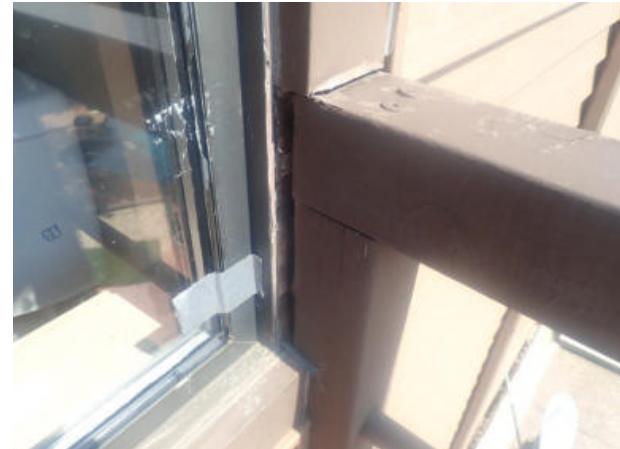
Voids were observed between the siding and the master bathroom balcony railing. This will allow rain to penetrate behind the vinyl siding. I recommend installation of flashing or corrections, as needed.

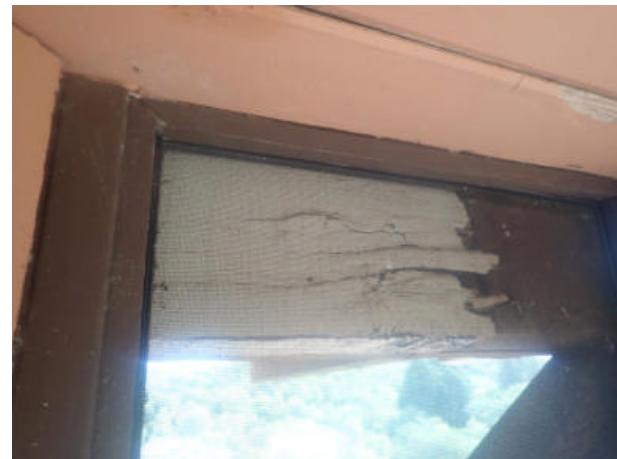
Decayed/damaged lumber was found at a support girder at the rear. This could be seen from the lower deck outside of the kitchen. Exterior decks are subject to the weather and therefore have a limited life. Decay/damage of this type is specifically described as having been caused by a wood destroying pest or organism in the California Business & Professions Code §8505 and is the responsibility of a pest inspector licensed by the California Structural Pest Control Board. This should be inspected for wood-destroying organisms and damage by a licensed branch 3 inspector and any damaged or infected lumber replaced with new material or treatment made, as needed. I recommend the use of pressure treated lumber for exterior structures as it is more resistant to this type of damage than untreated lumber.

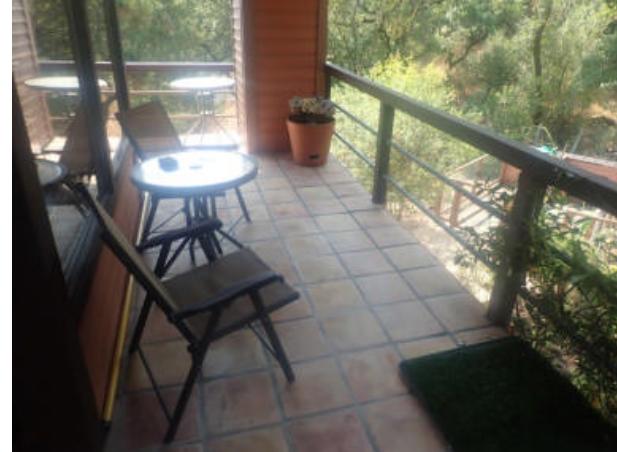
Spacing between railing members is greater than currently allowed. Please refer to the Right Side Deck notes for related information.

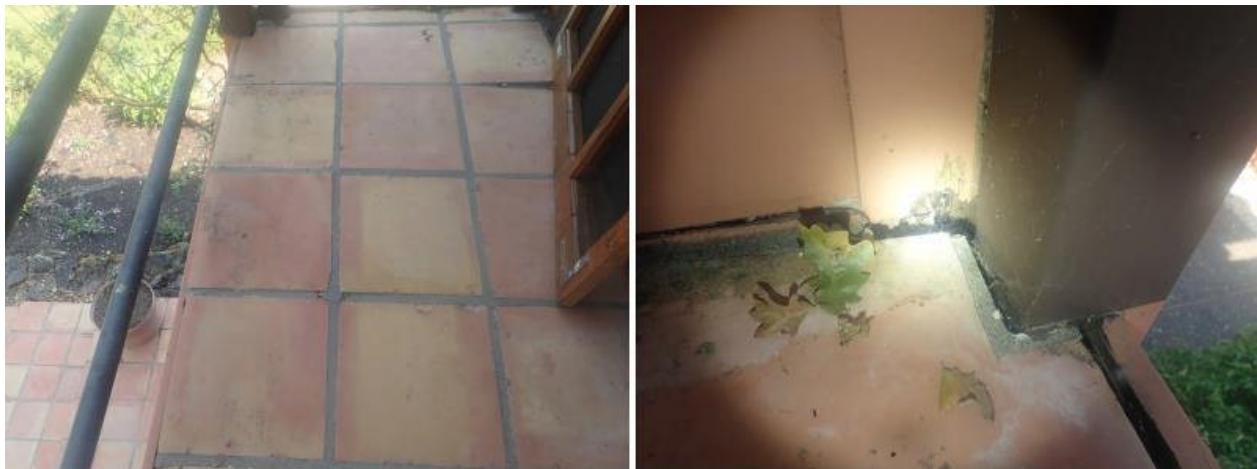
Left/Front Bedroom Balcony:

The deck tiles are buckled and loose, and a void was found at the right side wall adjacent to the deck surface. I am concerned that water has gained entry to the wood framing below and adjacent to the balcony. Further review and repairs will likely require removal of the tile surface. If any damaged floor sheathing or framing are found at that time, repairs should include replacement of damaged lumber.

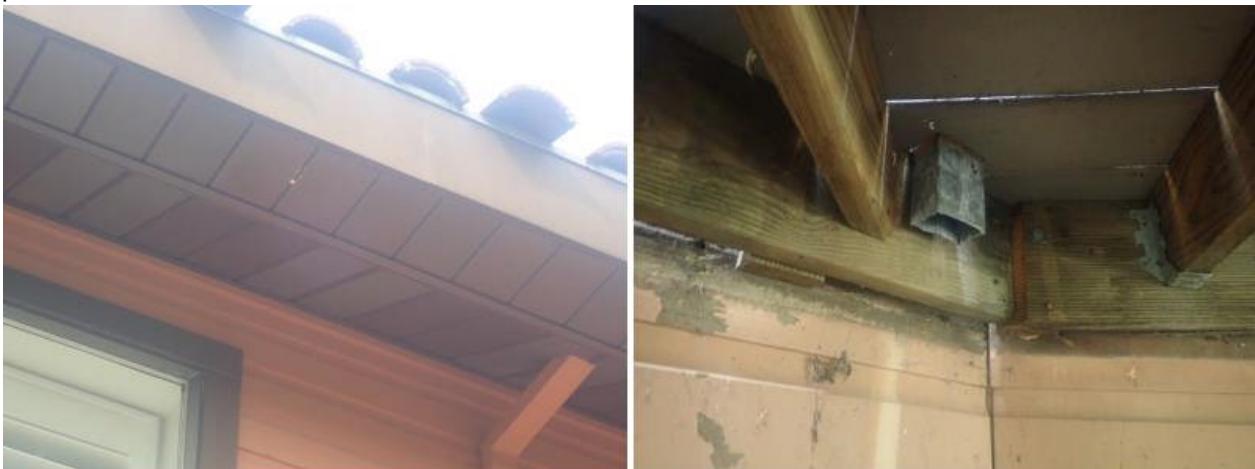
Gutters are integral with the roof. Integral gutters will require periodic maintenance and cleaning. Gutters should be inspected annually and seams should be sealed with a good grade of caulk or mastic to prevent leaking to the eaves and causing moisture damage to the wood framing.

Stains under the enclosed soffit at the left side indicate that gutters will leak at connections. Corrections are advised.

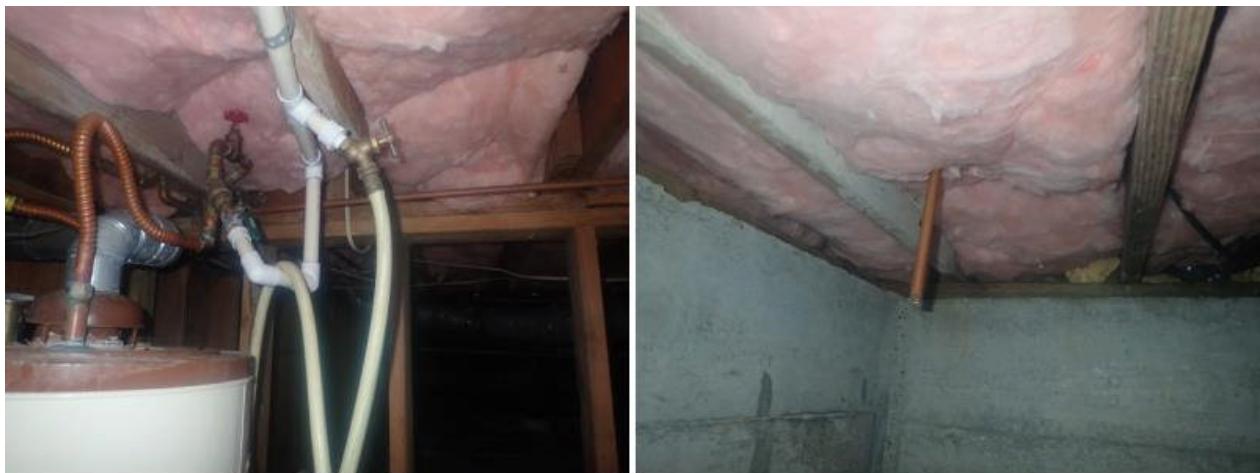
Where visible, distribution piping is copper and PVC.

PVC piping has been used in the foundation crawlspace area. PVC (polyvinyl chloride) piping is not approved for use as distribution piping. While this piping appears to be for the exterior irrigation and not for interior domestic use, PVC should not be used within the building envelope as it has a greater tendency to break/fail which can lead to significant amounts of water in the foundation crawlspace area. My recommendation is to replace this piping with a material that is approved for distribution piping.

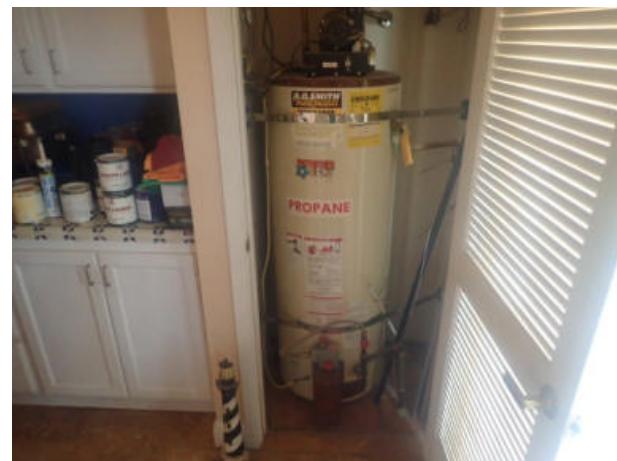
No drain pan present under this appliance. If a leak were to develop, the water would flood the floor in this area. A properly sized pan should be installed with an adequately sized drain pipe that discharges at the exterior of the building, preferably to a location that is readily visible so that any leaking will be easily noticed.

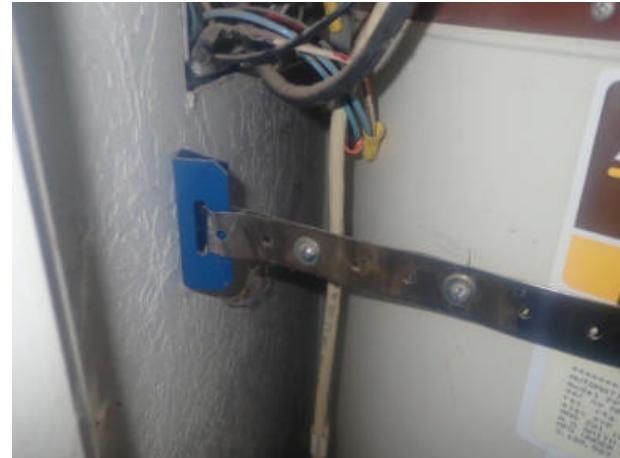
Seismic/earthquake bracing for the water heater is inadequate. While two straps are present, they do not appear to have been installed as specified and may not perform as intended. The intent of seismic bracing is to restrict the water heater from falling over in the event of an earthquake. The distance from the tank to the wall is greater than 1 inch, which will allow the tank to move laterally during an earthquake. Most manufacturers' instructions require this space be filled with a bracket or a framework installed to limit movement. Complete instructions can be obtained from the manufacturer of the kit. These should be reviewed and corrections made, as needed. More information can be obtained from the Division of the State Architect or from the pamphlet titled The Homeowners' Guide to Earthquake Safety.

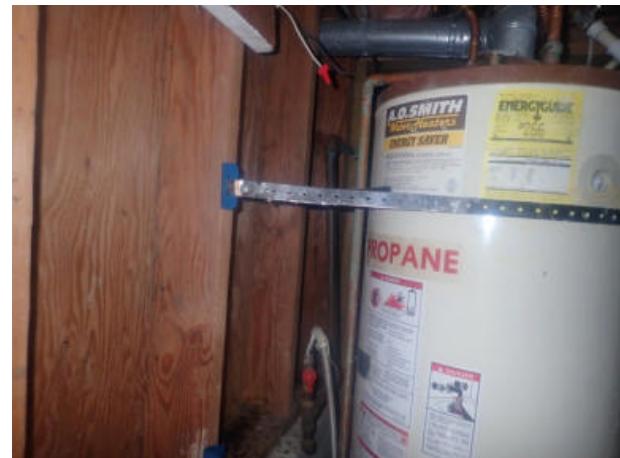
Seismic/earthquake bracing for the water heater is inadequate. While two straps are present, they do not appear to have been installed as specified and may not perform as intended. The distance from the tank to the wall is greater than 1 inch, which will allow the tank to move laterally during an earthquake. Most manufacturers' instructions require this space be filled with a bracket or a framework installed to limit movement. Complete instructions can be obtained from the manufacturer of the kit. These should be reviewed and corrections made, as needed. More information can be obtained from the Division of the State Architect or from the pamphlet titled The Homeowners' Guide to Earthquake Safety.

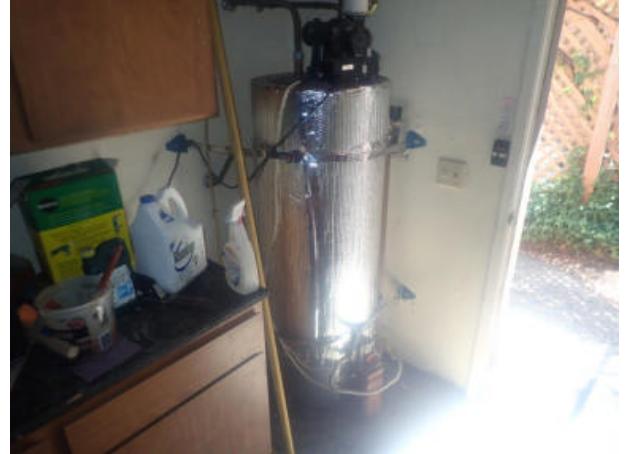
Water heater is resting directly on the garage floor.

Typically, a water heater is required to be a minimum of 18 inches above the garage floor. This is intended to raise the flame to prevent ignition of any gas fumes which can collect in the garage. This indicates that this water heater was not installed by a licensed plumbing contractor. This water heater should be raised to conform to current safety requirements.

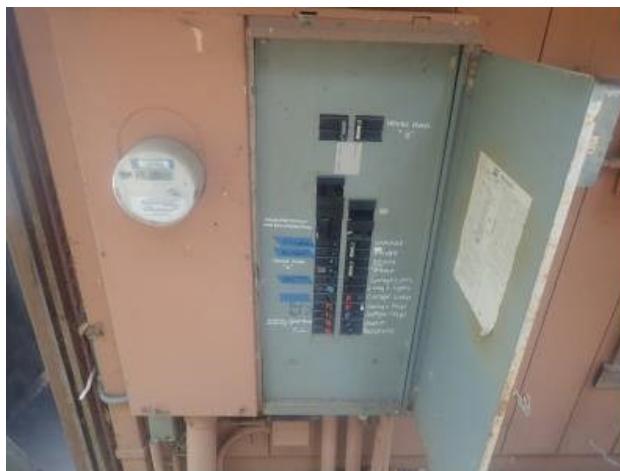
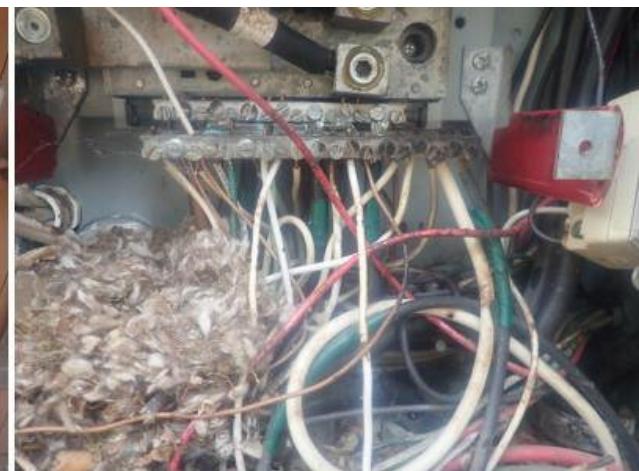
Knockouts are missing at the dead-front as well as the panel enclosure wall.

Knockouts are missing at the dead-front as well as the panel enclosure wall. The openings in the dead-front present a potential safety hazard as they provide access to the energized electrical wiring and buss bars of the panel. The interior openings has allowed small animals access to the interior of the panel. This is typically corrected by inserting snap-in covers; tape is not an acceptable substitute. Corrections are advised.

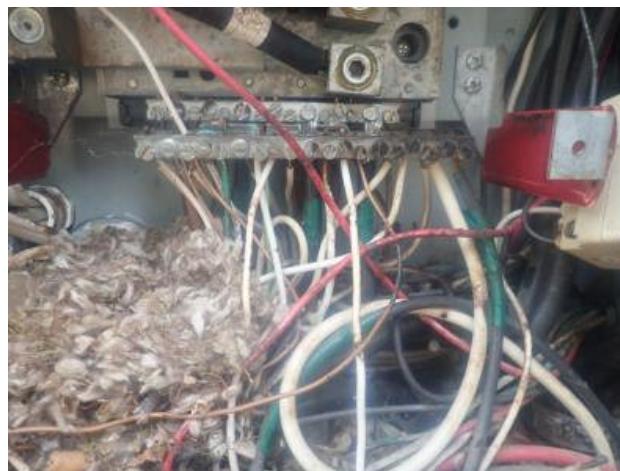
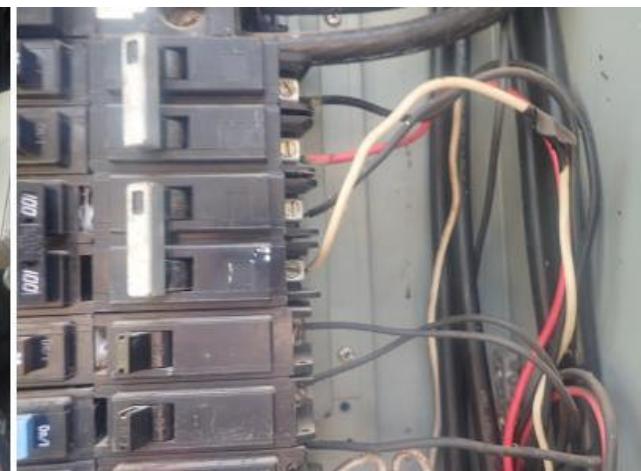
Multiple wires are connected to a single lug on the neutral terminal bar where only one wire should be connected. This can prevent the wires from having positive contact with the connector which could lead to arcing or other problems with the electrical system and is normally corrected by moving wires so that only one neutral (white) wire is attached at each terminal connection. While this is a straightforward correction, any modification of the electrical system should be done by a licensed electrical contractor.

A white wire has been connected to a circuit breaker. Current construction standards generally reserve white for the "neutral" conductor. When a white wire is used for a 240 volt circuit, the wire is typically wrapped with another color, such as black, to properly identify it as a voltage carrying conductor.

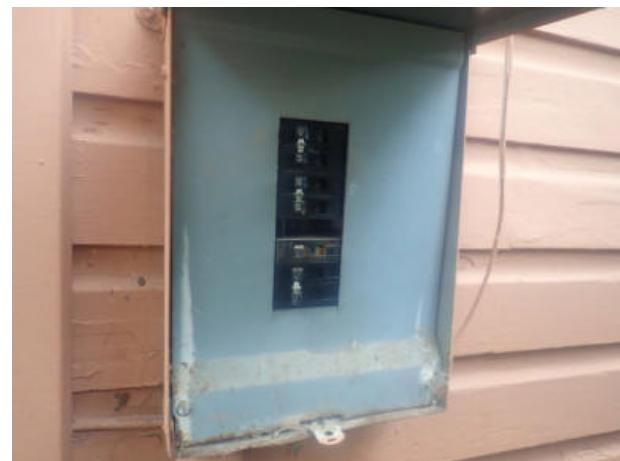
I was unable to determine what this panel serves.
Most of the circuit breakers have been disconnected
from the outgoing wiring.

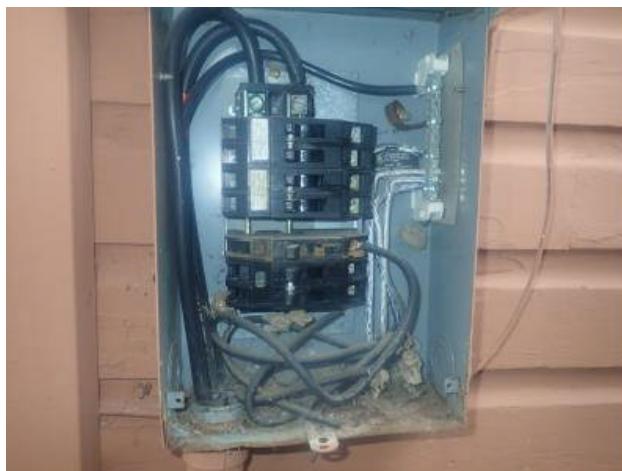
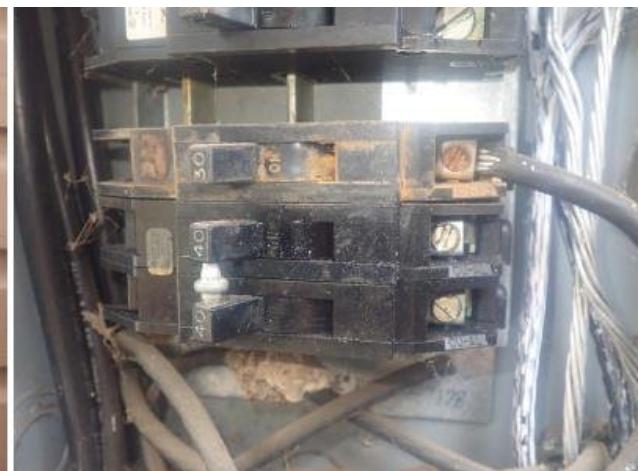
A single-pole, 30 ampere circuit breaker is present in this panel. While not necessarily improper, a 120 volt, 30 amp circuit is unusual in residential construction. I was unable to determine what this circuit serves. I suggest consulting with the current owner for more information. If no documentation or further review is desired, a licensed electrical contractor should be consulted.

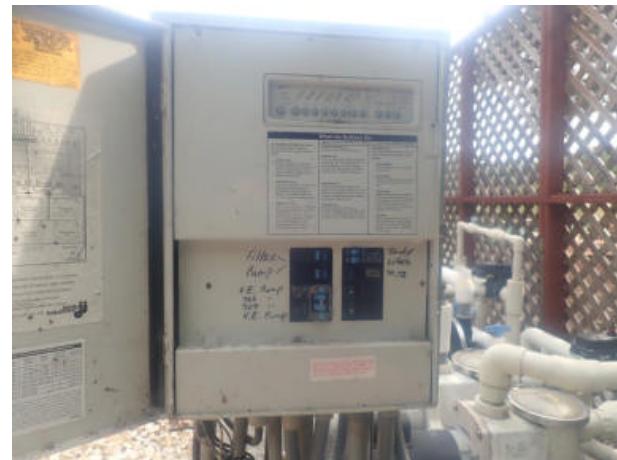
Not all of the pool circuits are GFCI protected. Current construction standards require all electrical for new pools and related equipment to be GFCI protected. While this may not be required by the local building department, having a licensed electrical contractor upgrade any needed electrical with GFCI protection is advised to help increase safety.

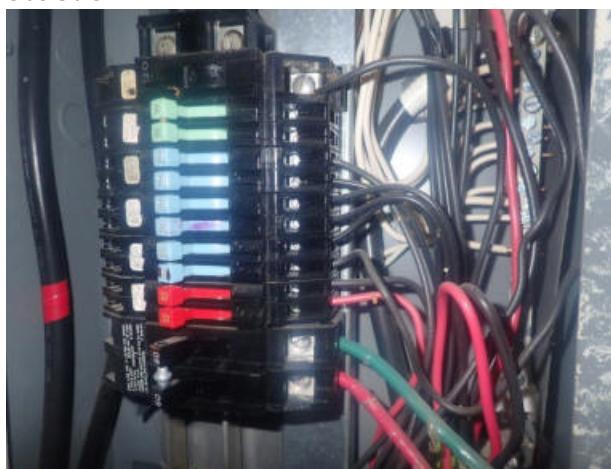
Over Current Protection:

Over current protection is provided by circuit breakers.

Panel make: Sylvania.

Conditions have been reported with this brand of electrical panel (Zinsco/Sylvania) that include arcing at the circuit breaker/buss bar connections. This condition is largely due to the method of attachment between the circuit breakers and the buss bars. As a result of this design, this panel is more likely to fail than a modern panel. To the best of my knowledge, there is no governmental or officially recognized agency currently tracking failures from these circuit breakers or panels and any information that I have been able to find regarding failures is anecdotal. This brand of

panel was very commonly used in structures built between the early 1960s through the late 1980s. Consequently, I find this brand of panel in the vast majority of buildings constructed during that time period. Some electrical contractors are reluctant to perform work on these panels, typically citing liability concerns regarding failure. As these panels are no longer being manufactured, upgrade/replacement parts can be difficult and expensive to obtain should the need arise. While no evidence of arcing was observed within this panel at time of inspection, positive determination of the breaker/buss bar connection can only be made by having an electrician remove the circuit breakers in order to inspect the buss bars. However, removing and replacing circuit breakers to examine the buss bar could loosen a connection that had acceptable contact before it was disturbed. As a result, the most prudent course would be to replace this existing panel with a new panel equipped with modern circuit breakers. A licensed electrical contractor can provide more information, costs and any upgrades.

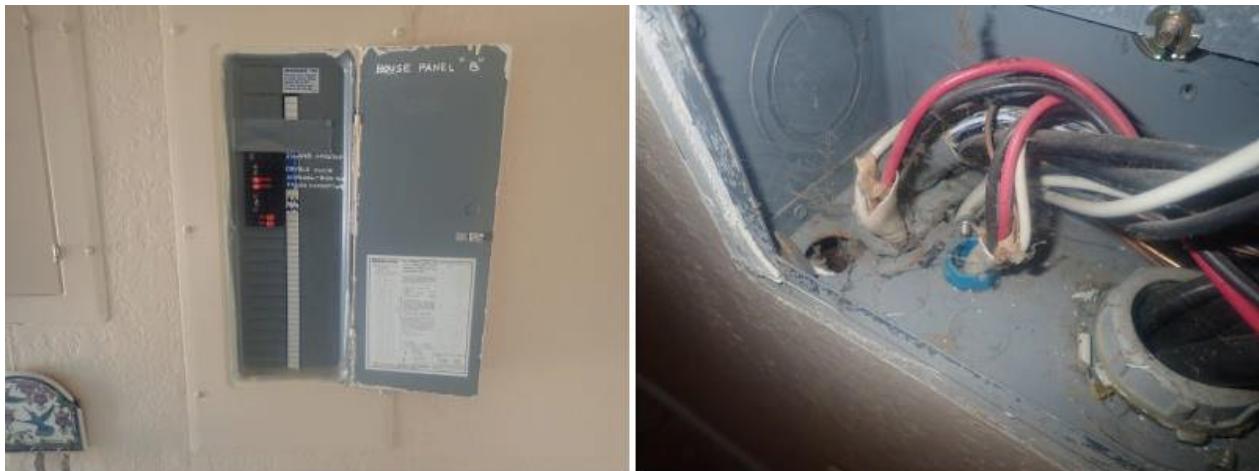
General:

Located at the laundry area.

Knockouts are missing at the panel enclosure wall. This is typically corrected by inserting covers specifically designed to close these openings.

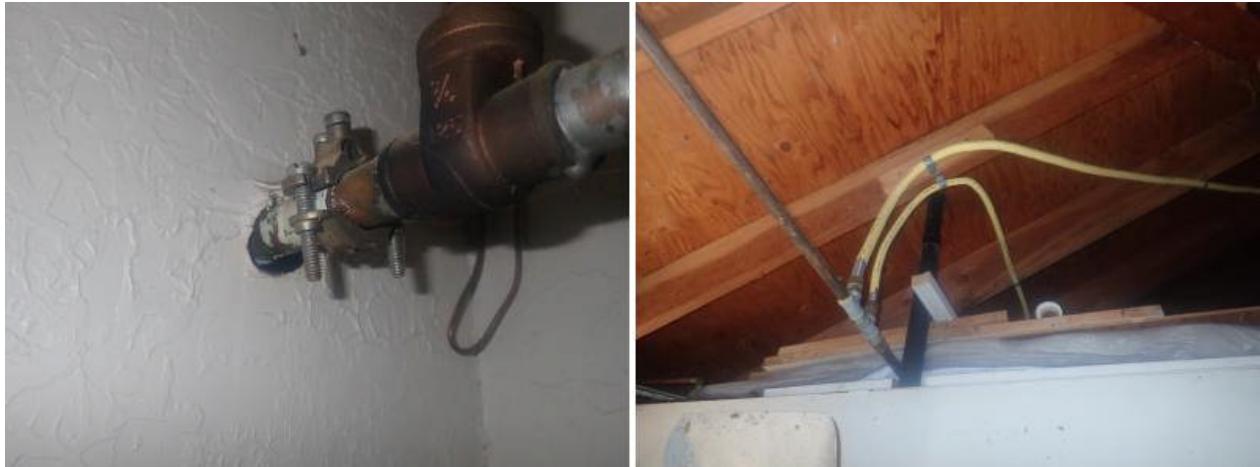
Grounding & Bonding:

Grounding system has likely been provided by a concrete encased electrode or "ufer" ground. A "ufer" utilizes the foundation system for grounding and is not visible. Grounding is checked at receptacle outlets and visually at the panel.

The bonding clamp adjacent to the water heater is loose. Clamps should be properly secured or replaced, as needed, to ensure proper bonding of the metal pipe.

No "bonding" jumper found on the water heater supply piping or the gas supply piping. Metal piping is currently required to be connected (bonded) to the electrical grounding system. This may not have been required at time of construction. Should the metal piping become energized (through a short-circuit or other means), the bonding circuit is intended to conduct the electrical current to ground. Normally, a bonding jumper is provided between the inlet and outlet water supply pipes at the water heater, at any dielectric plumbing fittings as well as on a rigid section of the gas supply line to ensure that all of the metal supply piping is properly bonded. While this does not necessarily indicate that the plumbing system is unsafe, bonding of the hot water piping or the gas supply piping could not be verified and installation of bonding jumpers is advised.

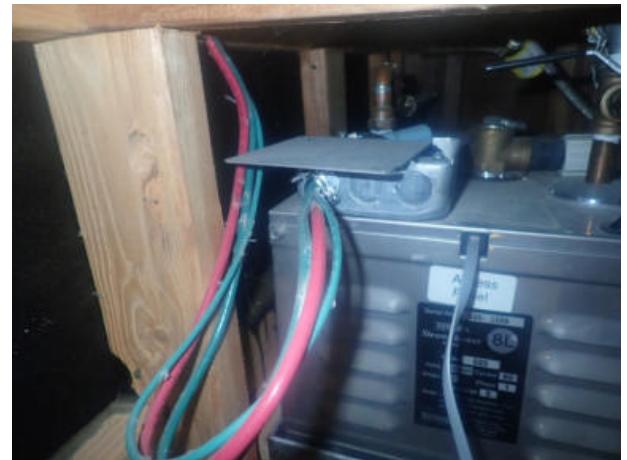
Individual conductors have been used at the steam generator in the master bathroom. In addition, the cover plate for the junction box is not properly installed. Typically, a manufactured nonmetallic sheathed cable is used for electrical wiring in residences. When individual conductors are used, they are enclosed in a conduit for protection. Corrections/repairs should be made by a licensed electrical contractor.

Receptacle outlets are GFCI protected.

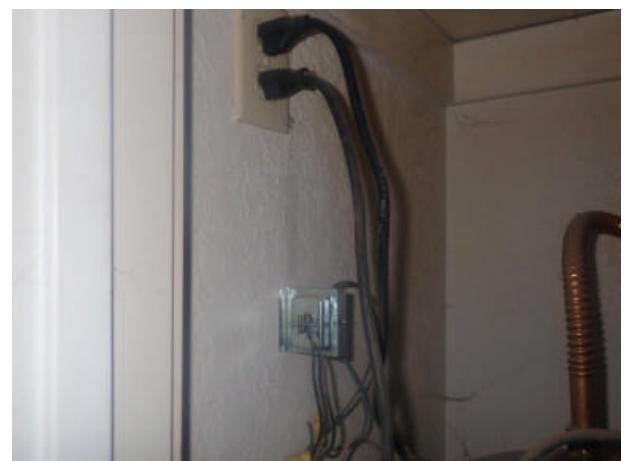
**Interior Fixtures:**

Unprotected electrical splices present adjacent to the laundry area water heater. Electrical splices should be enclosed in a covered junction box to help prevent separation of the splices. Corrections should be made by a licensed electrical contractor.

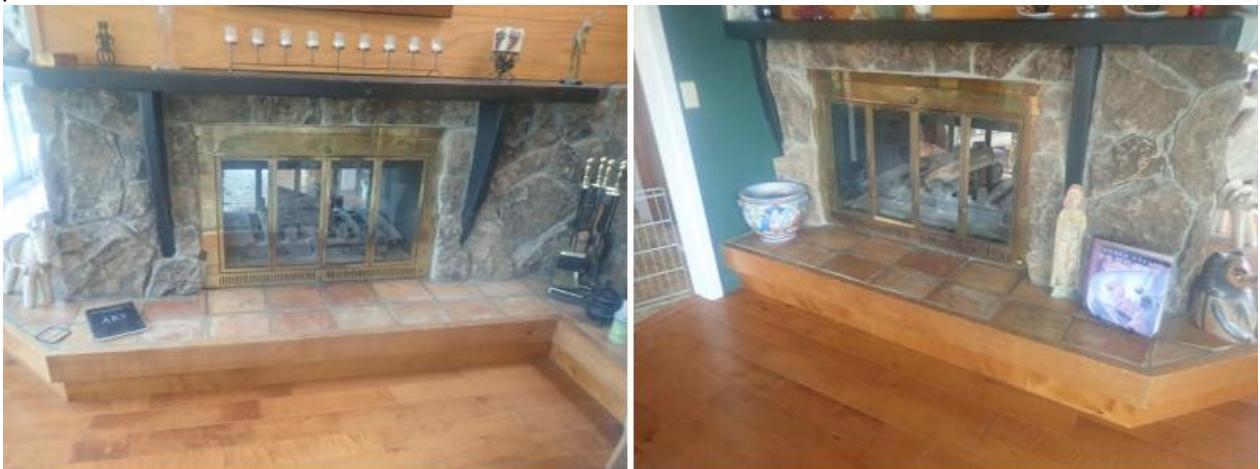
Living Room Fireplace:

Manufactured, "zero clearance" fireplace unit.

A visual review was conducted of the readily accessible areas; however, portions (particularly sections of the chimney) are not fully accessible. If this fireplace has not been cleaned and inspected within the last year, I recommend cleaning and a more complete inspection conforming to NFPA 211 (14.4) "Level II" (or comparable) by a qualified chimney sweep or fireplace specialist. The period of time around transfer of ownership is an excellent chance to have this done. I also advise annual cleaning and inspection to allow continued safe operation.

Soot/creosote build up observed. Routine cleaning by a qualified chimney sweep is recommended to ensure safe and efficient operation.

No throat damper present. If I recommend replacement of the damper or corrections, as needed.

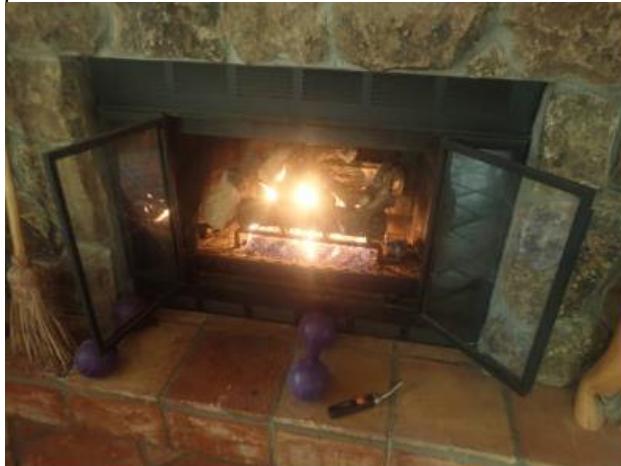
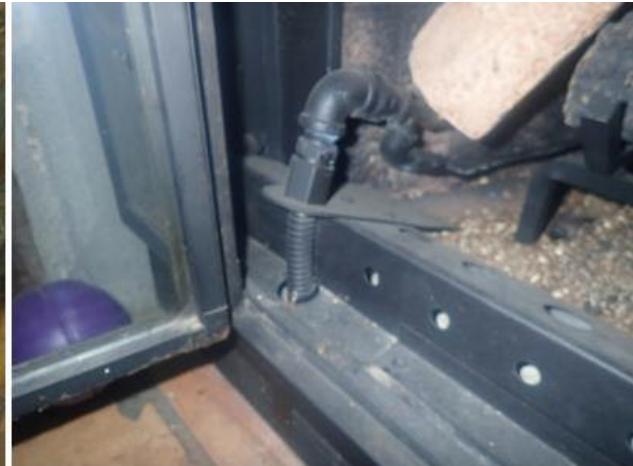
Den Fireplace:

Manufactured, "zero clearance" fireplace unit.

A flexible gas line has been run to the front of the firebox and is providing gas to the burner. I am concerned that this is not a proper installation. I could not find the gas shutoff valve. Flexible gas connectors are allowed for use between the gas shutoff valve and the appliance, as long as both the valve and appliance are in the same room. In addition, the sharp metal edges of the hole could damage the thin metal of the connector. I recommend review by a licensed and qualified plumbing contractor or gas fireplace technician and corrections, if needed.

Glass at the front of the fireplace is discolored. This occurs as a byproduct of the gas combustion. Usually, this can be cleaned off with a vinegar/water solution or glass cleaner (the glass will need to be removed in order to access the interior surface). However, occasionally, this film can become etched into the surface of the glass. This should be cleaned on an annual basis or as recommended by the manufacturer.

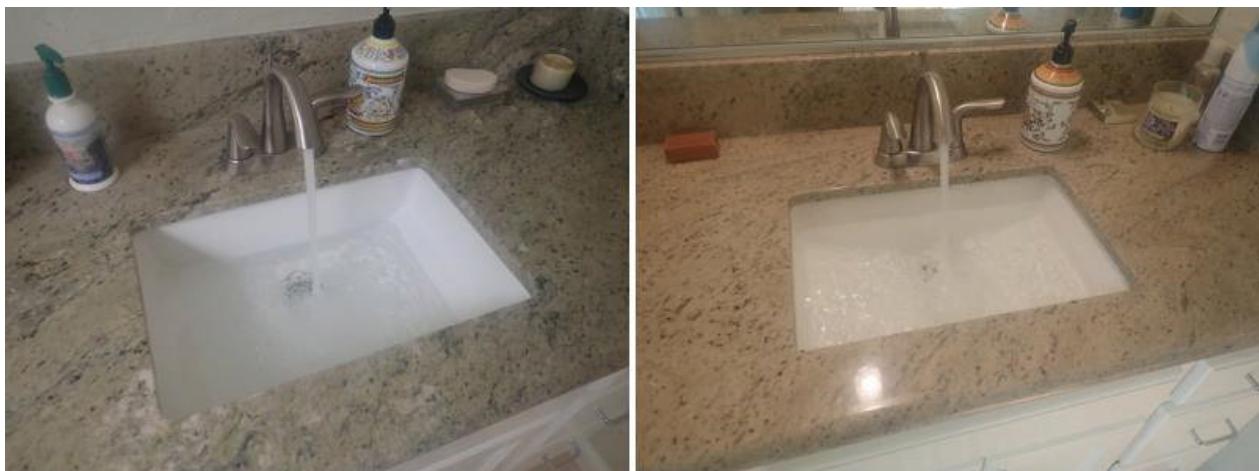
Sink:

Two sinks present.

A leak was observed at the outer sink drain. Repairs should be made by a licensed plumbing contractor to prevent damage to cabinet and/or structure.

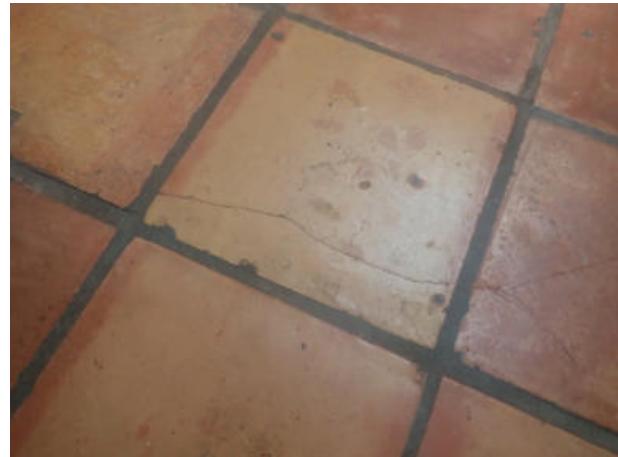
Floors:

Interior floors are sloped/uneven at various areas. Noticeably sloped floors were found in the master bedroom, left/front bedroom, upstairs hallway, and downstairs sitting area. Sloped floors were observed at other areas as well. The current owner indicated that this was a result of inadequate foundation support that has been corrected. I recommend review of the engineering documentation for specific information.

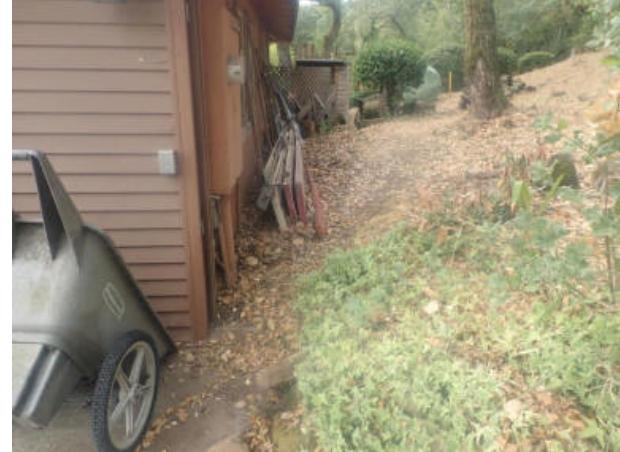
Grade & Drainage:

The floor level of the right side rooms is below exterior soil grade. No evidence of moisture penetration was observed at the interior of this room at time of inspection. I recommend consulting with the seller for information regarding this area and any indications of past water penetration, mold or mildew. If information indicates water penetration, I recommend review by a qualified drainage specialist or landscape contractor and corrections, as needed. Further review would require excavation of soil.

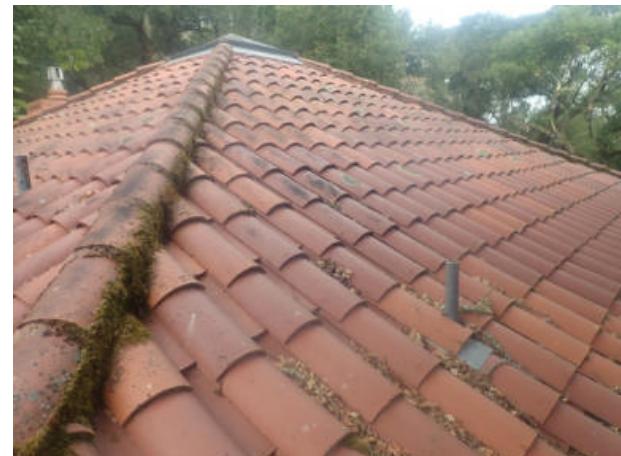
Condition:

Damaged/displaced tiles were observed at the left side of the roof. Damaged tiles should be replaced by a licensed roofing contractor to prevent leaks and subsequent moisture damage.

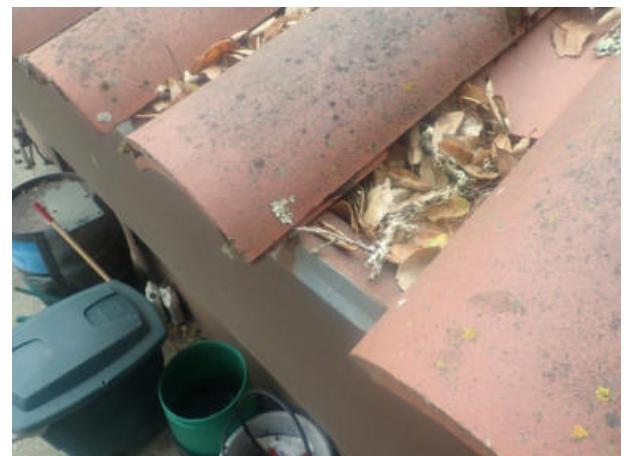
Debris is present in the gutters. Debris should be routinely cleaned from the gutters. Debris build up can cause overflows and damage to gutters.

Integral gutters will require periodic maintenance and cleaning. Gutters should be inspected annually and seams should be sealed with a good grade of caulk or mastic to prevent leaking to the eaves and causing moisture damage to the wood framing.

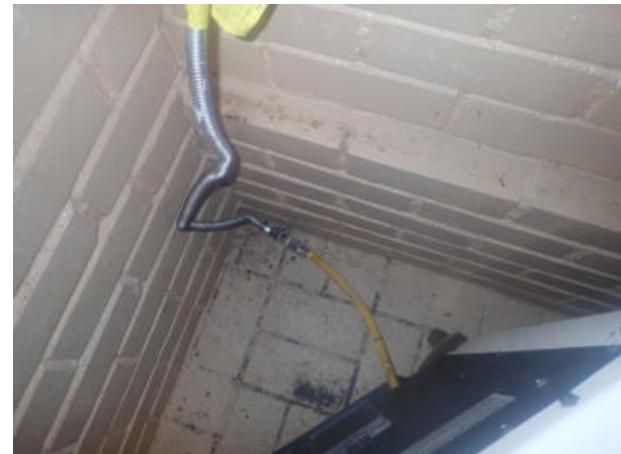
Fireplace:

Gas-fired fireplace. These units are designed for gas only and solid fuel should not be used.

Two flexible gas connectors have been connected in tandem. These gas connectors are only approved to be connected to each other. I recommend replacement with a single gas connector of an appropriate length or moving the rigid gas pipe so it is close enough that the shorter flexible connector can reach. Corrections should be made by a licensed plumbing or heating contractor.

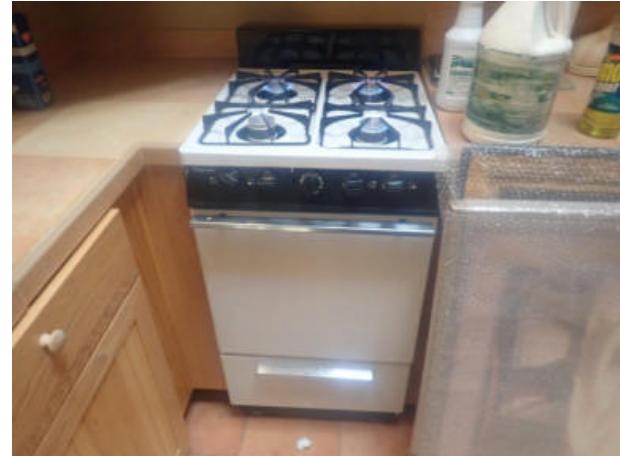
Brand: Magic Chef, gas range.

The burner at the left/front did not ignite automatically when operated. Cleaning, adjustment or repairs are needed to restore proper operation.
