Inspected for:  
Linda or Bret Anderson  
3510 Alta Vista Avenue  
Santa Rosa, CA

## Full Circle Inspections, Inc.

11/30/2020

Re: 3510 Alta Vista Avenue  
Santa Rosa, CA

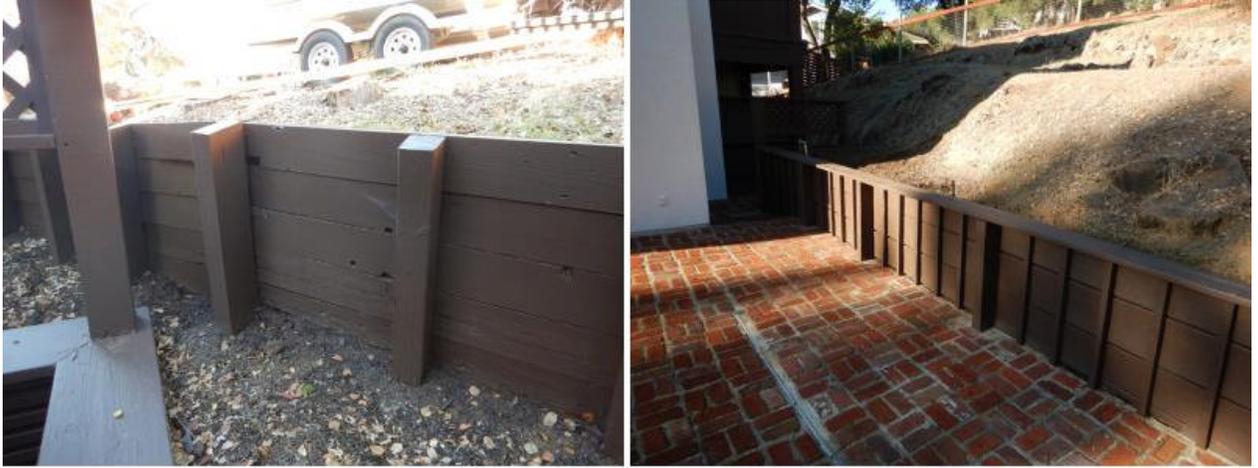
### Retaining Walls:

Walls consist of wood and block.

Sections of the wood retaining walls are leaning somewhat.

The presence of the stucco prevented review of the condition of the block retaining walls.

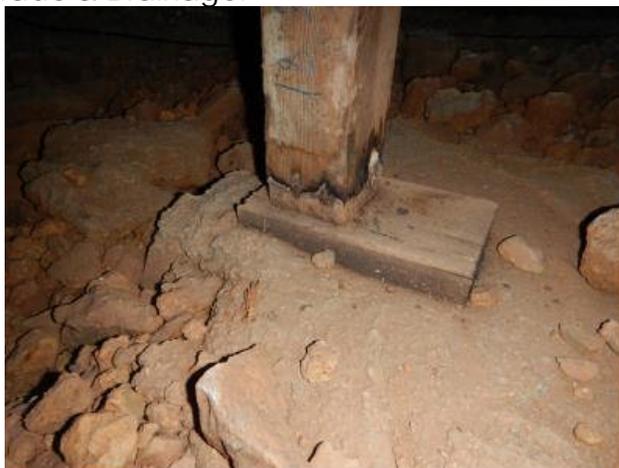
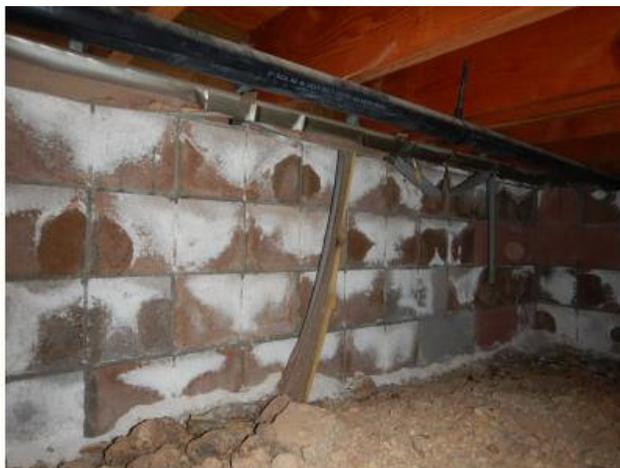
**Grade & Drainage:**

Soil was dry at time of inspection.

Moisture stains and efflorescence on the foundation walls indicate standing water has collected in the crawlspace area in the past. Efflorescence was also observed on the foundation walls. While seasonal water is not uncommon in foundation crawlspaces in this area, water has come into contact and damaged a wood post/support. This is a recurring condition; however, I cannot determine if this has been corrected or is continuing. One course of action would be to hire a civil engineer to review this home and design a drainage system. Another course would be to inspect the crawlspace during the rainy winter months to determine how much water actually enters the crawlspace as well as the basement area and whether or not a drainage system is necessary. If excessive levels of moisture is found, installation of a drain system may be necessary to intercept water before it enters the foundation area. Please refer to the exterior/drainage notes earlier in this report for related information.

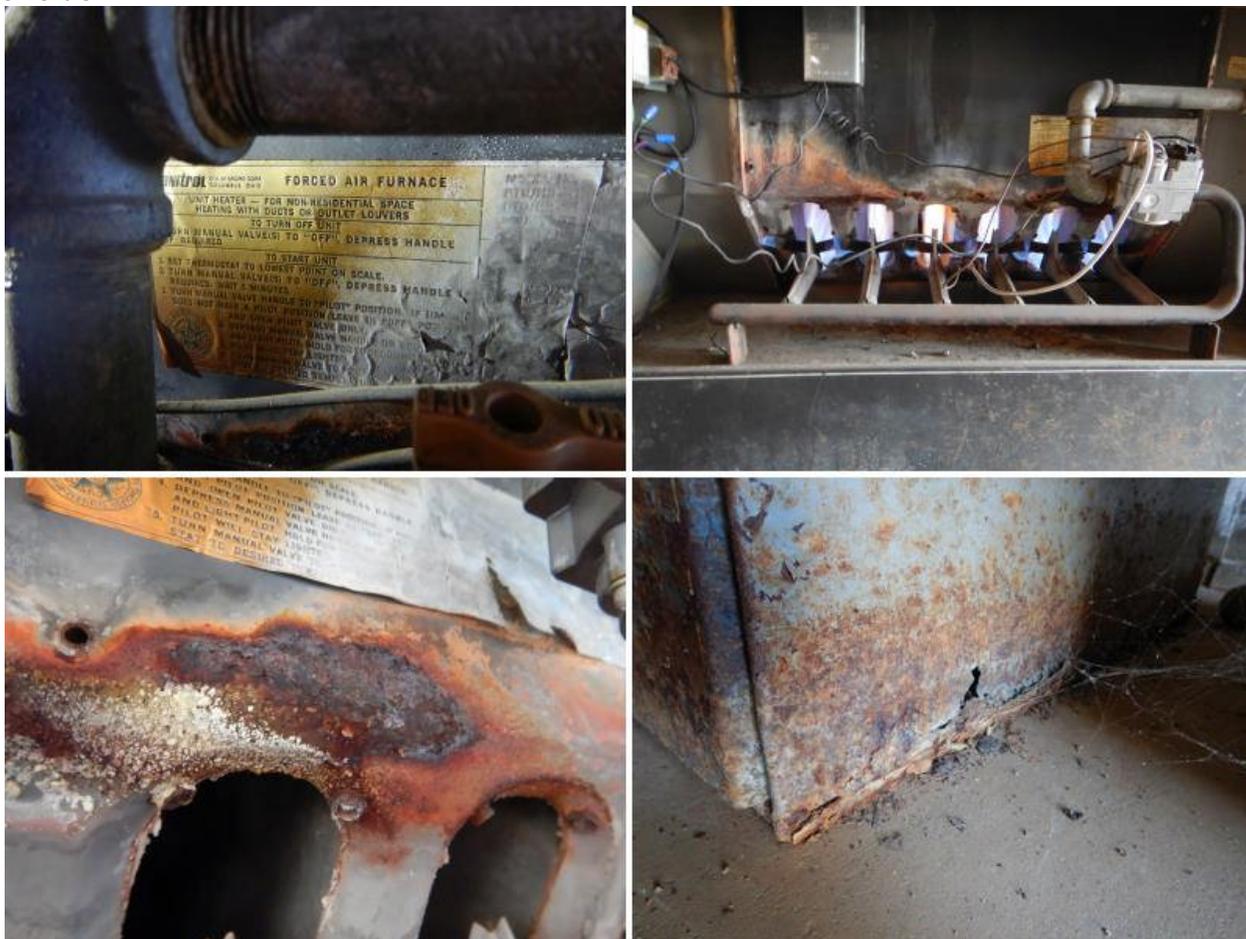
Gas shutoff valve and electric disconnect present.

The label states that this furnace is for non-residential use. I do not know if there are any potential safety issues with this furnace been installed in a residence. More information can be obtained from a licensed heating contractor.

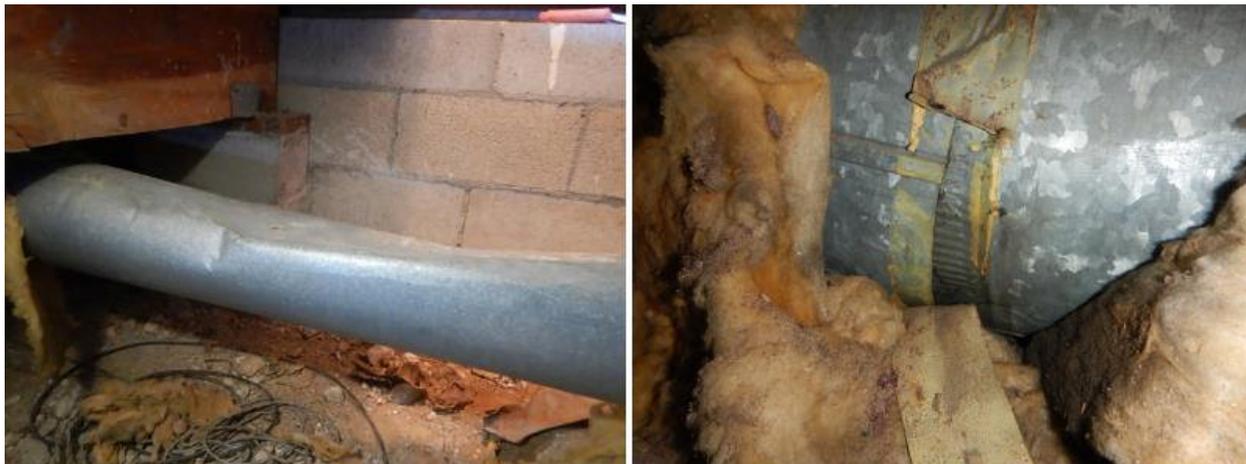
**Distribution:**

Where visible, the distribution method consists of sheet metal ducting.

Sections of the ducting have been damaged. The ducting is partially crushed and separations were observed at seams/connections. This will reduce the air flow through the ducting and the efficiency of the heating system. Ducting should be repaired or replaced, by a licensed heating contractor.

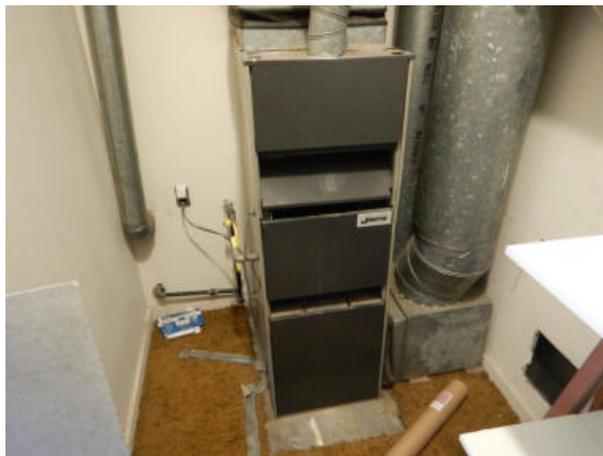
This is an older appliance that is likely beyond its expected life. I was unable to remove the flame shield. While this appliance functioned at the time of the inspection, older heaters have a greater chance of having a cracked heat exchanger, do not have the safety features that are present on current models and tend to require increased maintenance and repairs. In addition, many furnace contractors are unwilling to perform maintenance/repairs on older appliances due to the potential hazards and liability involved. Installation of a new, efficient heater is my primary recommendation. At a minimum, this heater should be reviewed by PG&E or a licensed heating contractor prior to occupancy or use, any necessary corrections/repairs made to ensure safe operation, and then inspected on an annual basis thereafter.

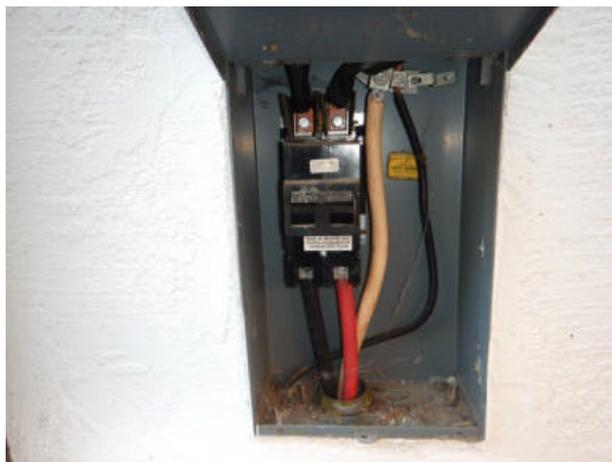
#### Over Current Protection:

Over current protection is provided by circuit breakers. Service disconnect (main) is present.

Conditions have been reported with this brand of electrical panel (Zinsco/Sylvania) that include arcing at the circuit breaker/buss bar connections. This condition is largely due to the method of attachment between the circuit breakers and the buss bars. As a result of this design, this panel is more likely to fail than a modern panel. To the best of my knowledge, there is no governmental or officially recognized agency currently tracking failures from these circuit breakers or panels and any information that I have been able to find regarding failures is anecdotal. This brand of panel was very commonly used in structures built between the early 1960s through the late 1980s.

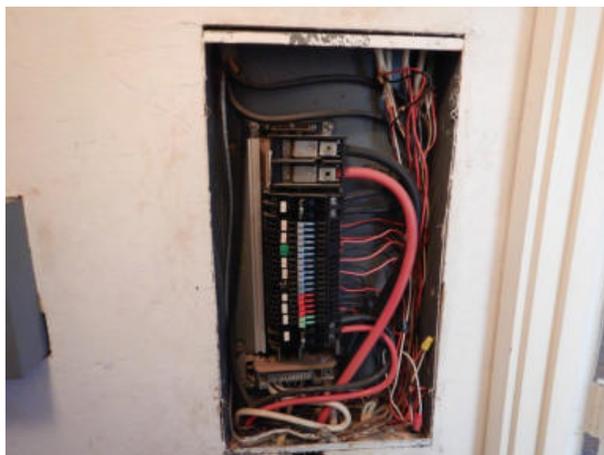
A split bolt connector has been used to connect the grounding wires together. While this was common at time of original construction, current construction standards do not allow more than three grounding conductors under a single terminal. Ideally, a grounding terminal block would be installed in the panel.

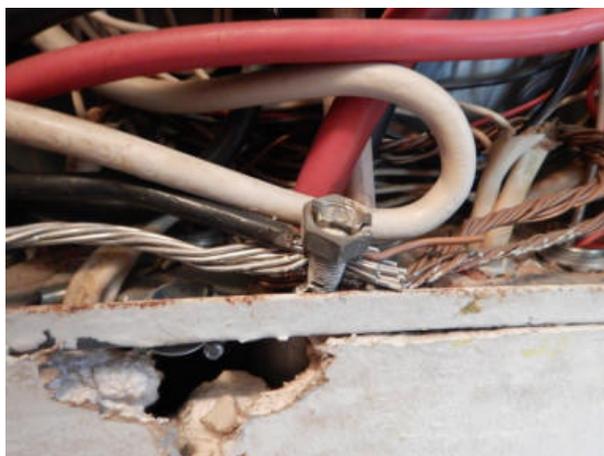
Located at the foyer closet.

Clearance to access this panel is restricted. Please refer to the previous panel for related information.

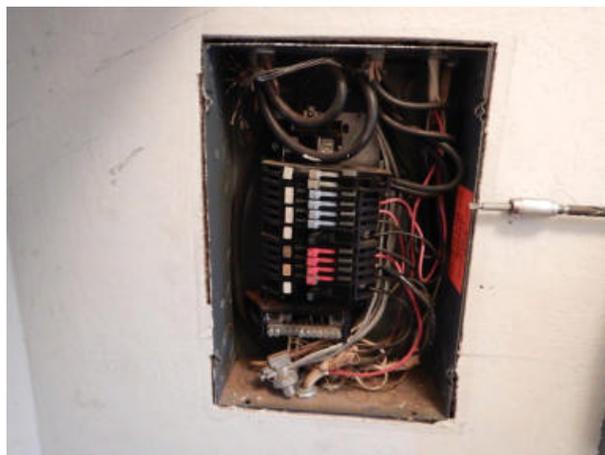
A split bolt connector has been used to connect the grounding wires together. Please refer to the previous panel for related information.

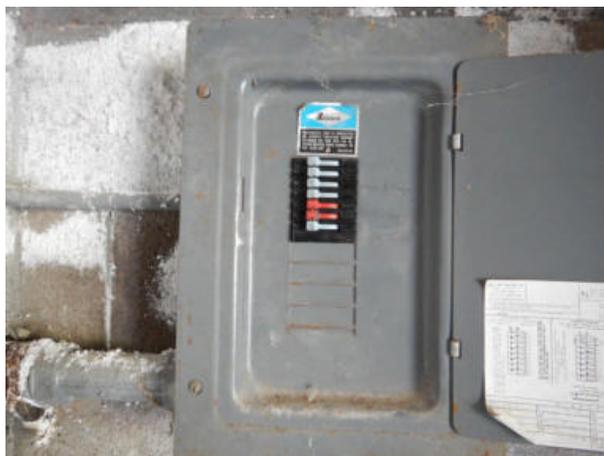
Not all of the pool circuits are GFCI protected. Current construction standards require all electrical circuits for new pools and related equipment to be GFCI protected. I suggest hiring a licensed electrical contractor to upgrade the pool electrical with GFCI devices as well as make any needed or additional upgrades or corrections to help increase safety.

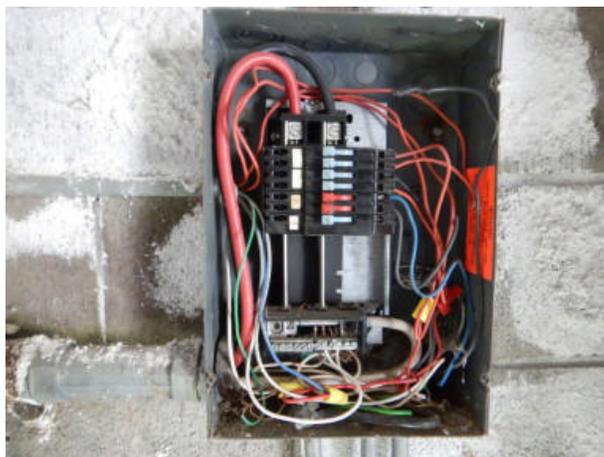
A split bolt connector has been used to connect the grounding wires together. Please refer to the previous panel for related information.

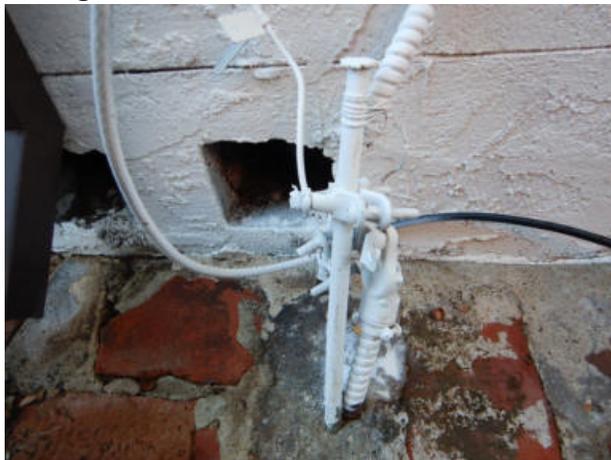
Ground rod is present.

The ground rod extends above soil level. Current construction standards require that ground rods be in contact with the earth for a minimum of 8 feet. As most standard ground rods are 8 feet long, the top of the rod should be even with the soil level. Corrections will likely require driving the rod so the top of the rod is even with soil grade. The appropriate person to make corrections is a licensed electrical contractor.

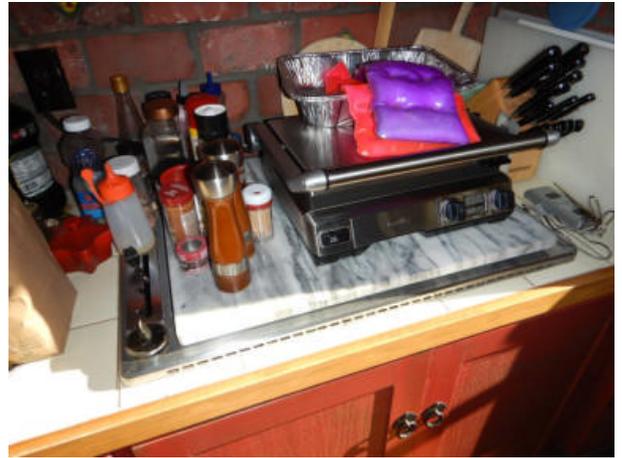
**Grill:**

Personal property was piled on top of the grill. As a result, this could not be tested. I recommend verification of operation once the property has been removed.

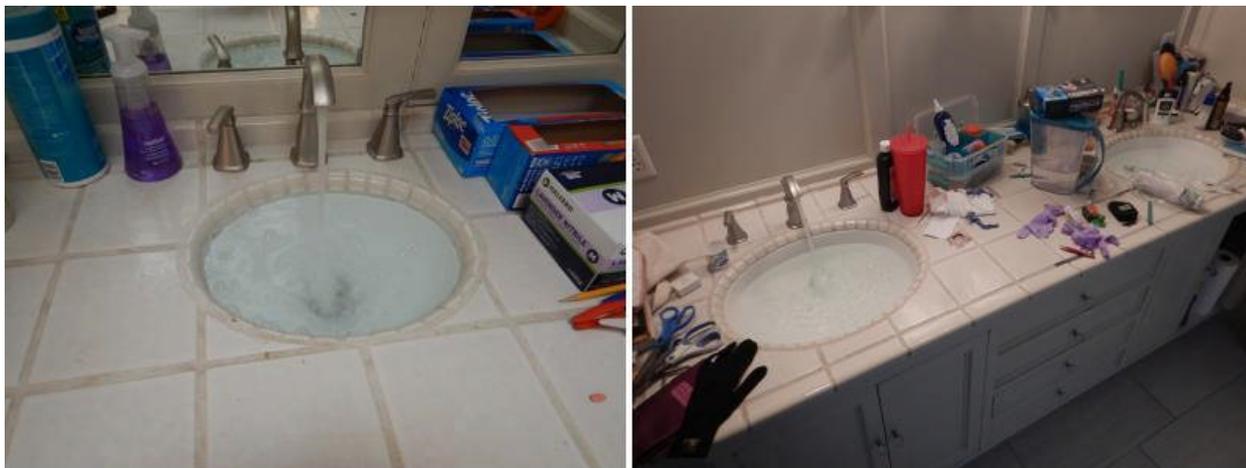
#### Sink:

Three sinks present.

No overflow drain provided at the single sink. This is as originally designed/manufactured. Caution is advised as the sink could overflow if not monitored while the faucet is on.

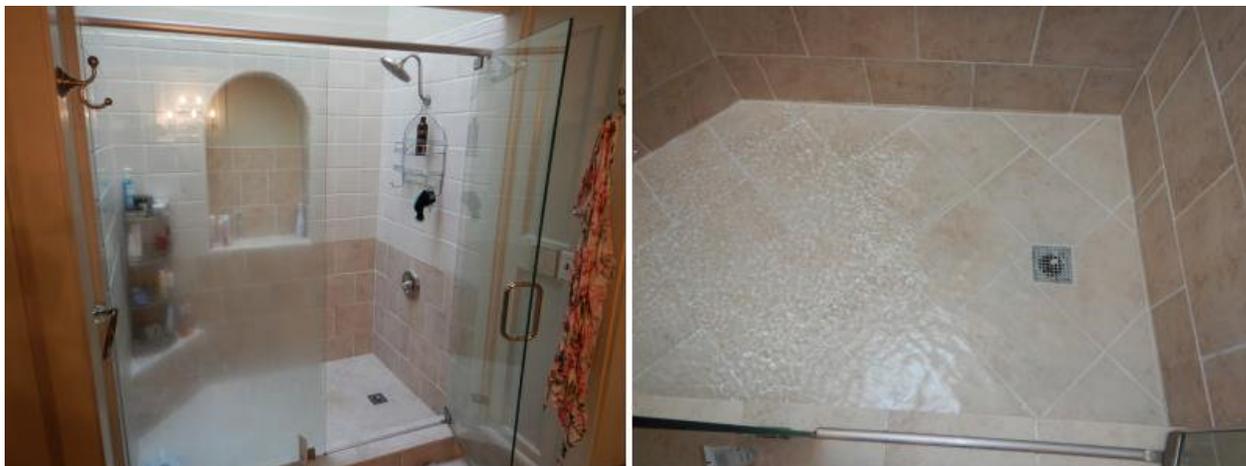
#### Shower & Surround:

Tile surround walls and pan. Single lever faucet.

The condition of the shower pan liner could not be verified. As this shower is located above a finished ceiling, I did not fill the pan with water and it is likely that a pest inspector will not fill the pan either. If the waterproof pan liner leaks, filling the pan with water would result in moisture damage to the finished ceiling below. I recommend obtaining a signed damage waiver from the seller to allow a pest inspector to fill the shower pan with water and test the condition of the waterproof pan liner.

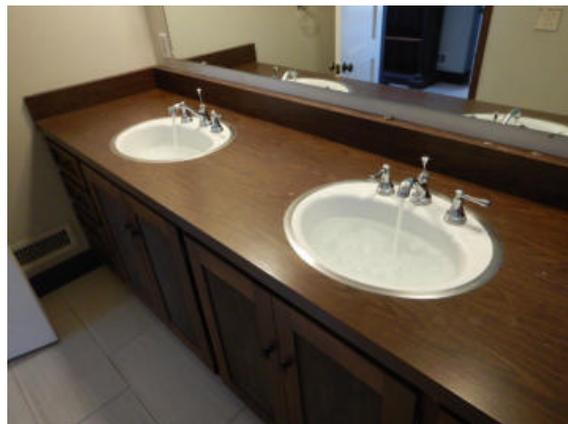
Plumbing fittings and valves are older. I suggest preventative replacement.

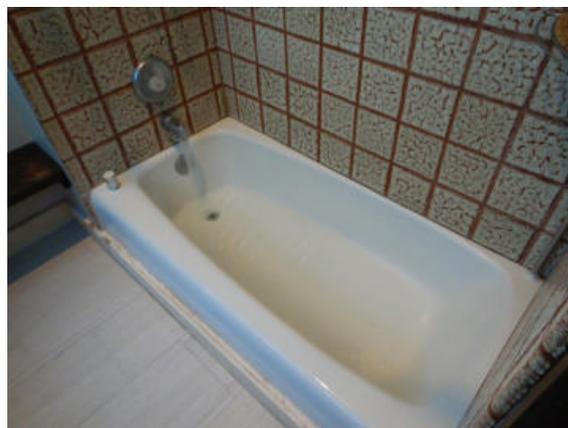
No mechanical ventilation provided. As a window is present, a ventilation/exhaust fan may not have originally been required. However, many people will not open a window when showering if the weather is cold, which can contribute to excess moisture/humidity in the bathroom. I suggest installation of an exhaust fan to discharge humid air to the exterior.

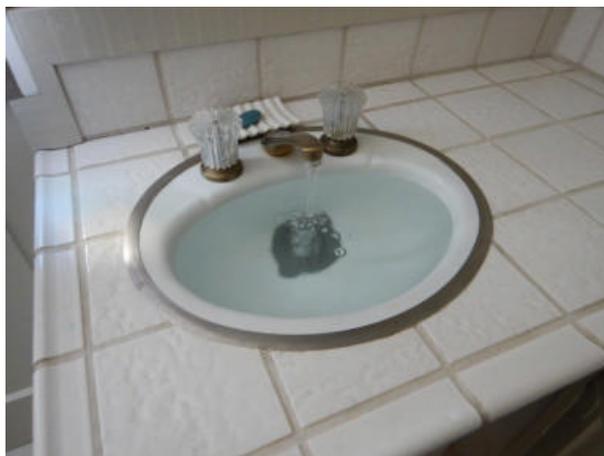
Plumbing fittings and valves are older. I suggest preventative replacement.

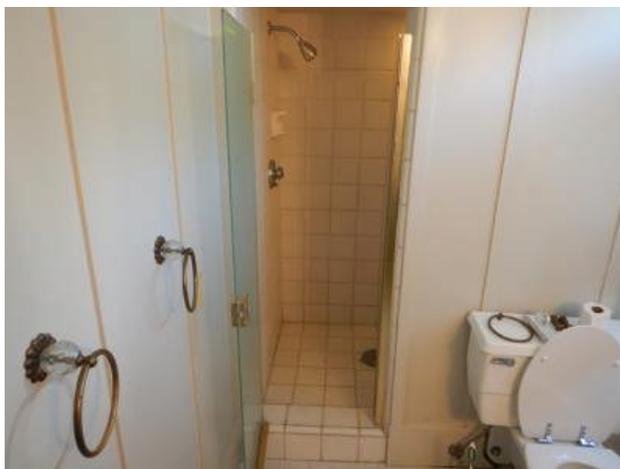
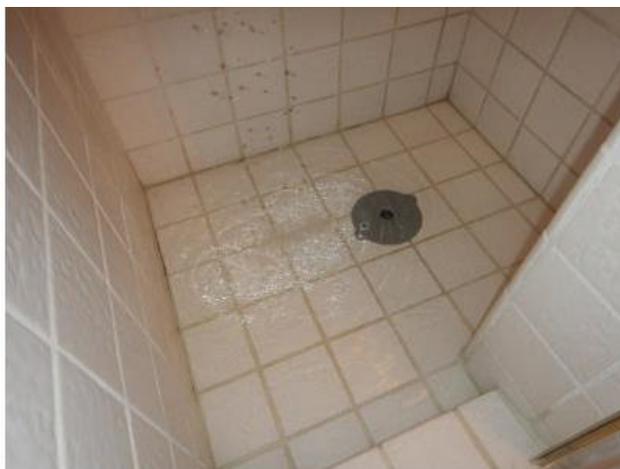
### Shower & Surround:

Tile surround walls and pan.

Cracks/voids present in grout. While missing grout is common and often recurs, this should be patched, regouted or caulked, as needed.

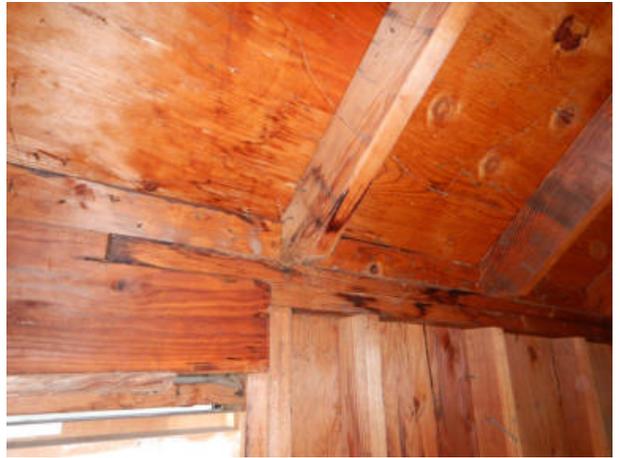
Moisture stains were observed at several areas. The condition of the roof suggests that this is due to leaking that has been corrected.

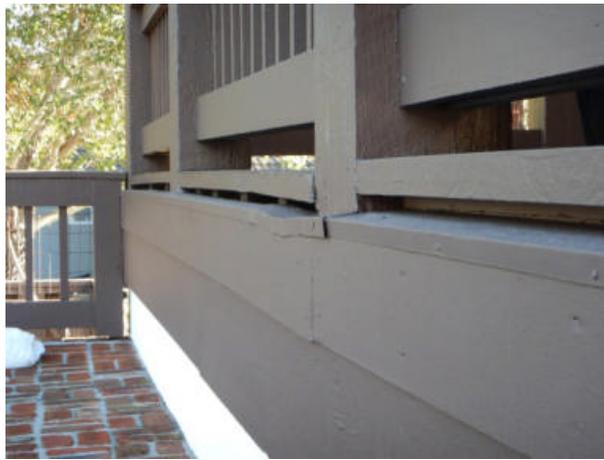
Exterior wood members are decayed/damaged. Some of this damage appears to be structural posts. Replacement of damaged trim or any necessary repairs are advised.

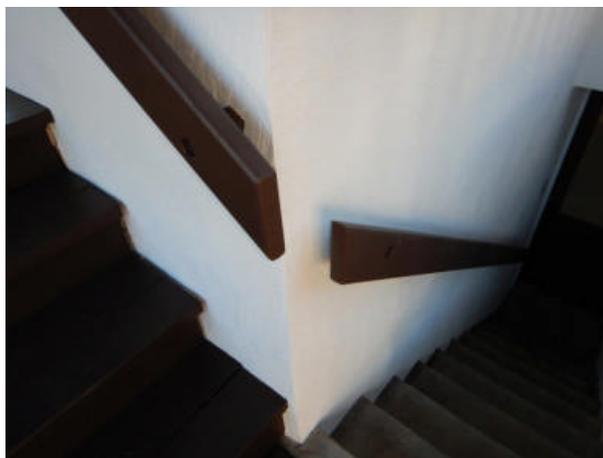
Steps:

Steps do not have a proper handrail. Typically, when more than three risers are present, a stairway should have a guardrail with a handrail that can be easily gripped. Handrails should have a minimum clearance from the wall or guardrail of no less than 1½ inches, should not project into the stairway more than 4½ inches, should be between 34 and 38 inches above the nosing and the ends of the handrail should "return" back to the wall or newel post to help prevent catching/hooking loose clothing or belongings on the projecting end. The diameter of a circular handrail should be between 1¼ and 2 inches in diameter. Handrails are intended to help prevent an individual from falling when ascending or descending a stairway.
