Gage Inspection Services

Property Inspection Report

811 Sentinel Ct, Santa Rosa, CA 95409
Inspection prepared for: Debrah Orlando
Real Estate Agent: Doug Swanson -

Date of Inspection: 6/2/2023 Time: 9:00 AM
Order ID: 1320

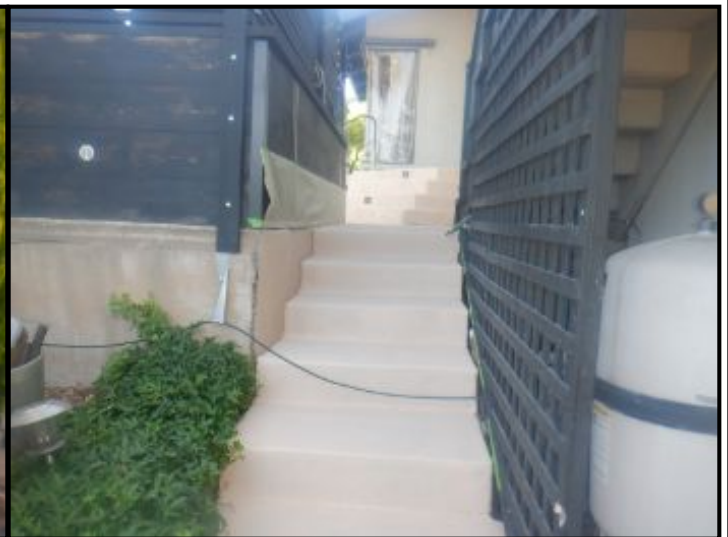
Page 21 Item: 3	Steps	<ul style="list-style-type: none"> • Attention • The railing system for the concrete stairway at the left side of the home does not have what is considered a gripable hand rail system. Installing a hand rail system up to current standards is recommended as a health and safety consideration. • Any stairway with 4 or more risers should have a handrail system installed. As a health and safety consideration it is recommended to install a railing/handrail system at the exterior concrete steps.
-----------------	-------	--

No handrail installed at stairway.

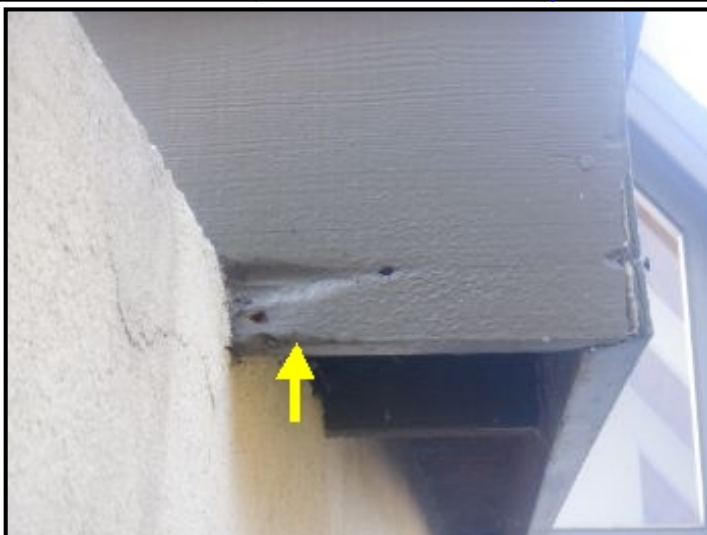
Page 25 Item: 7	Fascia Boards/Trim	<ul style="list-style-type: none"> • Maintenance • Fascia damage has been noted at the north exterior of the home. We recommend referring to the pictures and contacting a qualified contractor to review the current pest report and make needed repairs. • Bird damage was noted to the fascia boards at the north side peak of the roof. We recommend contacting a qualified pest control company for evaluation/recommendations.
-----------------	--------------------	--

Fascia damage at right side of home.

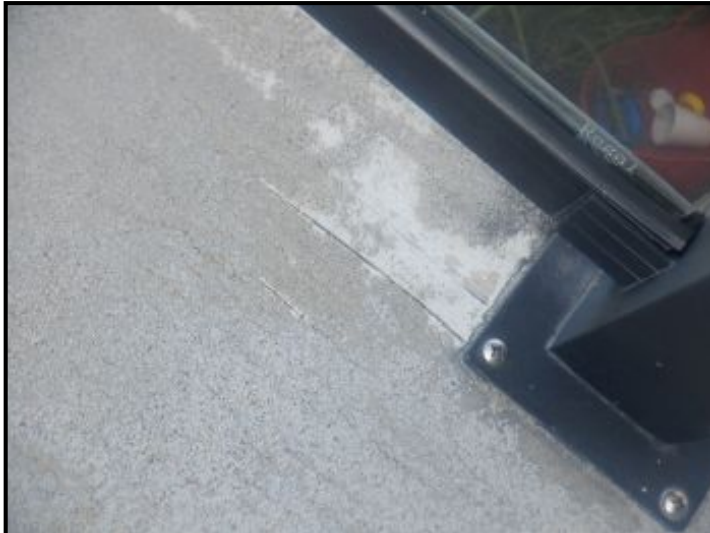
Page 29 Item: 1	Surface	<ul style="list-style-type: none"> • Attention • The south side balcony is a wood framed deck with a weather proof membrane installed. The surface coat is showing wear and is recommended to be resealed to prevent deterioration and potential moisture intrusion. • There is a lifted deck board off the bedrooms that may cause a potential tripping hazard. Its recommended to refasten the board to the deck framing as a preventative measure.
-----------------	---------	---

Worn surface at master bedroom deck.

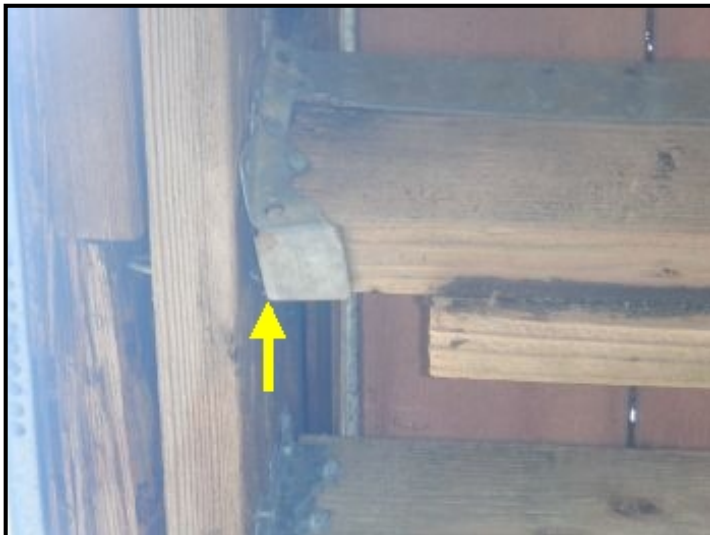
<p>Page 30 Item: 4</p>	<p>Foundation/Framing</p>	<ul style="list-style-type: none"> • Maintenance • There are joist hangers that are pulling away from the deck fascia board and fasteners that are not properly set. Though currently serviceable we recommend contacting the appropriate specialist for evaluation/repairs. • There was deterioration noted one of the deck joists at the left side of the home. Damaged wood should be removed and supported with new lumber and corrective measures to prevent this from recurring. We recommend referring to the current pest report.
------------------------	---------------------------	---

Joist hangers pulling away from deck fascia.

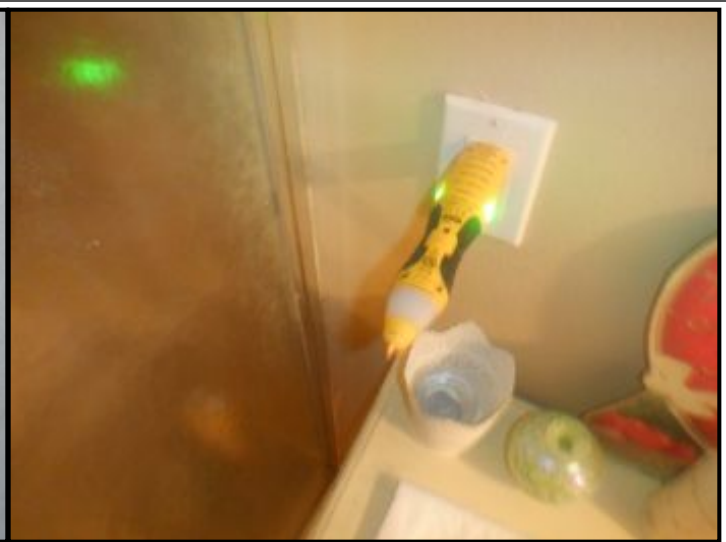
- Maintenance
- The exterior outlet at the deck off the master bedroom was tripped before the inspection started and the inspector was unable to reset indicating repairs/replacement is needed. Contact a qualified electrician for repairs.
- Current electrical standards require that ground fault interrupters (**GFCI**) be located in areas where there is a potential danger of electrical shock. Areas such as kitchens, bathrooms, garages and exterior outlets. The inspector recommend installing GFCI outlets at the outlet next to the studio shower and sink area as a preventative health and safety consideration.

Outlet next to studio shower not GFCI

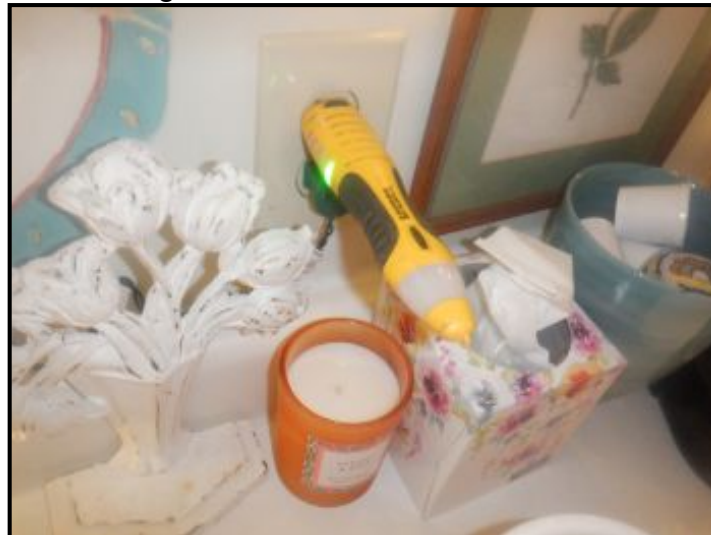
Outlet not GFCI next to sink in studio.

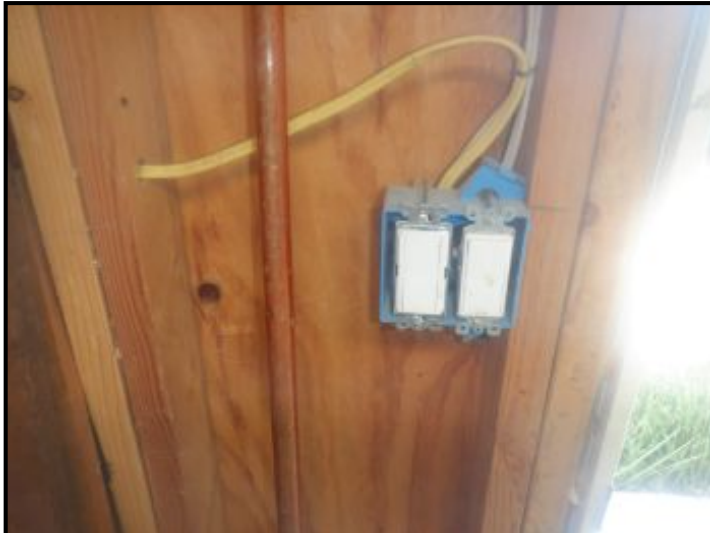
Missing cover plate in sub area.

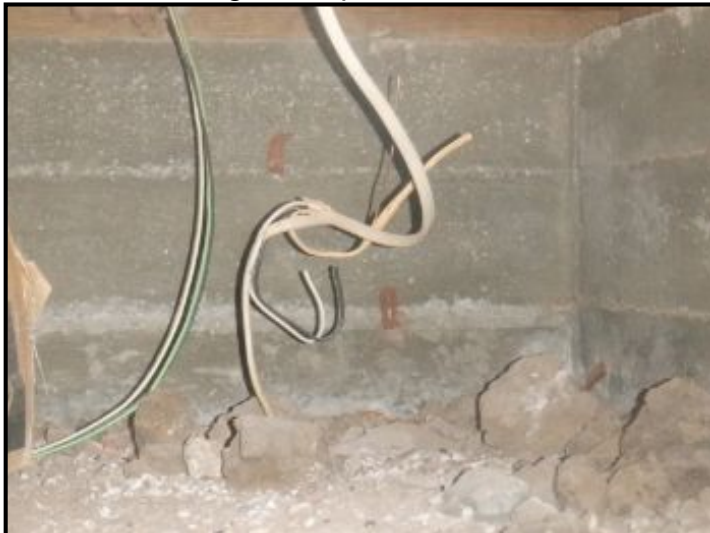
Exposed electrical in sub area.

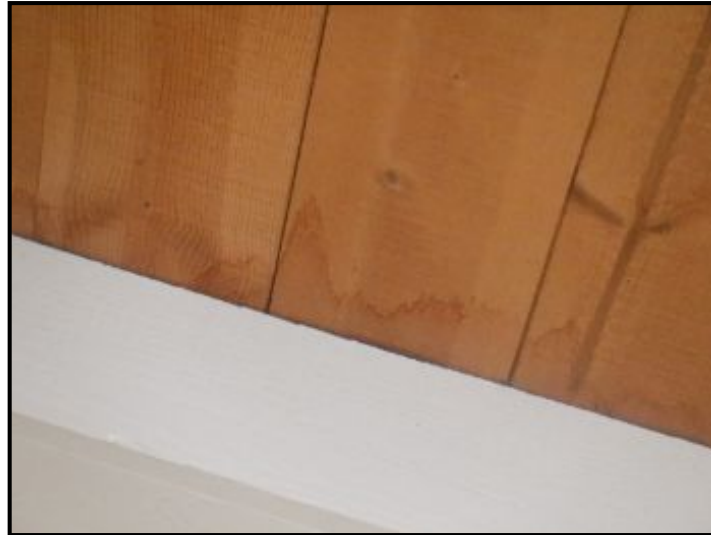
There is moisture staining noted at the ceiling of the family room, kitchen and loft indicating past leaking. The areas were dry at the time of the inspection and no major adverse conditions were noted. We recommend referring to the seller about any past leaking or repairs.

Moisture staining at ceiling.

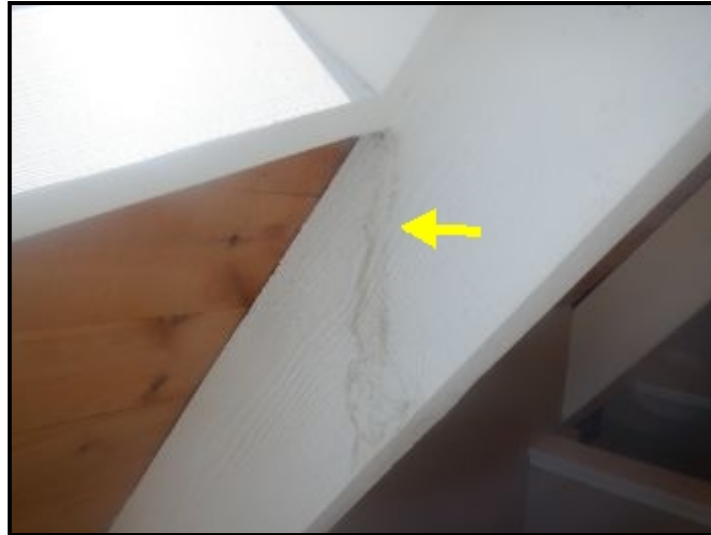
<p>Page 65 Item: 16</p>	<p>Skylights</p>	<p>Attention There is moisture staining around the skylight indicating past leaking. The areas are dry at the time of the inspection and no major adverse conditions were noted. We recommend referring to the seller about any past potential issues or repairs.</p>
-------------------------	------------------	--

Moisture staining at skylight.

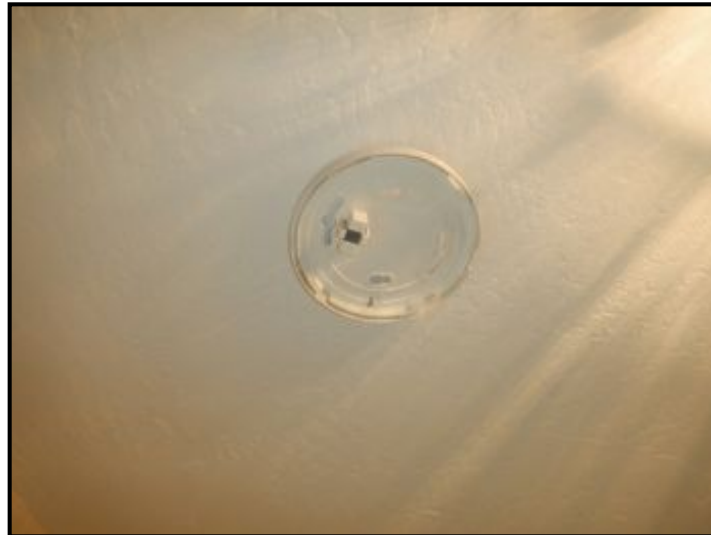
There is a missing smoke detector in the hallway. It is recommended to install newer 10 yr smoke detectors in the hallway as well as in each individual bedroom. Recommend testing the system prior to occupying the home and every month to identify functional operation of the detectors. If applicable, tall ceiling height installation may not be accessible for testing. California law requires that working smoke detectors be present upon the transfer of sale.

Missing smoke detector.

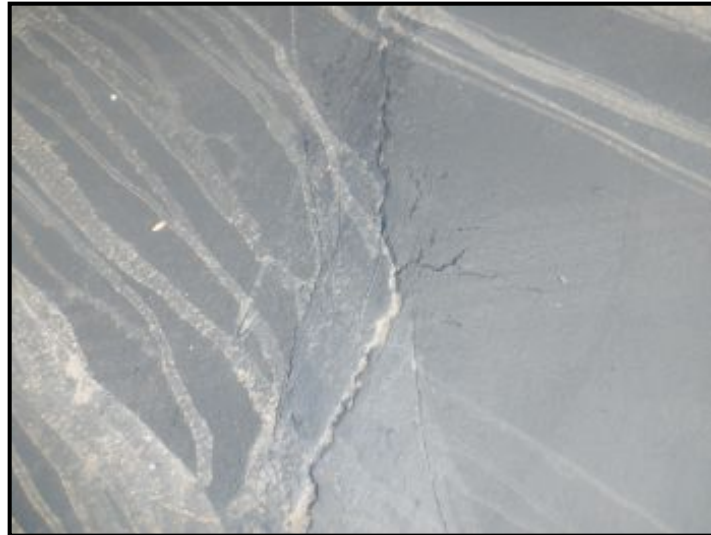
Normal settling type cracks were noted. All concrete, asphalt, and masonry eventually cracks. The cracks observed appear to be normal. The life expectancy of driveway and sidewalk paving is approx 40 to 50 years.

Cracking at driveway

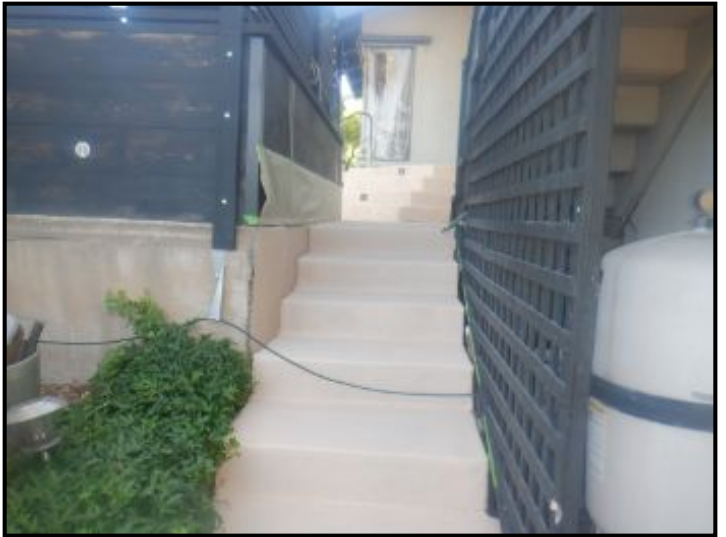
No handrail installed at stairway.

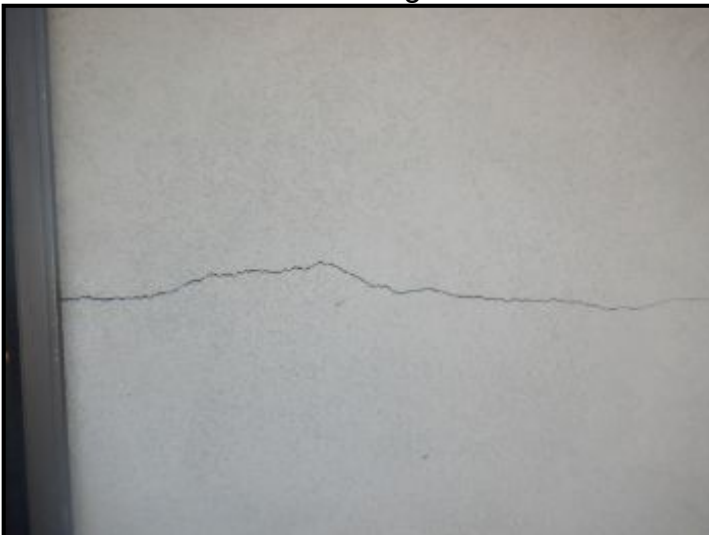
Seal stucco cracking as needed.

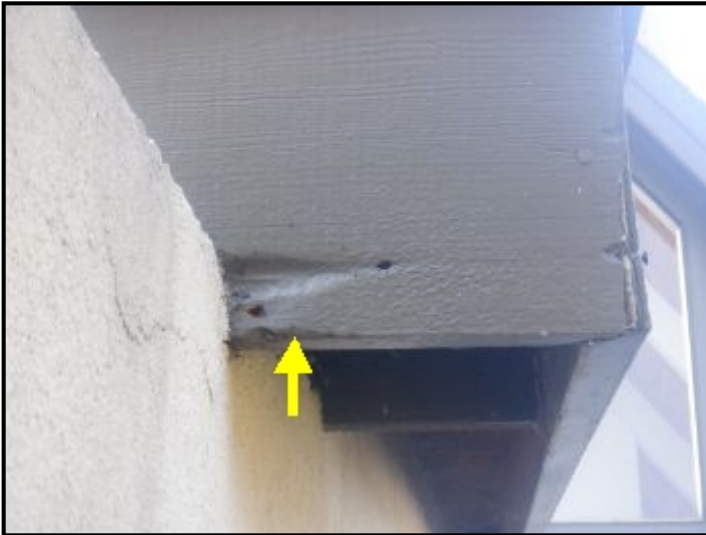
- Maintenance
- Fascia damage has been noted at the north exterior of the home. We recommend referring to the pictures and contacting a qualified contractor to review the current pest report and make needed repairs.
- Bird damage was noted to the fascia boards at the north side peak of the roof. We recommend contacting a qualified pest control company for evaluation/recommendations.

Fascia damage at right side of home.

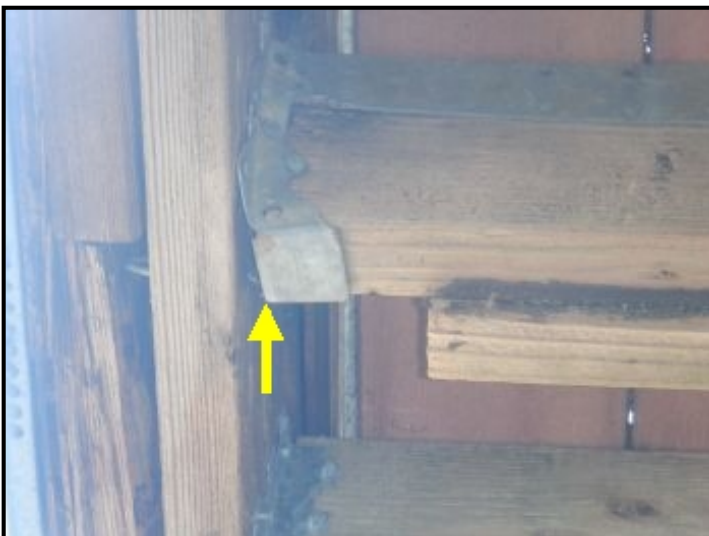
- Maintenance
- There are joist hangers that are pulling away from the deck fascia board and fasteners that are not properly set. Though currently serviceable we recommend contacting the appropriate specialist for evaluation/repairs.
- There was deterioration noted one of the deck joists at the left side of the home. Damaged wood should be removed and supported with new lumber and corrective measures to prevent this from recurring. We recommend referring to the current pest report.

Joist hangers pulling away from deck fascia.

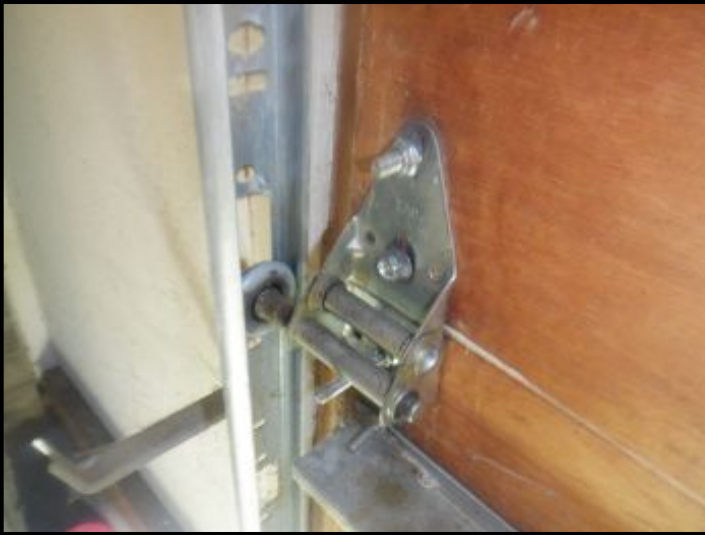
There are a few of the roller brackets that are loose causing the garage door to be rough when opening and closing. It is recommended to tighten any loose hardware as needed.

Loose roller brackets.

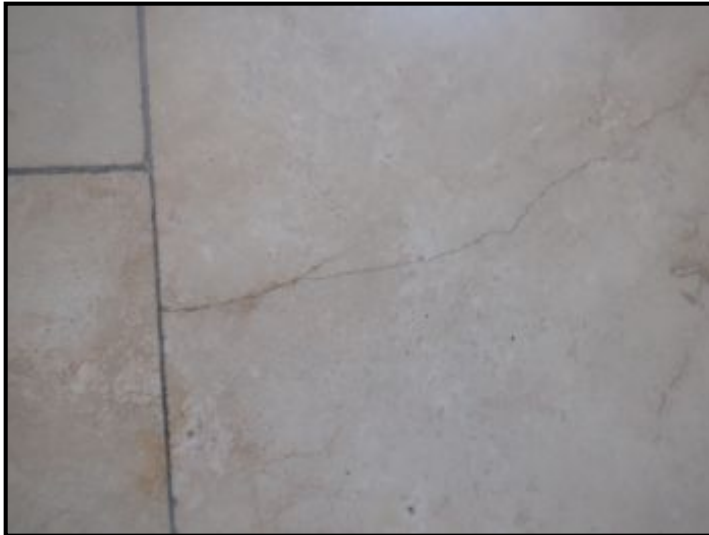
Though serviceable there are a hand full of flooring tiles that are cracked or have grout voids in the dining and entry area.

Cracked tiles at entry way.

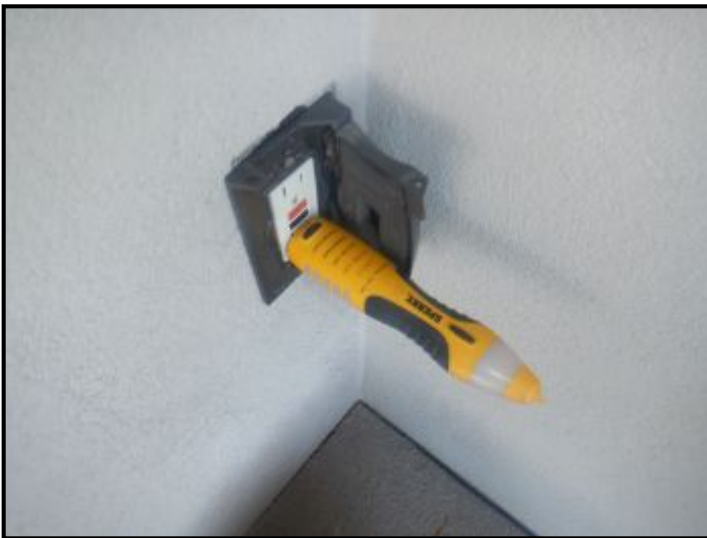
• The exterior outlet at the deck off the master bedroom was tripped before the inspection started and the inspector was unable to reset indicating repairs/replacement is needed. Contact a qualified electrician for repairs.

Deck GFCI not resetting.

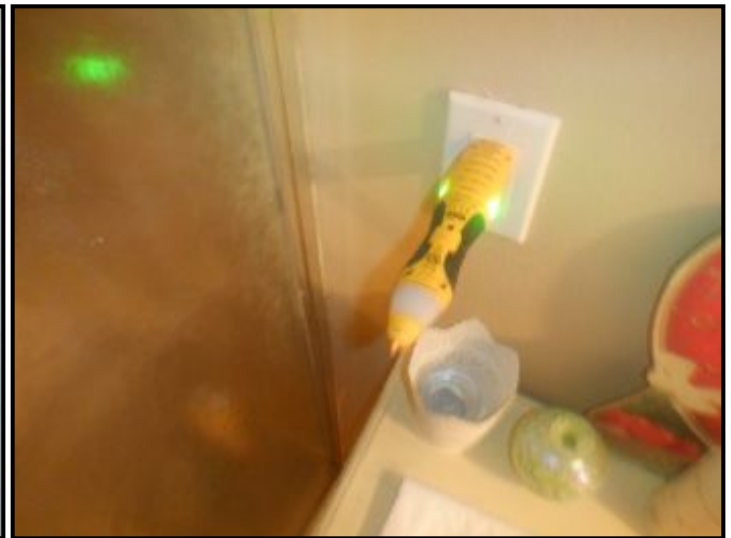
• Current electrical standards require that ground fault interrupters (GFCI) be located in areas where there is a potential danger of electrical shock. Areas such as kitchens, bathrooms, garages and exterior outlets. The inspector recommend installing GFCI outlets at the outlet next to the studio shower and sink area as a preventative health and safety consideration.

Outlet next to studio shower not GFCI

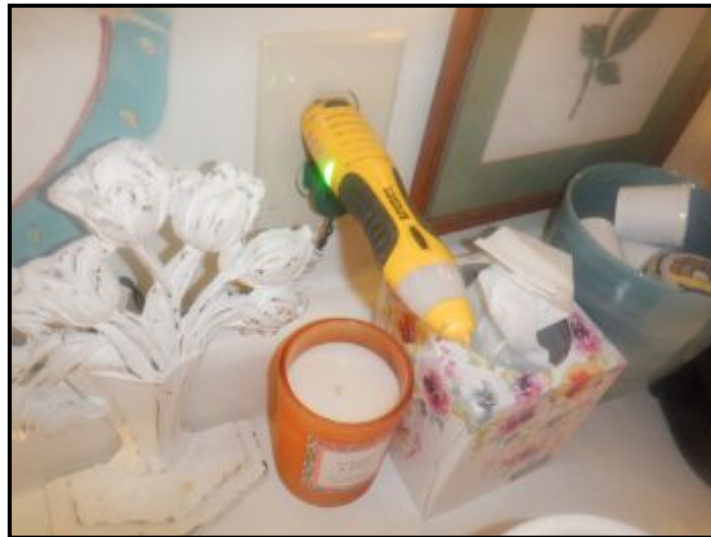
Outlet not GFCI next to sink in studio.

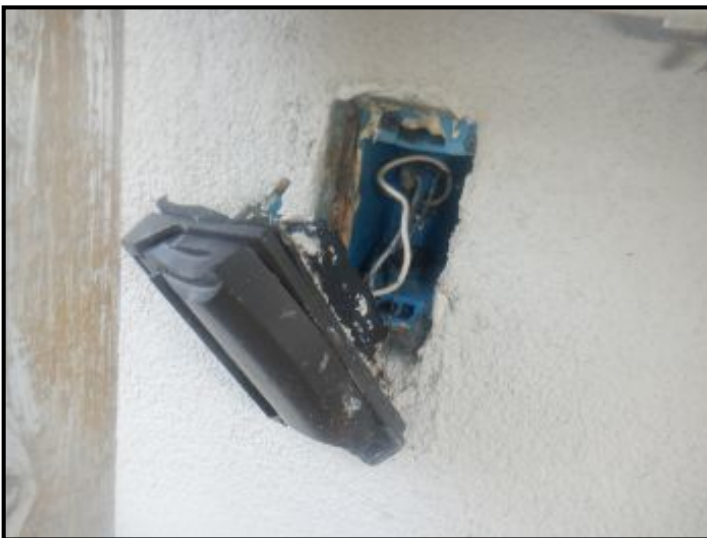
- Maintenance
- There is a loose electrical outlet with exposed wiring at the entry of the downstairs studio. Repairs are needed to properly secure the outlet to the structure and protect the wiring system.
- There is a missing junction box cover next to the entry of the downstairs studio. Installing the proper cover is recommended to protect the wiring system.
- All damaged or missing cover plates should be replaced with new cover plates to restore proper function and reduce the risk of electrical shorts and hazardous shocks. There is a missing cover plate in the cabinet above the stove top and missing covers in the sub area.
- There is unused and unprotected wiring in the sub area of the home. If the wiring is not desired removal is recommended.

Loose electrical outlet in front of studio.

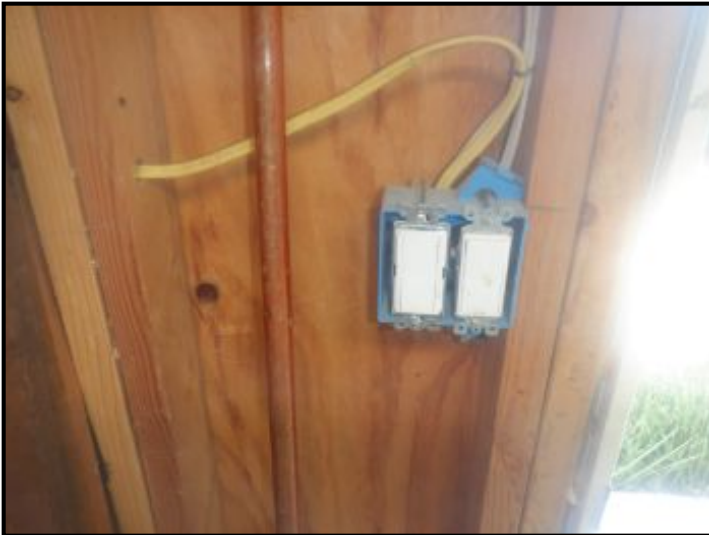
Missing cover plate in sub area.

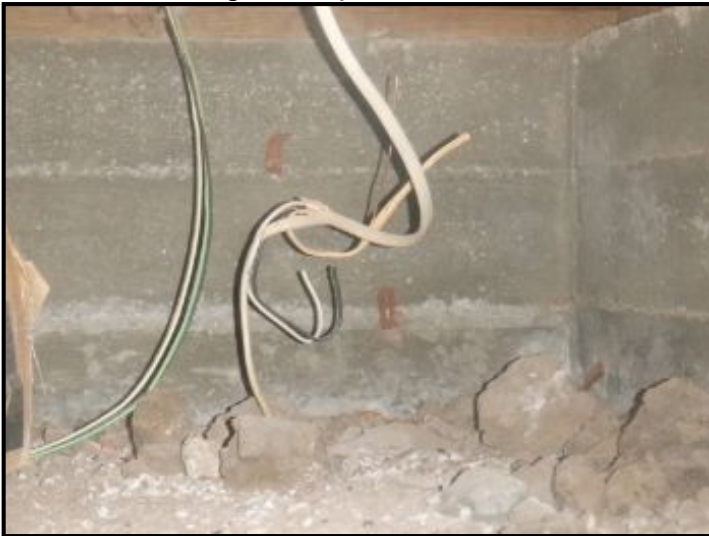
Exposed electrical in sub area.

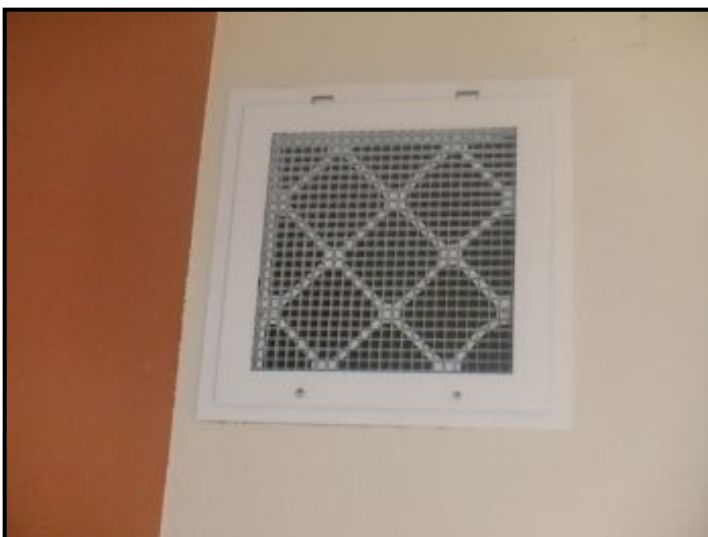
Replace air return filter.

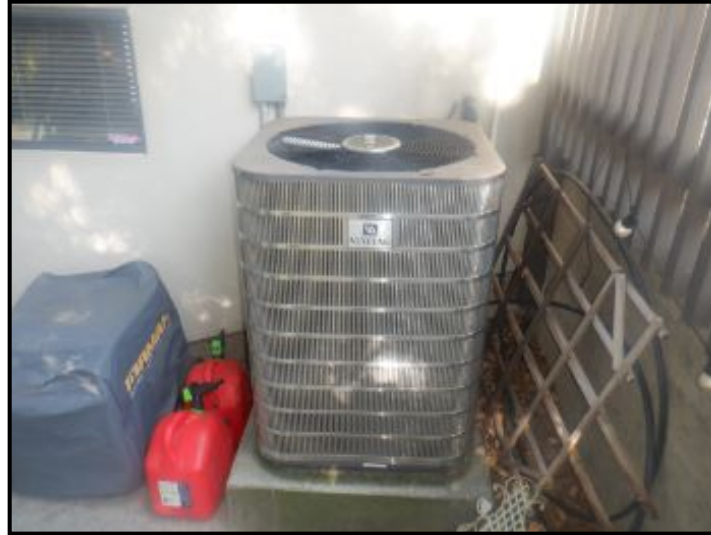
The exterior AC unit is not strapped to the concrete pad.

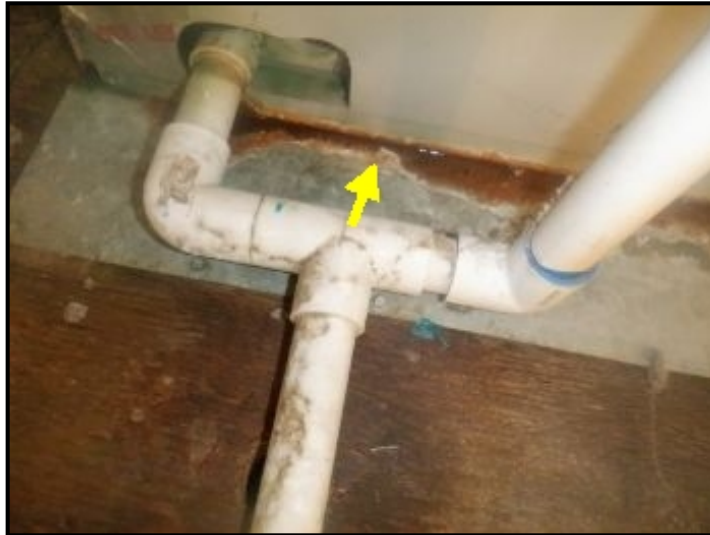
There is moisture on the platform under the A Coil at the furnace indicating leaking. Contact a qualified HVAC contractor for evaluation/repairs.

Leaking from furnace.

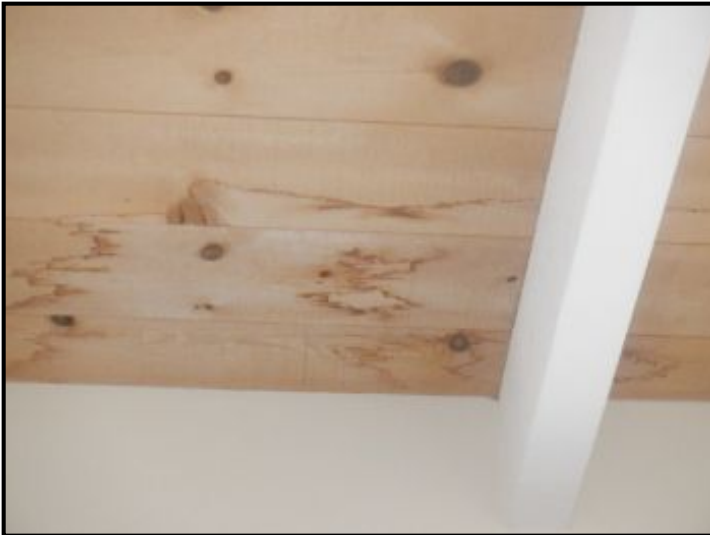
There is moisture staining noted at the ceiling of the family room, kitchen and loft indicating past leaking. The areas were dry at the time of the inspection and no major adverse conditions were noted. We recommend referring to the seller about any past leaking or repairs.

Moisture staining at dining room ceiling.
