Gage Inspection Services

Property Inspection Report

1617 Ronne Dr, Santa Rosa, CA 95404
Inspection prepared for: Bill Cileo
Real Estate Agent: Doug Swanson -

Date of Inspection: 7/13/2023 Time: 9:00 AM
Order ID: 1344

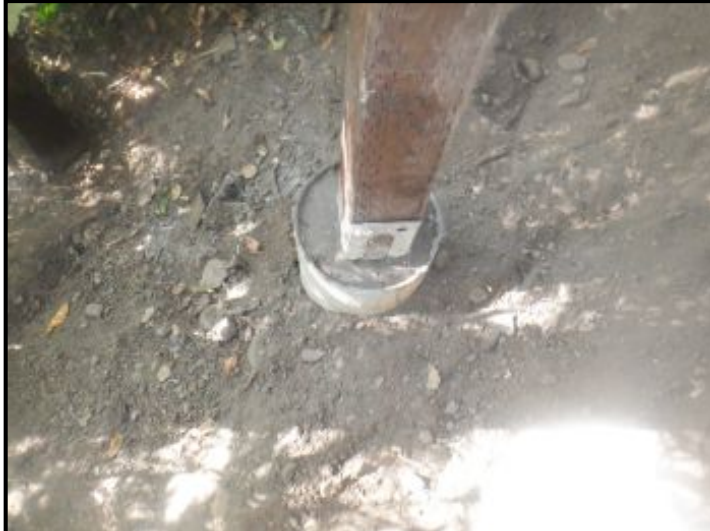
New deck framing installed.

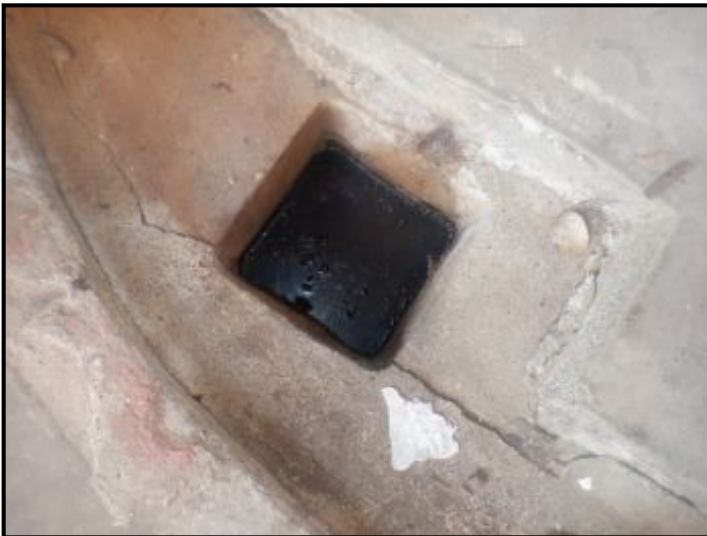
The natural grade at the right side of the home slopes to the structure. There is a drainage culvert that drains to day light under the deck and two sump pumps installed for additional drainage. Parties of interest should inquire with the owner and review the transfer disclosure as to any past or current drainage issues. Home owner is advised to monitor the exterior of the home to determine if any additional drainage system is needed.

Drain installed at right side of home.

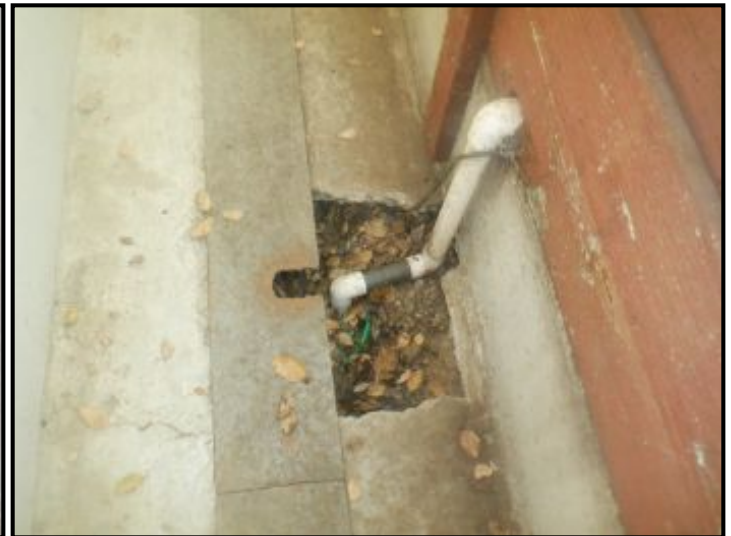
Sump pump at right side of home.

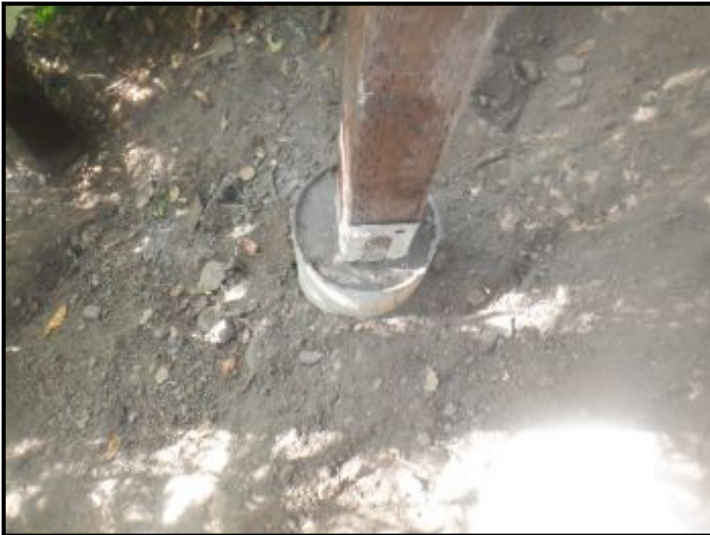
New deck framing installed.

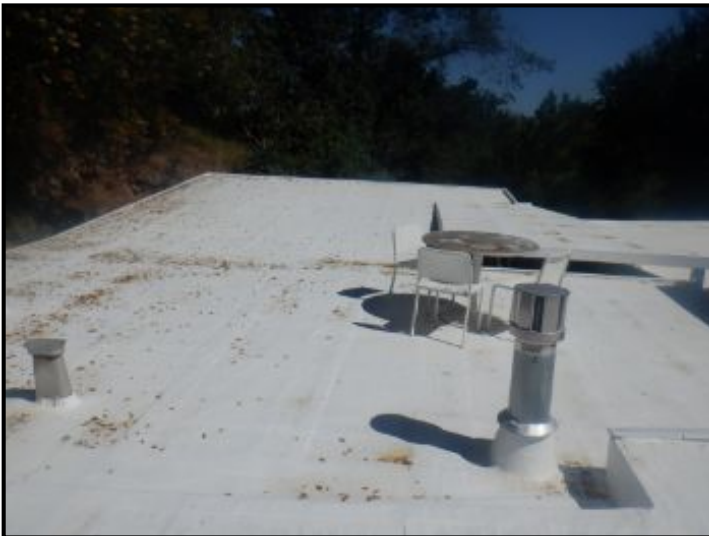
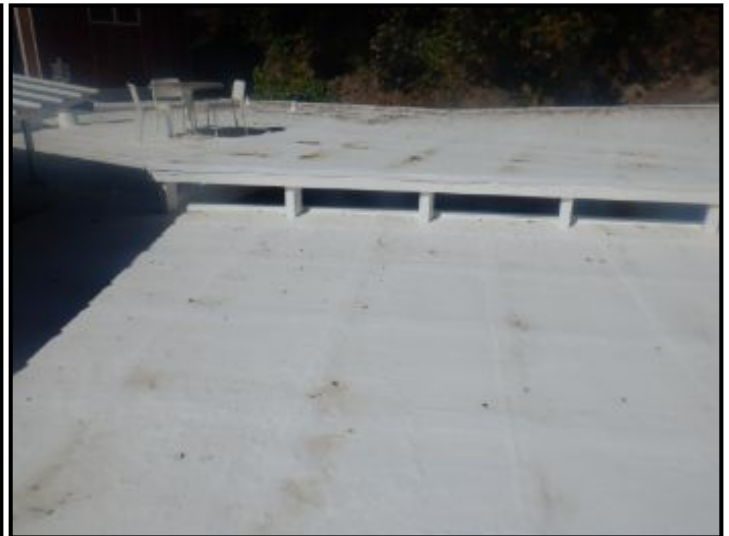
The roof cover material appears to have been recently installed and appears to be in satisfactory condition. Inquire with seller for permit, licensed roofing contractor information.
