# WOOD DESTROYING PESTS AND ORGANISMS INSPECTION REPORT

Building No. 6317	Street West Dry Creek Road	City Healdsburg	Zip 95448	Date of Inspection 6/6/2018	Number of Pages 5
----------------------	-------------------------------	--------------------	--------------	--------------------------------	----------------------

GENERAL DESCRIPTION: One story single family residence with attached garage.	Inspection Tag Posted: SUBAREA
	Other Tags Posted:

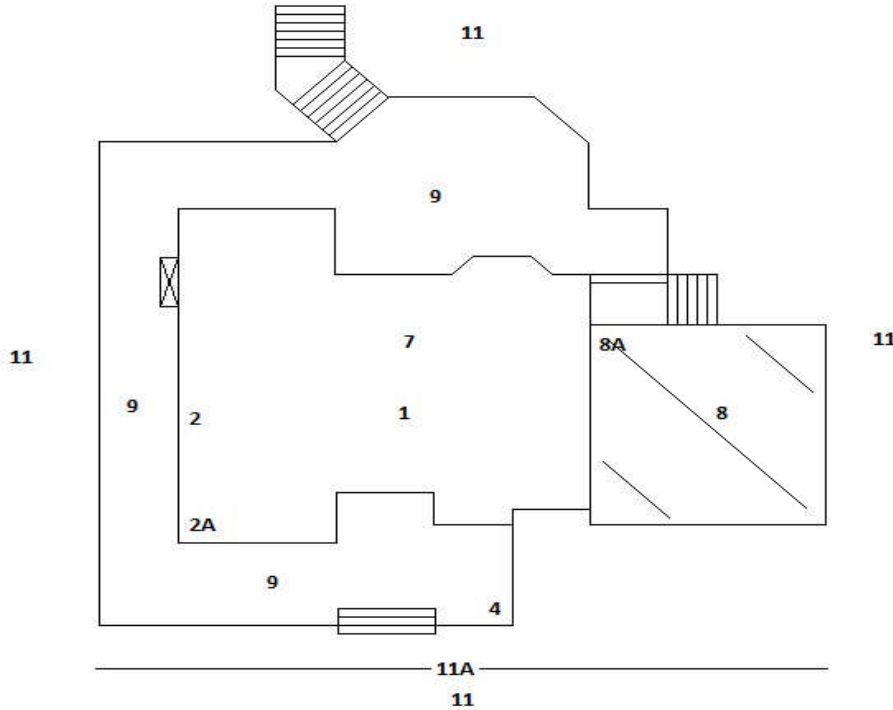
**Diagram Not To Scale**

An inspection has been made of the structure(s) shown on the diagram in accordance with the Structural Pest Control Act. Detached porches, detached steps, detached decks and any other structures not on the diagram were not inspected.
