WOOD DESTROYING PESTS AND ORGANISMS INSPECTION REPORT

Building No. 811	Street Sentinel Court	City Santa Rosa	Zip 95409	Date of Inspection 6/6/2023	Number of Pages 10
---------------------	--------------------------	--------------------	--------------	--------------------------------	-----------------------

GENERAL DESCRIPTION: Multi level single family residence with attached garage. Furnished and occupied.	Inspection Tag Posted: GARAGE
	Other Tags Posted: NONE CURRENT

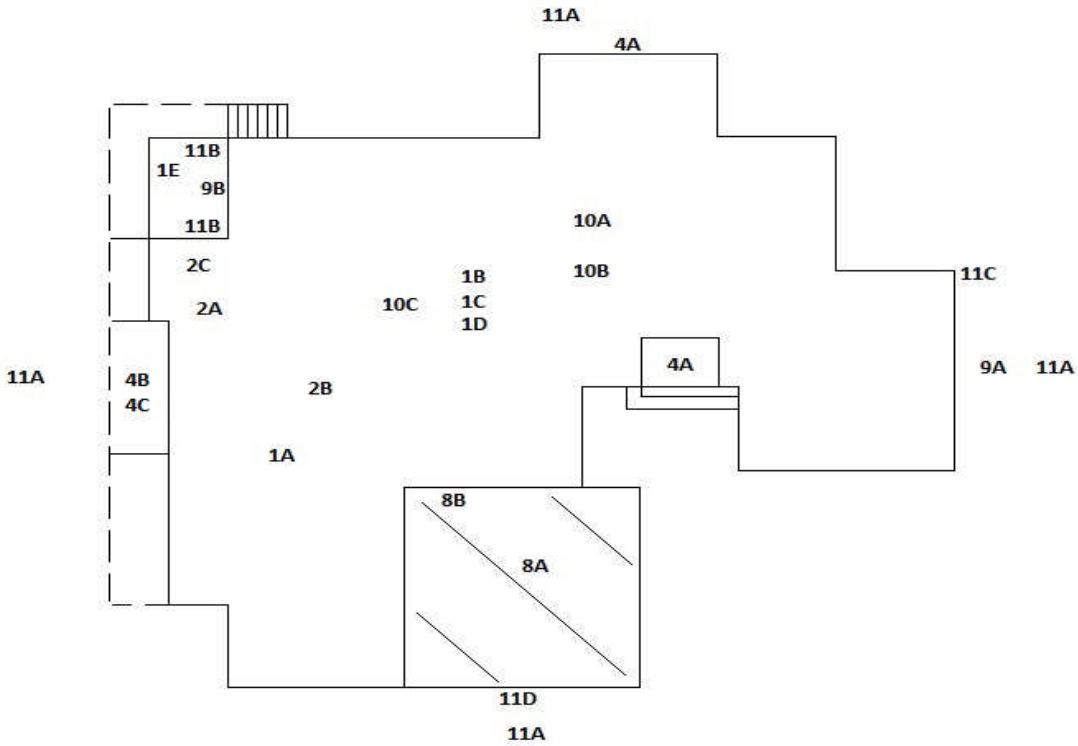
Diagram Not To Scale

An inspection has been made of the structure(s) shown on the diagram in accordance with the Structural Pest Control Act. Detached porches, detached steps, detached decks and any other structures not on the diagram were not inspected.
